**SUNY POTSDAM**  
**BARRINGTON STUDENT UNION**  
**SUMMARY OF ASBESTOS SAMPLES AND ANALYSIS RESULTS**

SUNY Potsdam-Barrington Hall Student Union  
Updated: January 13, 2014

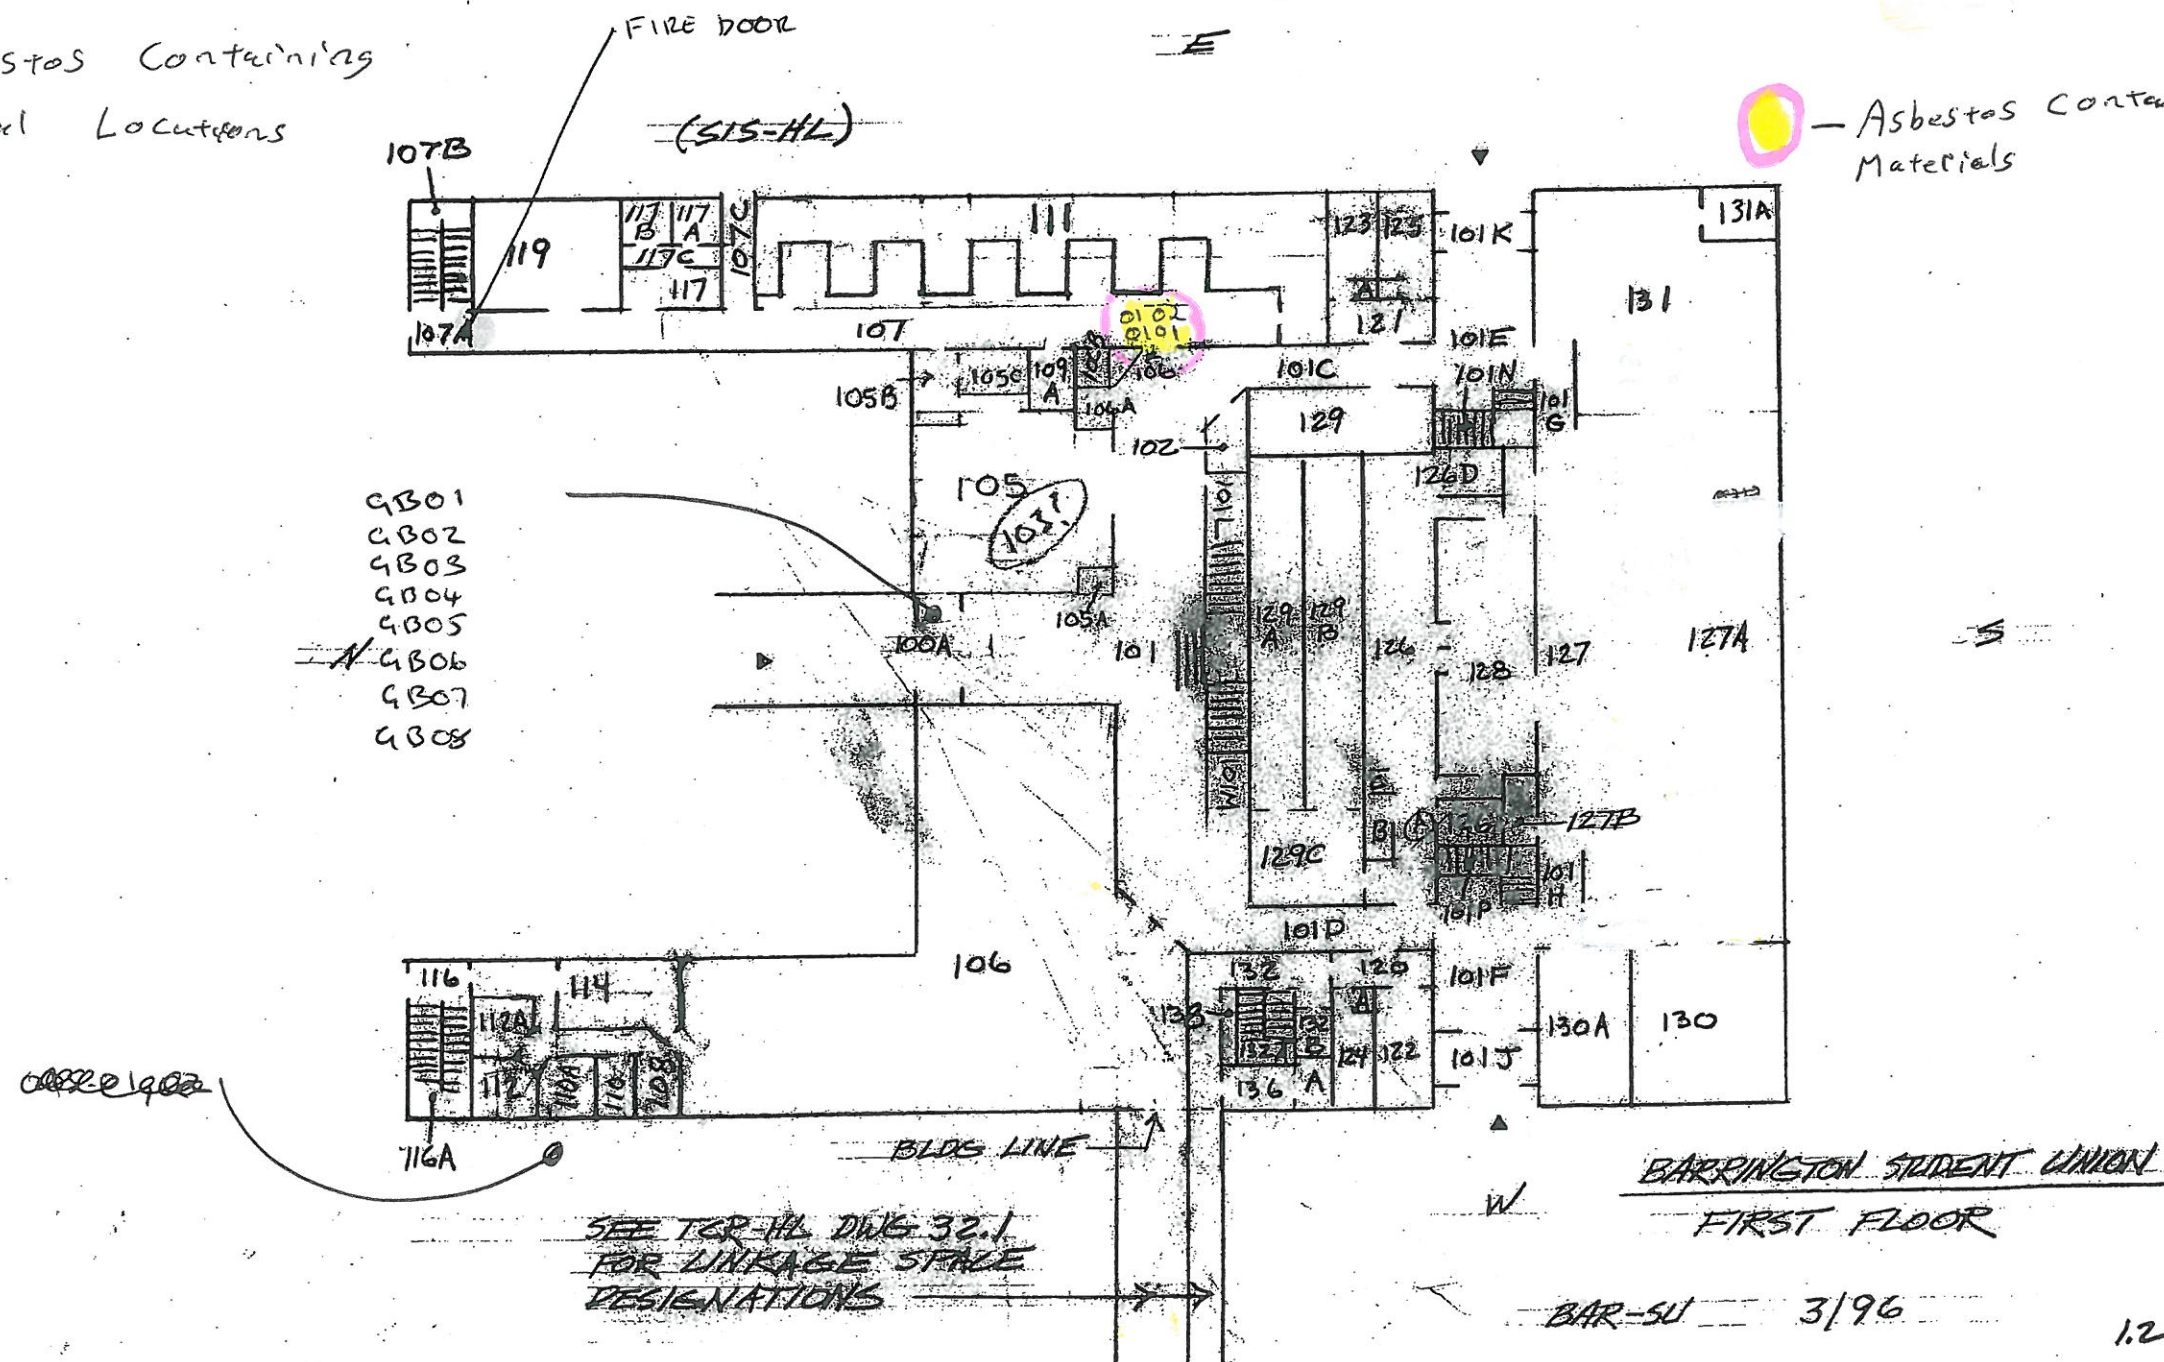
- Asbestos containing materials

## • FIRE Doors

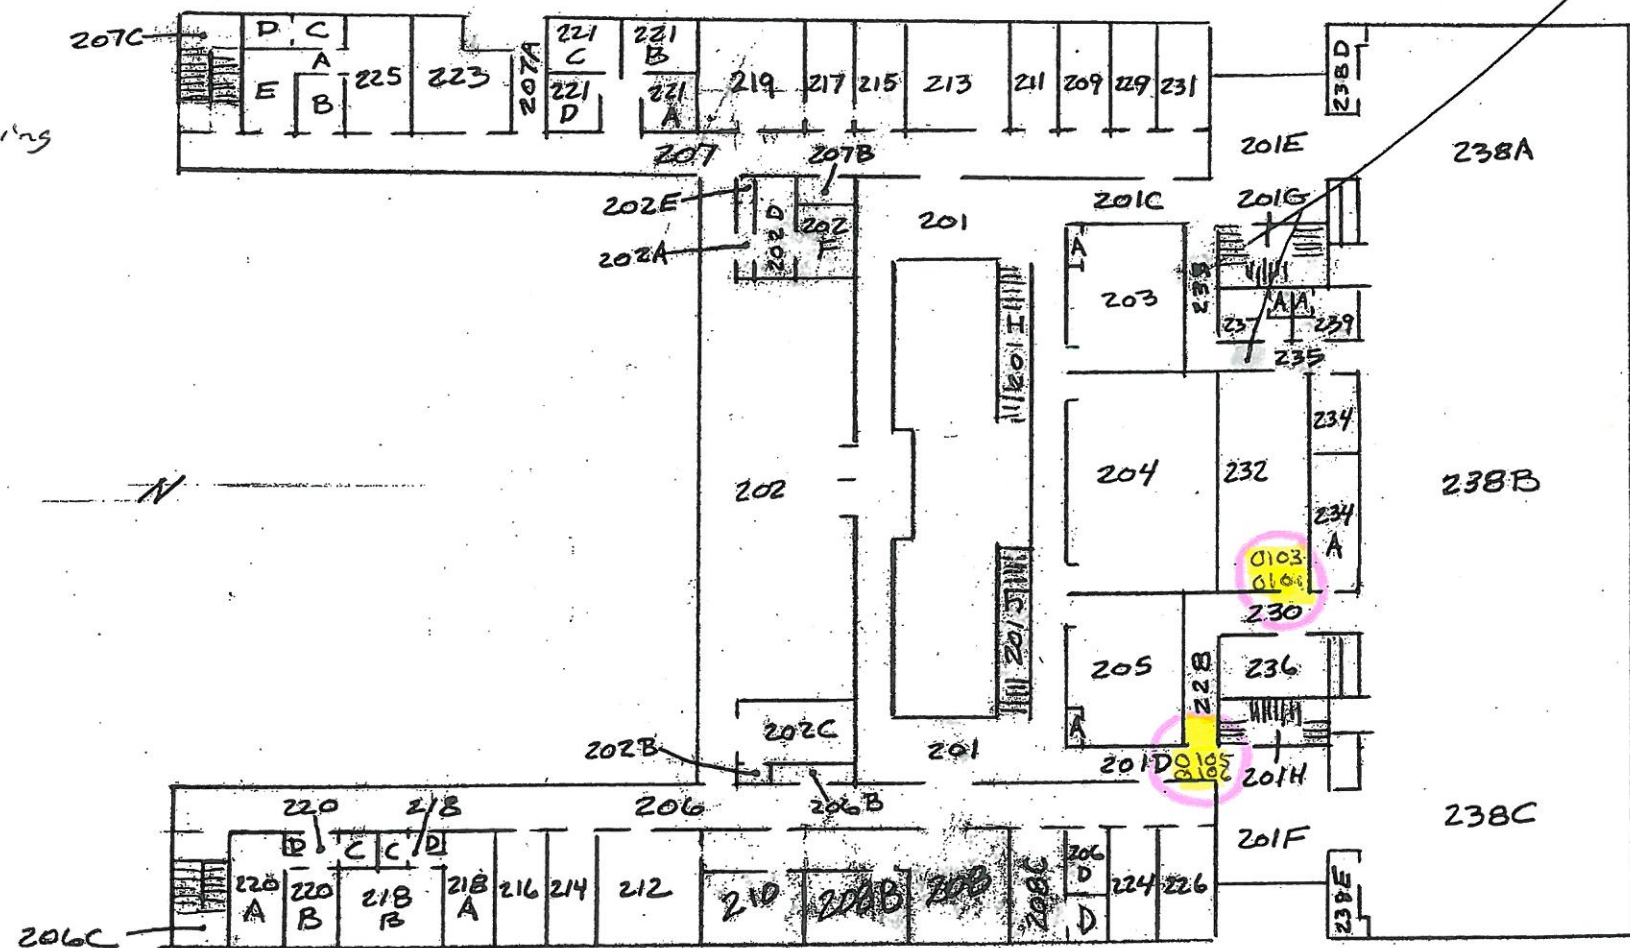
SECOND FLOOR

- Asbestos containing materials
