**SUNY POTSDAM**  
**BARRINGTON STUDENT UNION**  
**SUMMARY OF ASBESTOS SAMPLES AND ANALYSIS RESULTS**

**SUNY POTSDAM  
BARRINGTON STUDENT UNION  
ASBESTOS CONTAINING MATERIALS**

Date Received 01/17/14 AmeriSci Job # 214012572  
Date Examined 01/18/14 P.O. #  
ELAP # 11480 Page 1 of 1  
RE: 131223AC; SUNY Potsdam; 44 Pierrepont Ave., Potsdam,  
NY; Barrington Hall, 2nd Floor Hallway

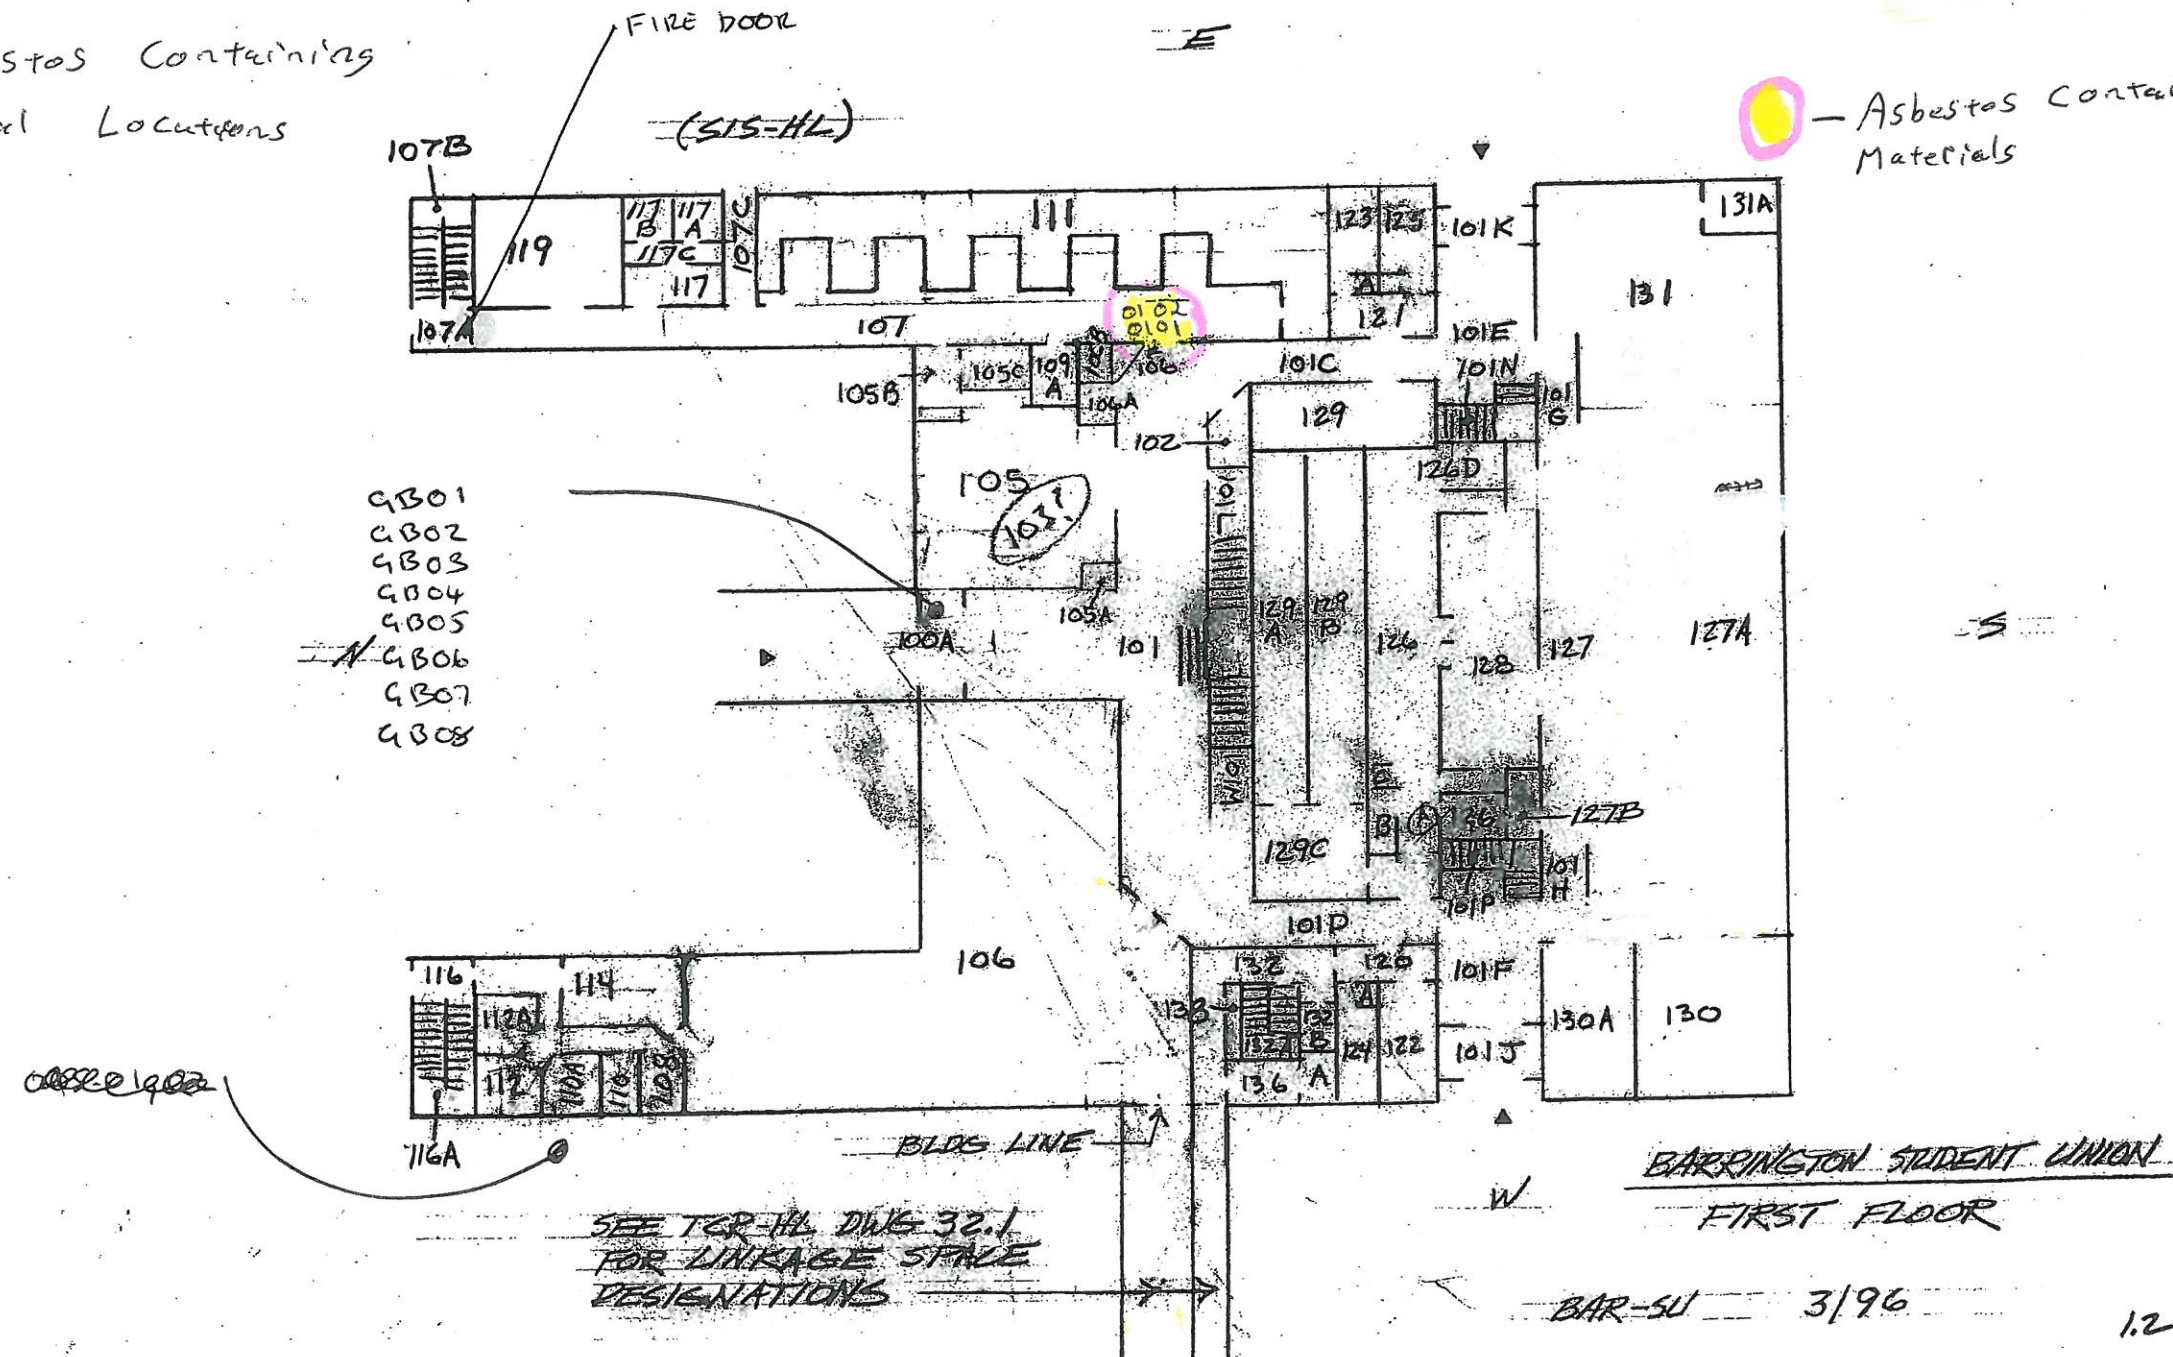
# Asbestos Containing Material Locations

Sample No.	Material Description	Sample Location	Asbestos %	Homogenous Locations	Condition	Friability	Qty*
02-01	Caulking	Exterior Door	1.6% Tremolite 0.4% Chrysotile	TBD	Good	Friable	<10 sq ft
029-01	Fitting Insulation	Large Diameter in Wet Wall	7.8% Chrysotile	TBD	Good	Friable	<10 sq ft
030-01	Fitting Insulation	1" Diameter in Wet Wall	8.7% Chrysotile	TBD	Good	Friable	<10 sq ft
003-02	Debris on Floor	3 <sup>rd</sup> Floor Mechanical Room	30.8% Chrysotile	TBD	Damaged	Friable	<10 sq ft
01-01	Fire Doors	East Entry to Post Office	30.8% Amosite	TBD	Damaged	Friable	60 sq ft
01-02	Fire Doors	East Entry to Post Office	26.7% Amosite	TBD	Damaged	Friable	60 sq ft
01-03	Fire Doors	2 <sup>nd</sup> Floor Kitchen Doors	30.8% Amosite	TBD	Damaged	Friable	50 sq ft
01-04	Fire Doors	2 <sup>nd</sup> Floor Kitchen Doors	23.5% Amosite	TBD	Damaged	Friable	50 sq ft
01-05	Fire Doors	2 <sup>nd</sup> Floor Center Hallway	17.4% Amosite	TBD	Damaged	Friable	60 sq ft

01-06	Fire Doors	2 <sup>nd</sup> Floor Center Hallway	17.4% Amosite	TBD	Damaged	Friable	60 sq ft
01-01	Insulation	Steam Line-Basement	12.5% Amosite Trace Chrysotile	TBD	Significantly Damaged	Friable	
06-01	Mudded Fitting	Sewer Drain Cleanout	1.3% Amosite	TBD	Significantly Damaged	Friable	
07-01	Debris # 2 **	Debris pile #2	25.0% Amosite	TBD	Significantly Damaged	Friable	
09-01	Debris #1 **	Debris pile #1	30.8% Amosite	TBD	Significantly Damaged	Friable

1 FIRE DOOR
