**Re: Limited Additional Asbestos Sampling and Testing  
Upgrade Electrical Distribution System – Various Buildings  
SUCF Project No. 12290  
SUNY Potsdam  
Potsdam, New York**

# **Limited Additional Asbestos Sampling and Testing**

**SUNY Potsdam  
Upgrade Electrical Distribution System – Various Buildings  
SUCF Project No. 12290  
Potsdam, New York**

**Conditions as of:  
January 27, 2009**

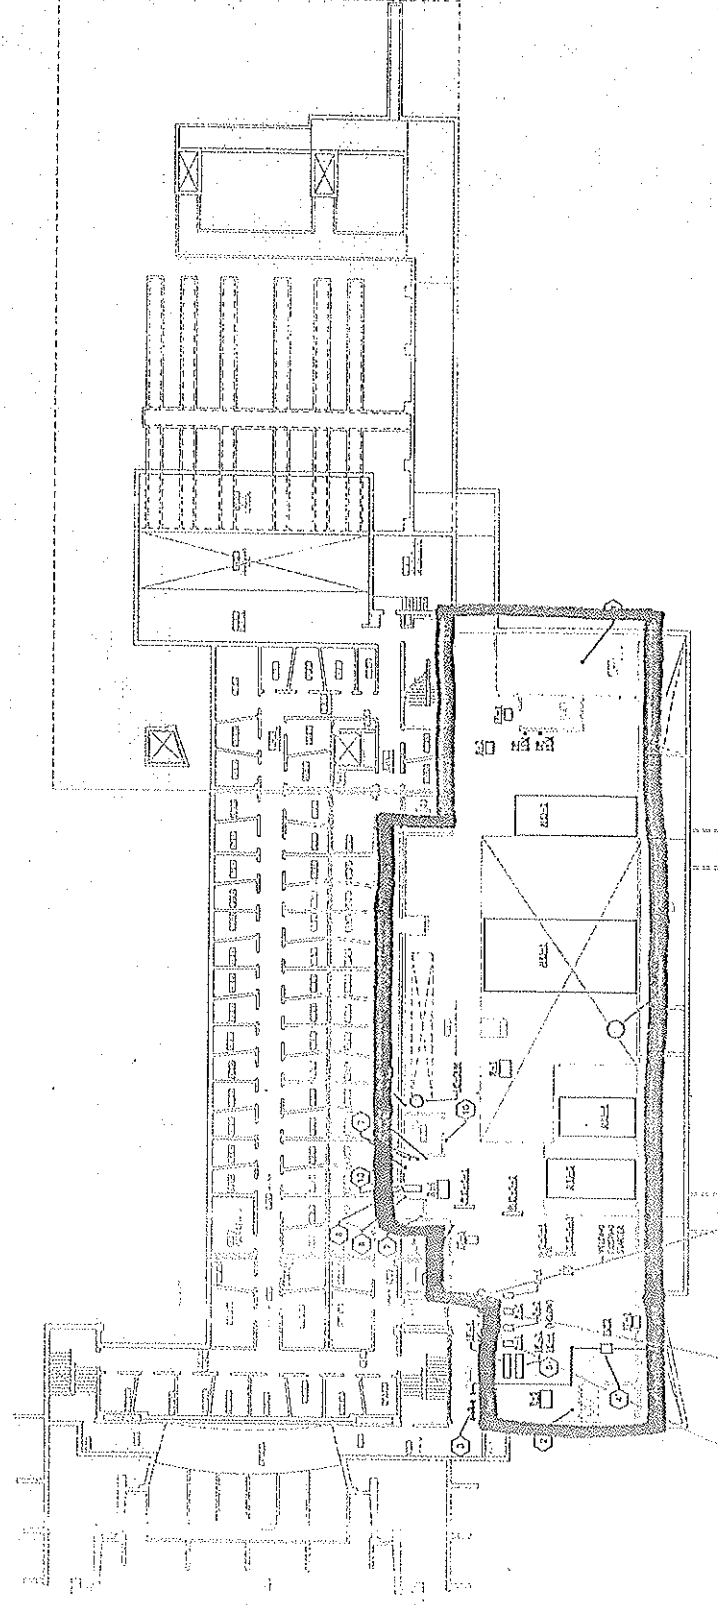
BASEMENT PLAN  
SCALE: 1/8" = 1'-0"

**Crane Music Complex**

- All samples from Crane Music Complex were analyzed as less than 1% asbestos. Materials are considered asbestos-containing when they are analyzed as greater than 1% asbestos.

| Sample | Description | Location | % Fibrous | % Non-Fibrous | % Asbestos Type |
|---|---|---|---|---|---|
| 0127-CRN-400-1<br>P180-1 | Gray, Fibrous,<br>Homogenous | Mud Fitting on Fiberglass - Basement | 20% | 80% | NAD |

CRN-400-1  
CRN-400-2  
CRN-400-3

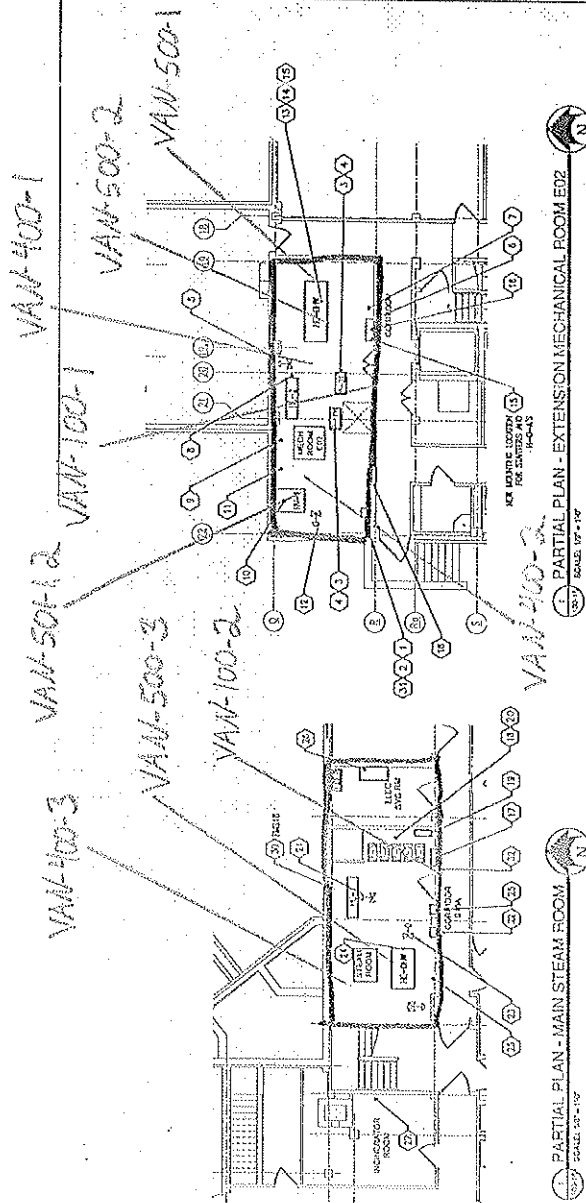
1 PARTIAL PLAN - MAIN STEAM ROOM  
SCALE 1/8" = 1'-0"

| Material # | Description - Location | Condition |
|---|---|---|
| VAN-400 | Mud fitting on fiberglass – Mechanical room E02, Main steam room | I |
| VAN-501 | Duct insulation stick pin mastic – Mechanical room E02 | I |

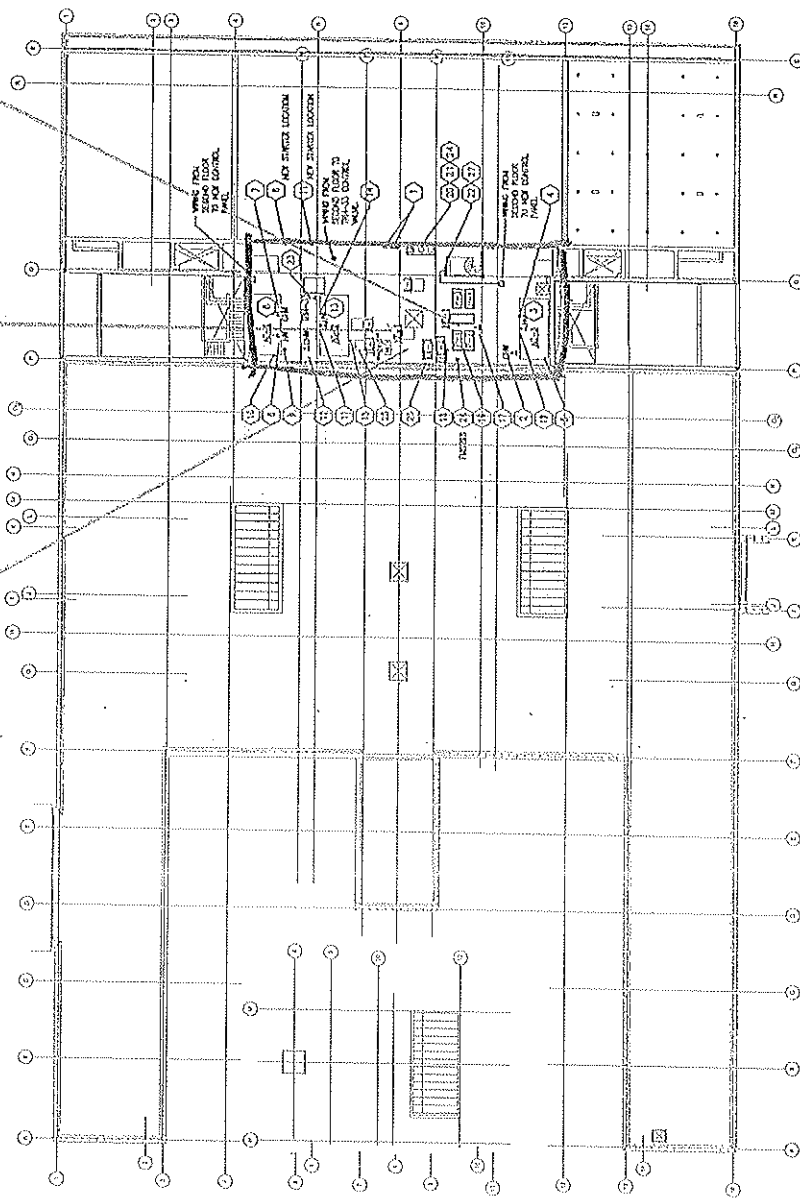
ATTIC PLAN  
SCALE: 1/4" = 1'-0"

| Material # | Description - Location | Condition |
|---|---|---|
| BAR-500 | Air duct insulation – Attic | I |

BAR-500-3
