**Re: Lead-based Paint Inspection Report  
SUNY Potsdam  
Barrington Student Union  
44 Pierrepont Avenue  
Potsdam, New York 13676**

**Lead-based Paint Inspection**

**SUNY Potsdam  
Barrington Student Union  
44 Pierrepont Avenue  
Potsdam, New York 13676**

**February 6, 2012**

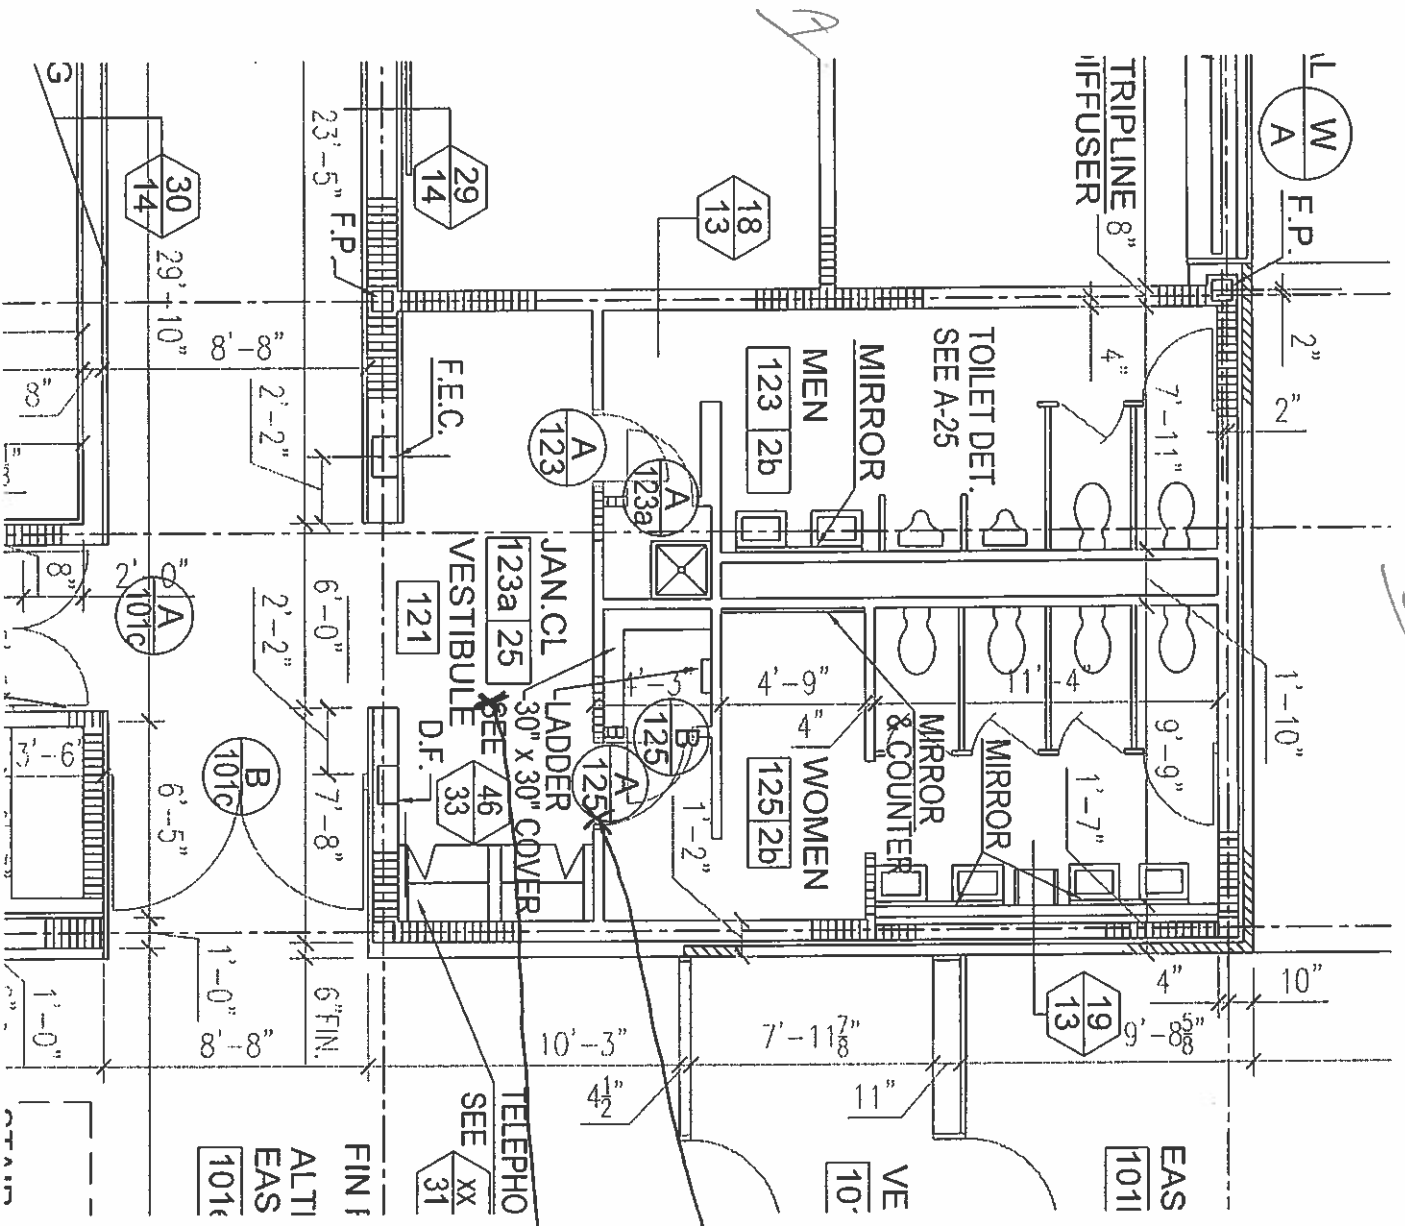
**Appendix C Floor Plans**

Paint chip #2

Paint chip #1
