**Re: Summary of Asbestos Containing Materials by Building  
Upgrade Electrical Distribution System – Various Buildings  
SUCF Project No. 12290  
SUNY Potsdam  
Potsdam, New York**

## Summary of Asbestos Containing Materials

**Appendix D   Asbestos sample location maps**

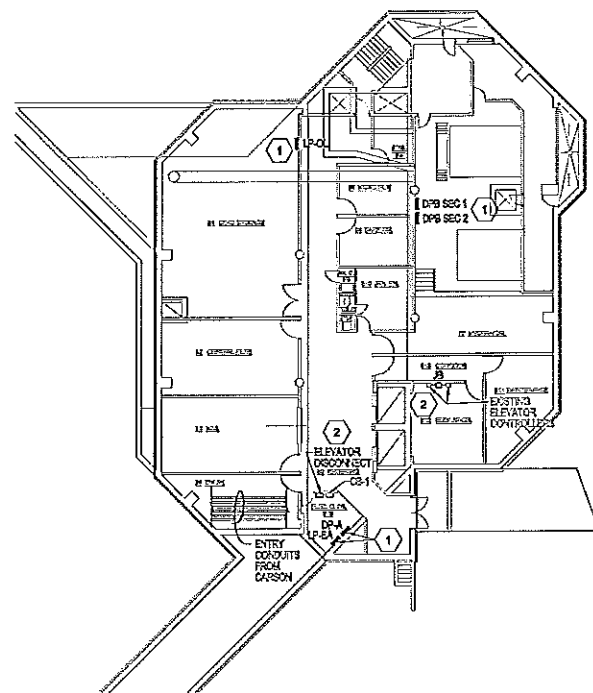
**C1 RAYMOND - BASEMENT PLAN**  
 SCALE: 1/8" = 1'-0"

**DRAWING SPECIFIC NOTES:**  
 1 REMOVE EXISTING PANELBOARD IN THIS LOCATION AND REPLACE WITH NEW PANEL BOARD AS SHOWN.  
 SEE A1 100B-1 FOR WORK ASSOCIATED IN THESE AREAS.

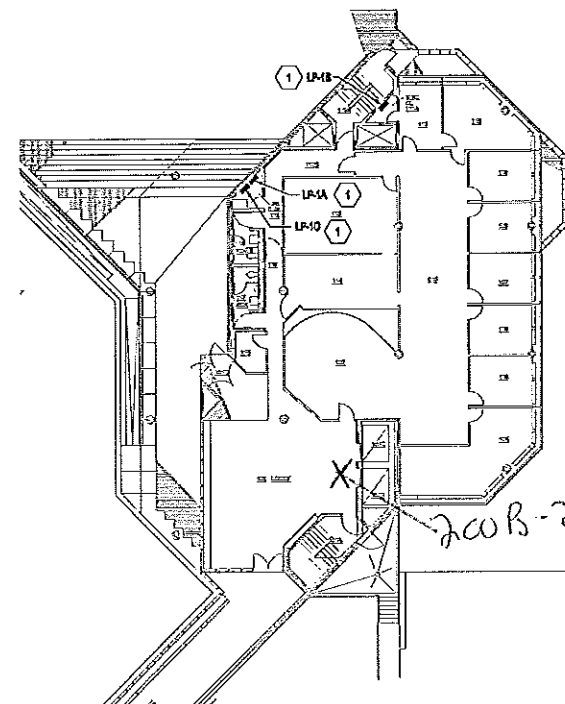
**C3 RAYMOND - FIRST FLOOR PLAN**  
 SCALE: 1/8" = 1'-0"

**DRAWING SPECIFIC NOTES:**  
 1 REMOVE EXISTING PANELBOARD IN THIS LOCATION AND REPLACE WITH NEW PANEL BOARD AS SHOWN.

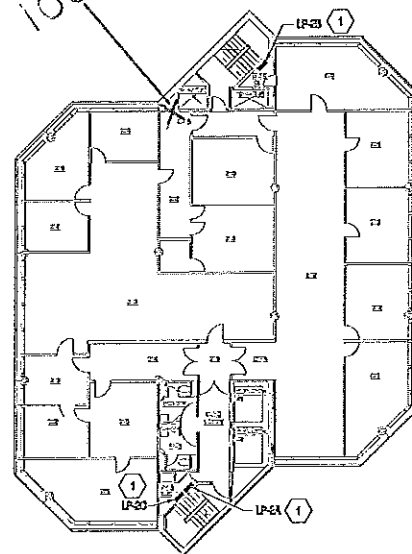
**A1 RAYMOND - SECOND FLOOR PLAN**  
 SCALE: 1/8" = 1'-0"

**DRAWING SPECIFIC NOTES:**  
 1 REMOVE EXISTING PANELBOARD IN THIS LOCATION AND REPLACE WITH NEW PANEL BOARD AS SHOWN.

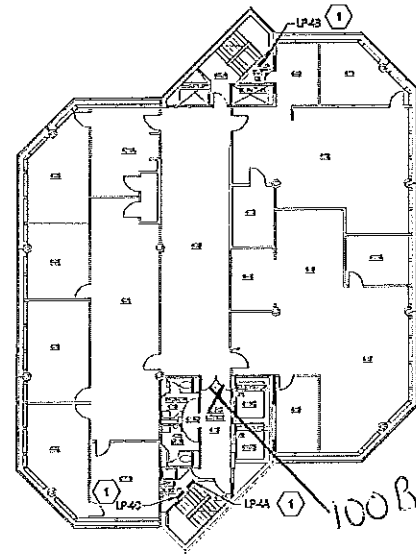
C1 RAYMOND - FOURTH FLOOR PLAN  
SCALE: 1/16" = 1'-0"

DRAWING SPECIFIC NOTES:  
1 REMOVE EXISTING PANELBOARD IN THIS LOCATION AND  
REPLACE WITH NEW PANEL BOARD AS SHOWN.

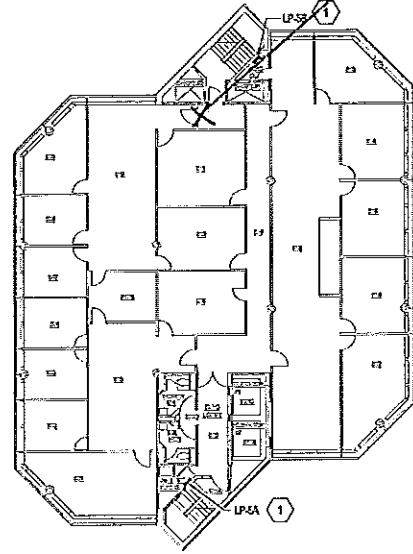
C2 RAYMOND - FIFTH FLOOR PLAN  
SCALE: 1/16" = 1'-0"

DRAWING SPECIFIC NOTES:  
1 REMOVE EXISTING PANELBOARD IN THIS LOCATION AND  
REPLACE WITH NEW PANEL BOARD AS SHOWN.

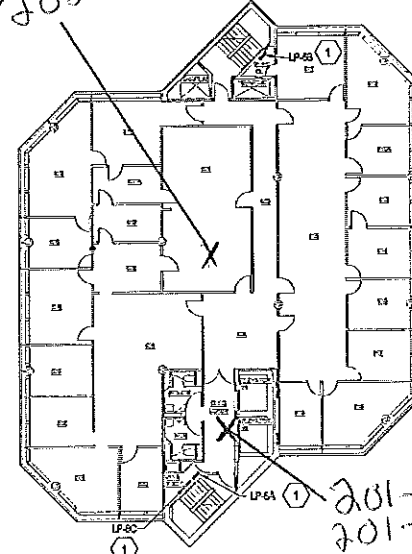
C3 RAYMOND - SIXTH FLOOR PLAN  
SCALE: 1/16" = 1'-0"

DRAWING SPECIFIC NOTES:  
1 REMOVE EXISTING PANELBOARD IN THIS LOCATION AND  
REPLACE WITH NEW PANEL BOARD AS SHOWN.

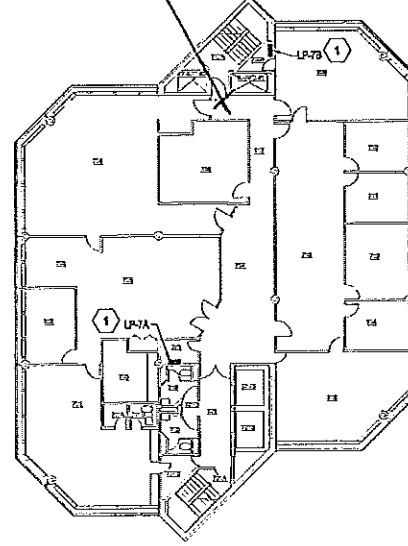
C4 RAYMOND - SEVENTH FLOOR PLAN  
SCALE: 1/16" = 1'-0"

DRAWING SPECIFIC NOTES:  
1 REMOVE EXISTING PANELBOARD IN THIS LOCATION AND  
REPLACE WITH NEW PANEL BOARD AS SHOWN.

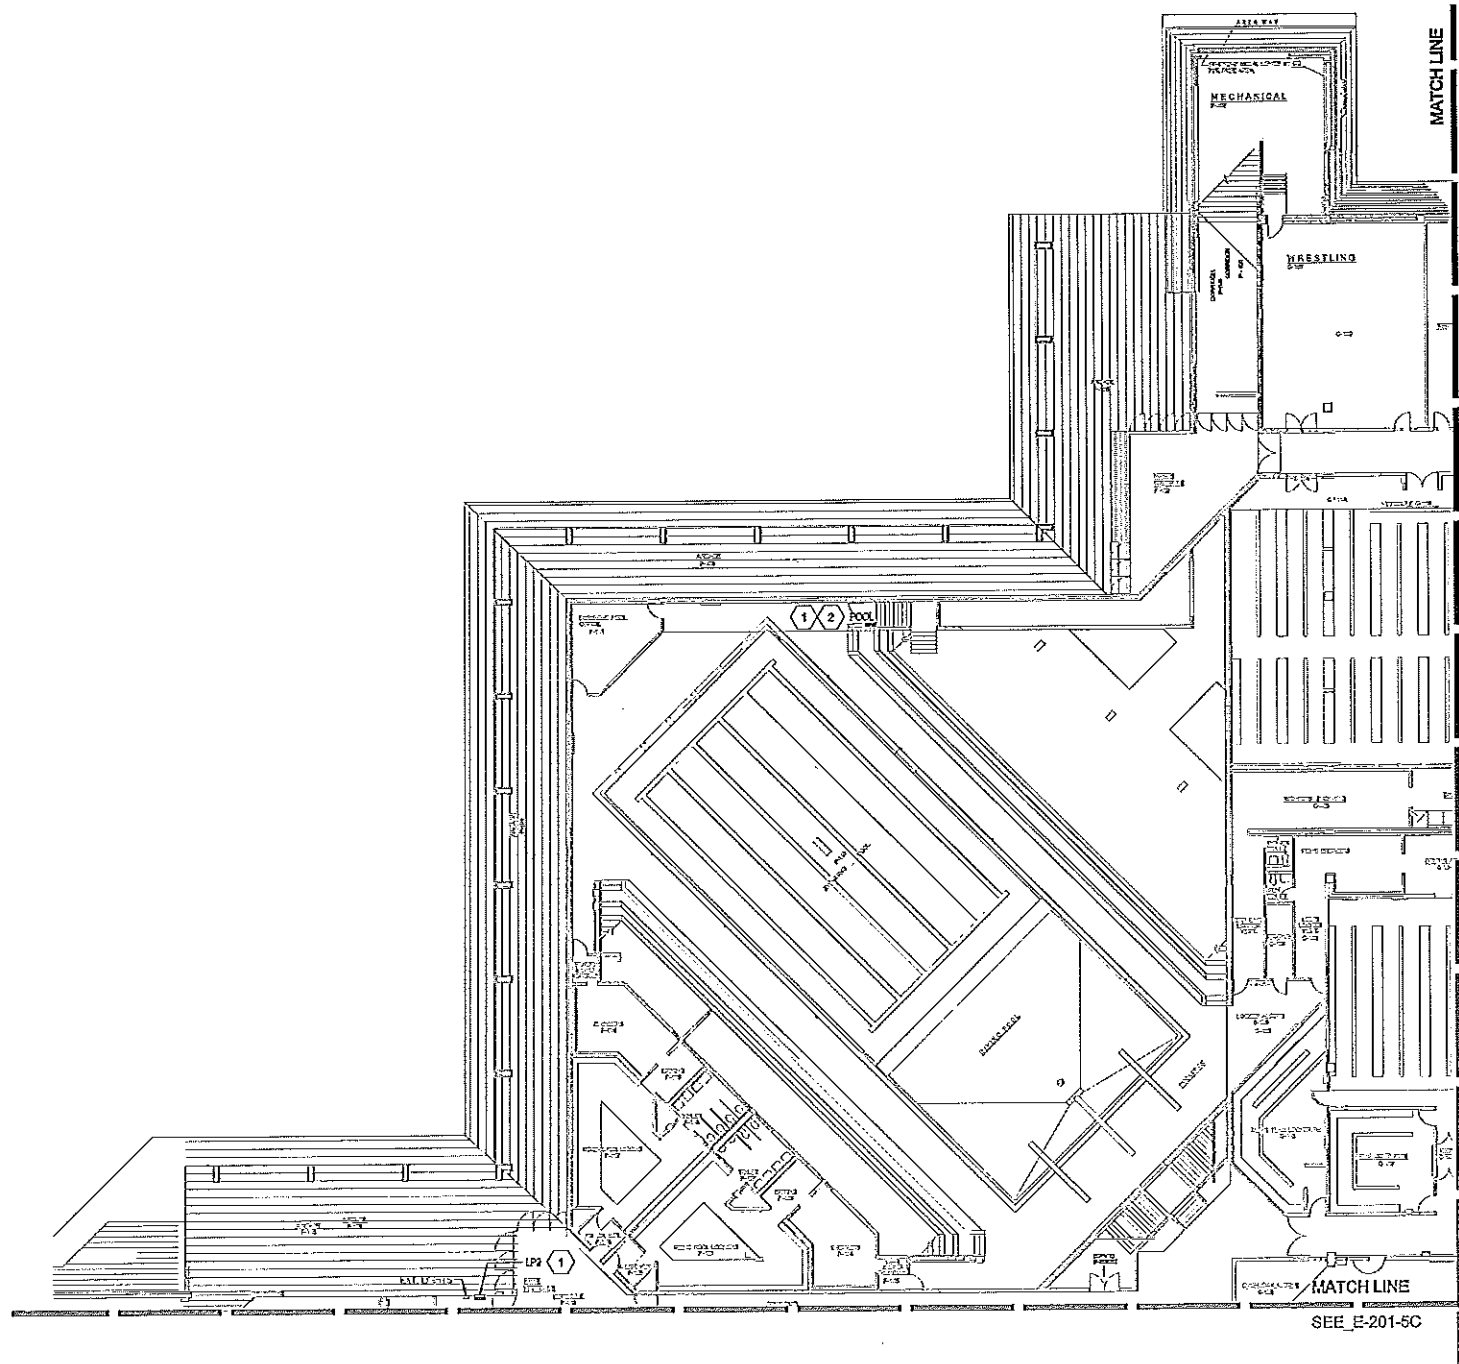
**A1 MAXCY - FIRST FLOOR PLAN**  
SCALE: 1/8" = 1'-0"

- DRAWING SPECIFIC NOTES:**
- 1 REMOVE EXISTING PANELBOARDS IN THIS LOCATION AND REPLACE WITH NEW PANELBOARDS AS SHOWN.
  - 2 PROVIDE NEW ENCLOSURE FOR THIS ELECTRICAL PANEL.

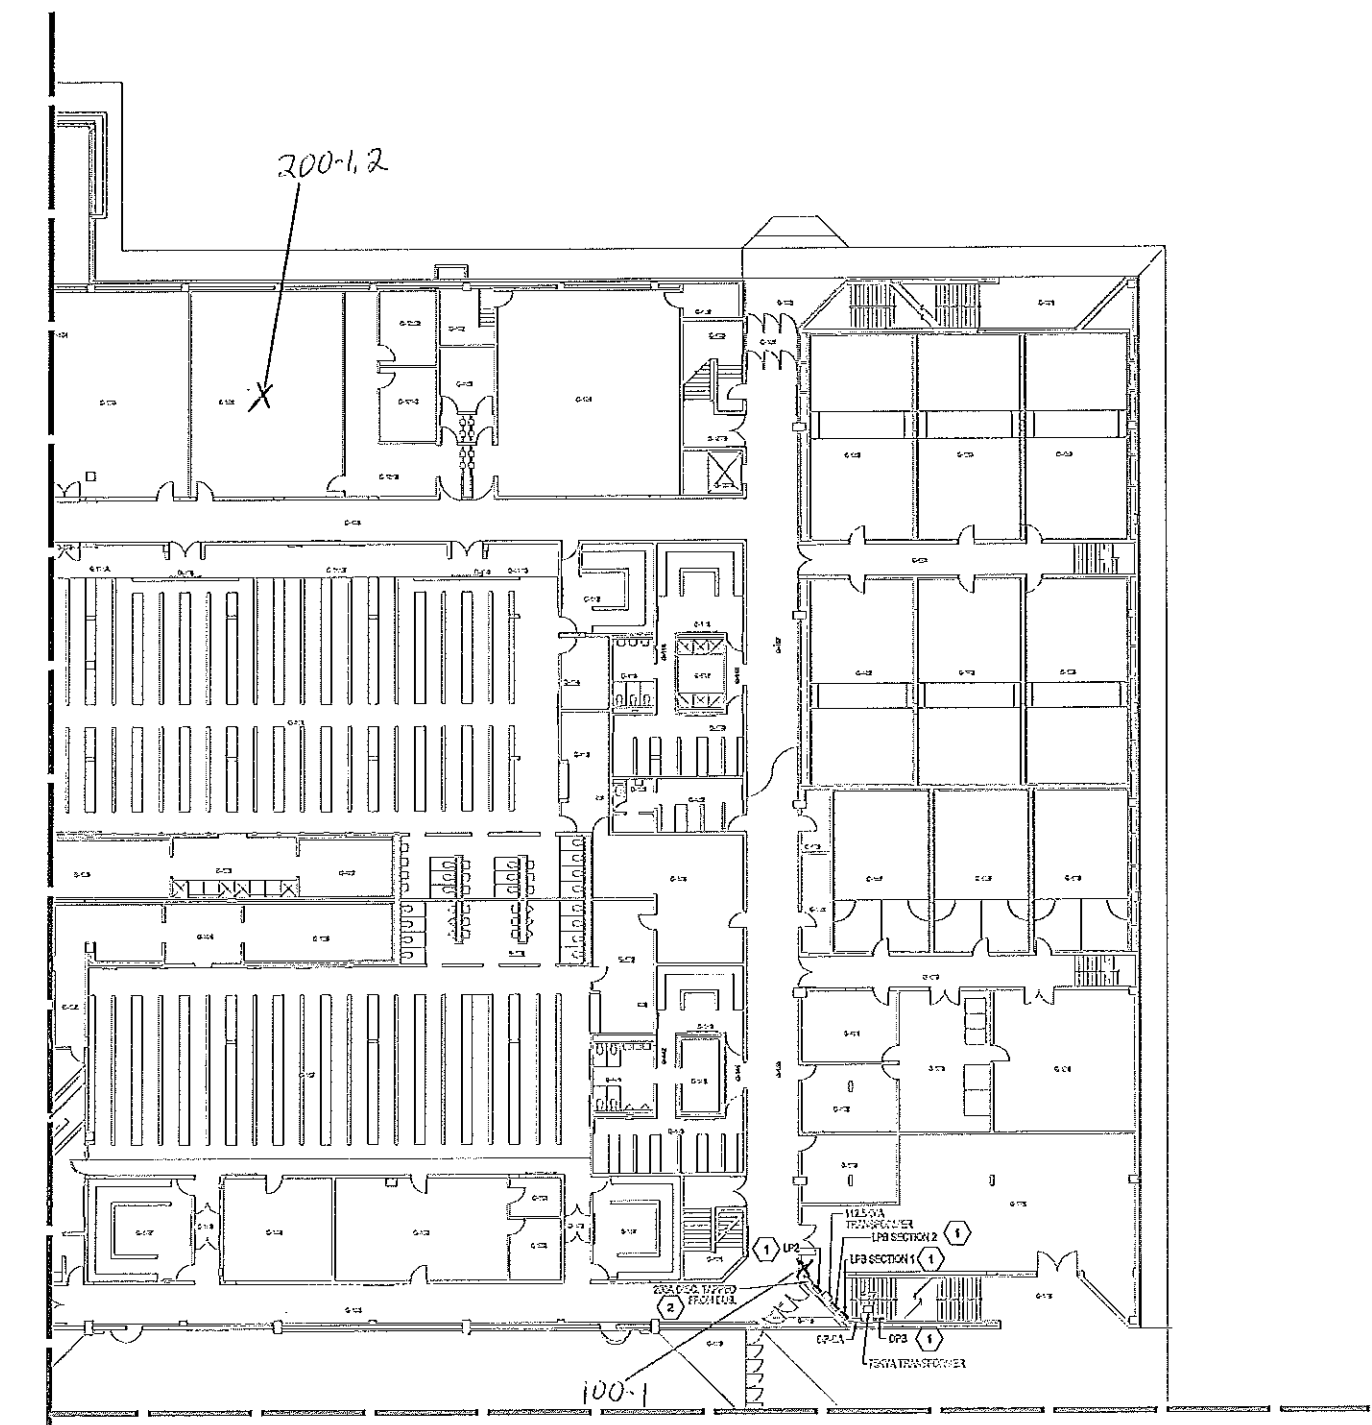
A1 MAXCY - FIRST FLOOR PLAN  
09/25/11 11' x 15'

- REVISION SPECIFIC NOTES
- (1) REMOVE EXISTING PANELS SHOWN IN THIS LOCATION AND REPLACE WITH NEW PANEL BOARD AS SHOWN
  - (2) SWITCH REMOVED

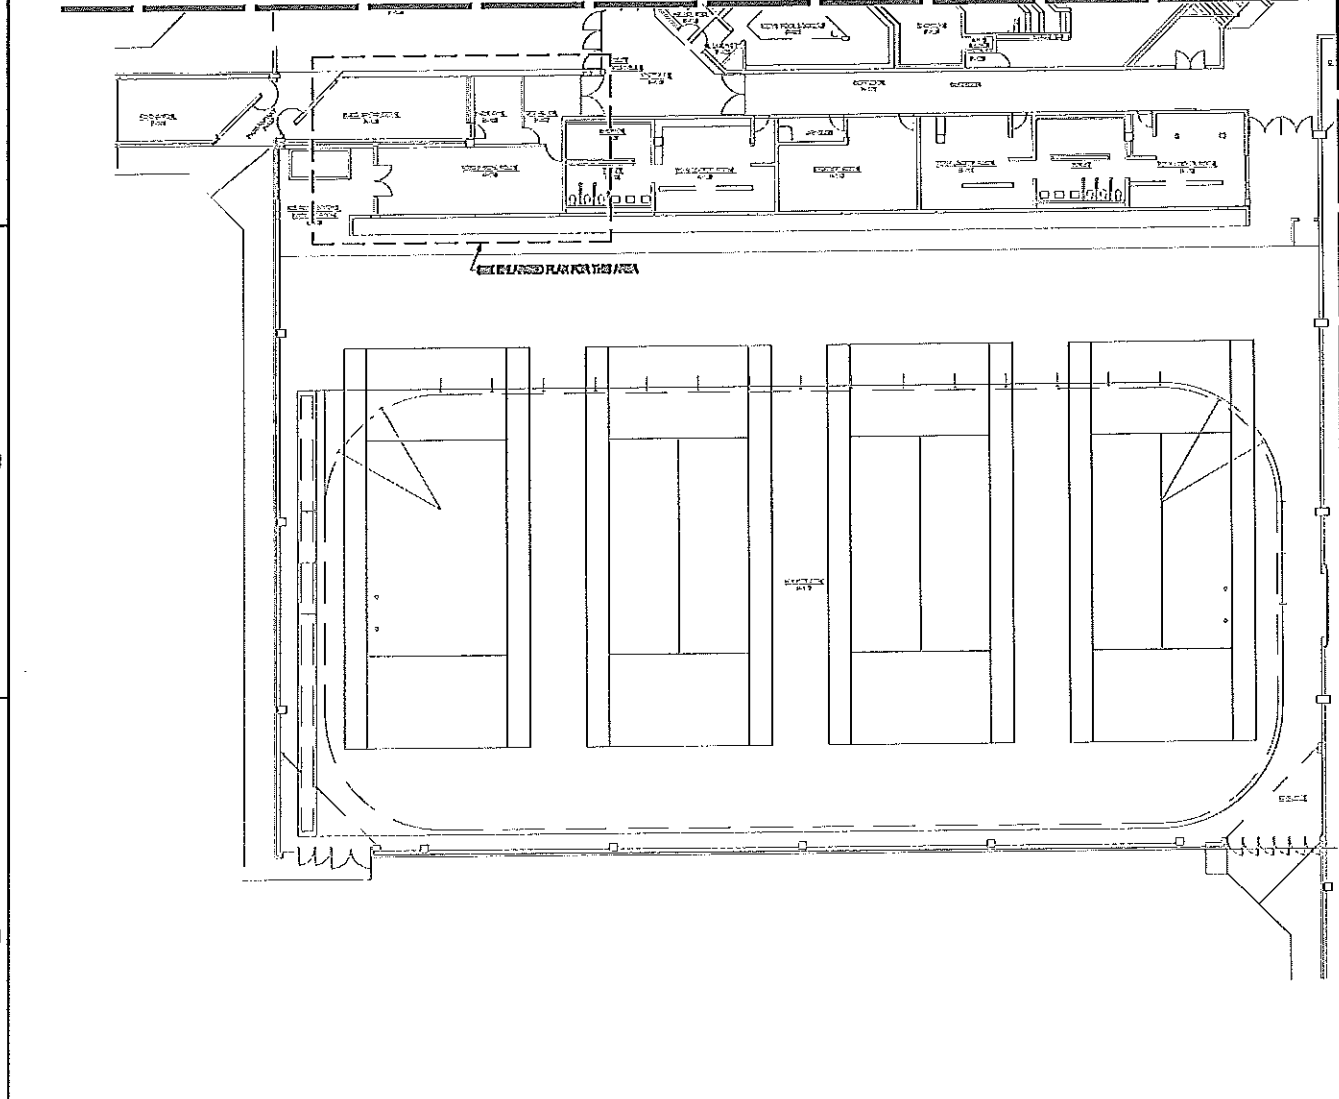
A1 MAXCY - FIRST FLOOR PLAN  
SCALE: 1/8" = 1'-0"

- DRAWING SPECIFIC NOTES:
- 1 REMOVE EXISTING PANELBOARD IN THIS LOCATION AND REPLACE WITH NEW PANEL BOARD AS SHOWN.
  - 2 REMOVE EXISTING MOTOR STARTERS REPLACE WITH NEMA SIZE 2 COORDINATION STARTERS IN NEMA 4X ENCLOSURES. RECONNECT EXISTING CONTROLS.
  - 3 EXISTING MOTOR STARTERS REMAIN.
  - 4 REMOVE EXISTING MOTOR STARTERS REPLACE WITH NEMA SIZE 1 COORDINATION STARTERS IN NEMA 4X ENCLOSURES. RECONNECT EXISTING CONTROLS.
  - 5 REMOVE EXISTING FUSED DISCONNECT SWITCH REPLACE WITH 200 AMP, 3 POLE UNFUSED SWITCH.
  - 6 PROVIDE CIRCUIT BREAKER IN SPACE IN EXISTING SWITCHBOARD. SEE SHEET E-201-5A ONE LINE DIAGRAM.
  - 7 PROVIDE DISTRIBUTION PANEL DPH. SEE PANEL SCHEDULE ON E-201-5A.
  - 8 REMOVE EXISTING 45 KVA TRANSFORMER MOUNTED ON FRAME SUPPORTED FROM CEILING. REMOVE FRAME.
  - 9 PROVIDE 112.5 KVA TRANSFORMER. PROVIDE NEW TRAPEZOID MOUNT. SEE DETAIL ON SHEET E-201-5A.

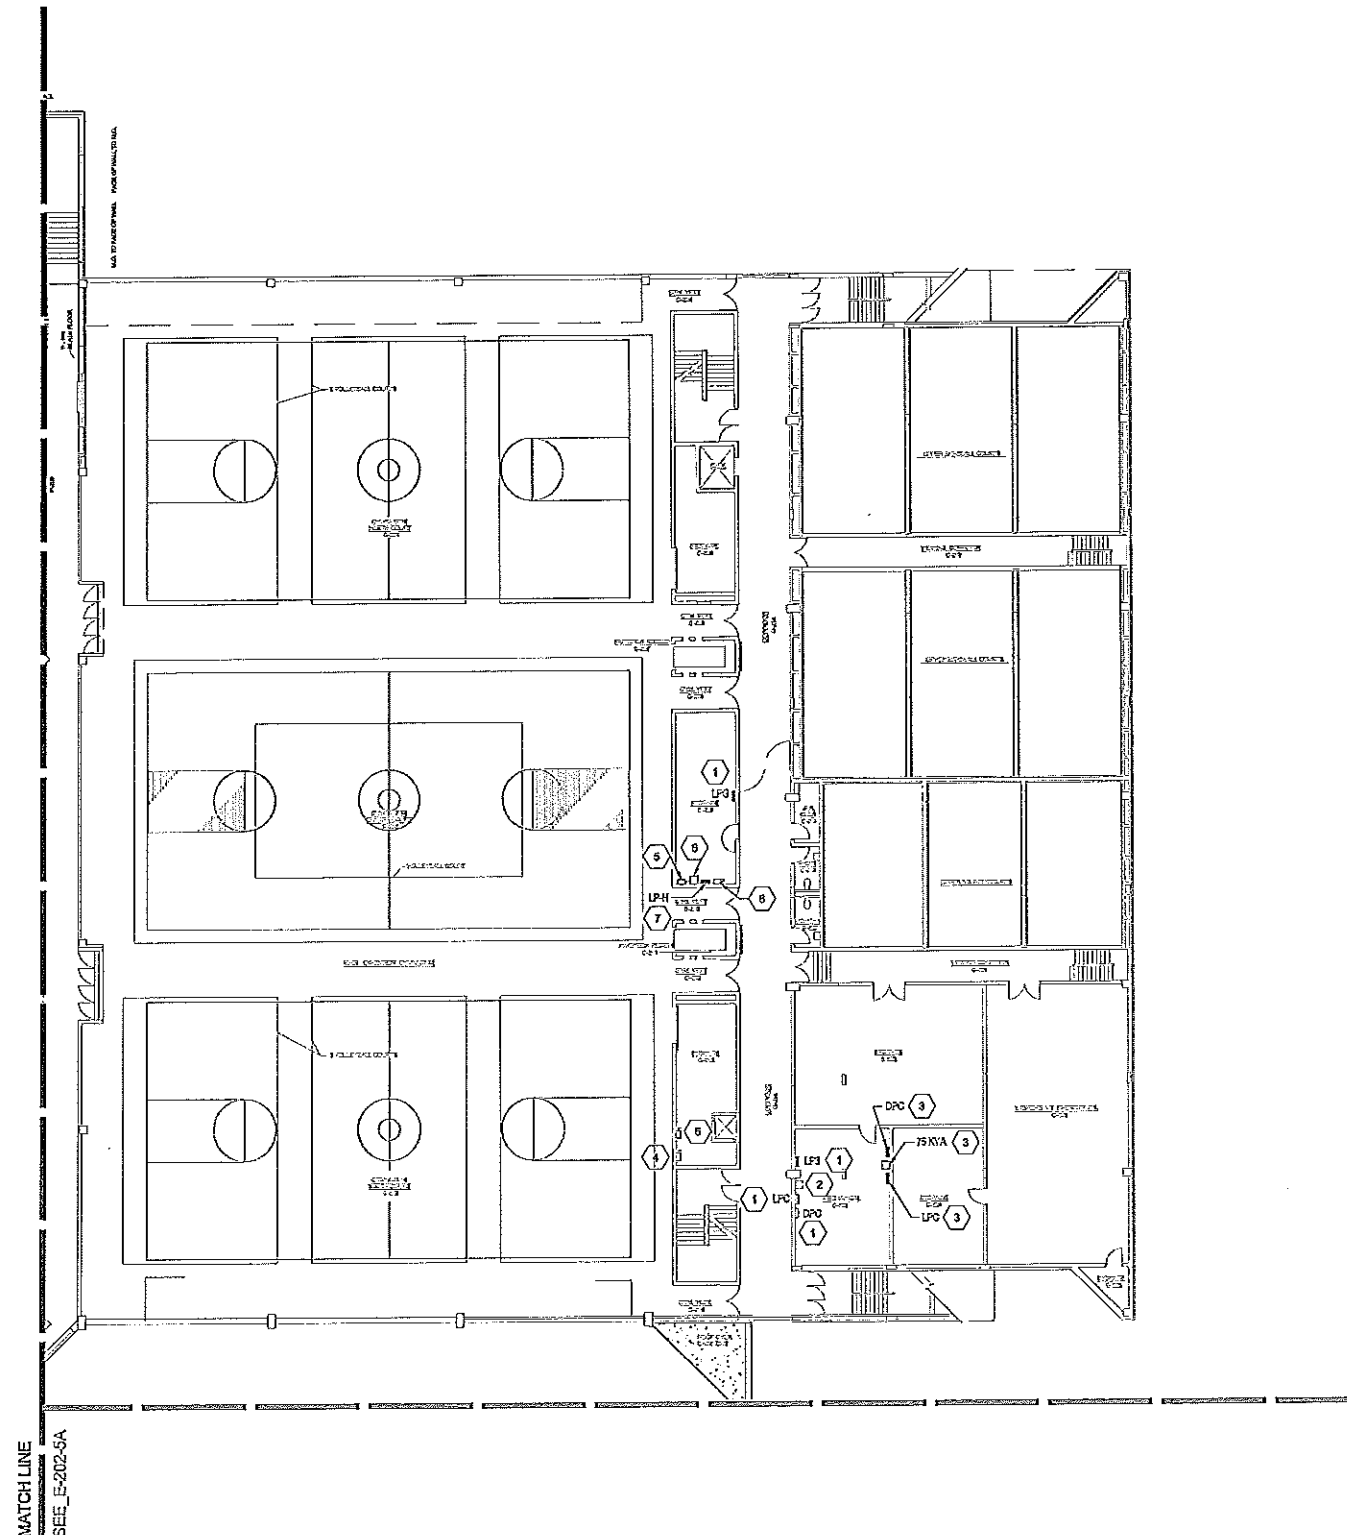
A1 MAXCY - SECOND FLOOR PLAN  
SCALE: 1/8" = 1'-0"

- DRAWING SPECIFIC NOTES:
1. REPAIR EXISTING PANELBOARD IN THIS LOCATION AND REPLACE WITH NEW PANELBOARD AS SHOWN LPO AND DPO TO BE RELOCATED. REPLACEMENT PANELBOARD FOR LPS SHALL BE INSTALLED IN SAME LOCATION AS EXISTING.
  2. REMOVE 40 KVA TRANSFORMER. INSTALL 75 KVA TRANSFORMER RELOCATED FROM ELECTRIC ROOM SHOWN ON SHEET E-202-5A.
  3. NEW LOCATION FOR DPO, LPO, AND TRANSFORMER. EXTEND BRANCH CIRCUITS AS REQUIRED.
  4. EXISTING 200 AMP FUSED SWITCH REMAINS.
  5. PROVIDE 400 AMP UNFUSED SWITCH.
  6. PROVIDE 150 KVA TRANSFORMER.
  7. PROVIDE PANEL LPH.
  8. PROVIDE 200 AMP UNFUSED SWITCH.

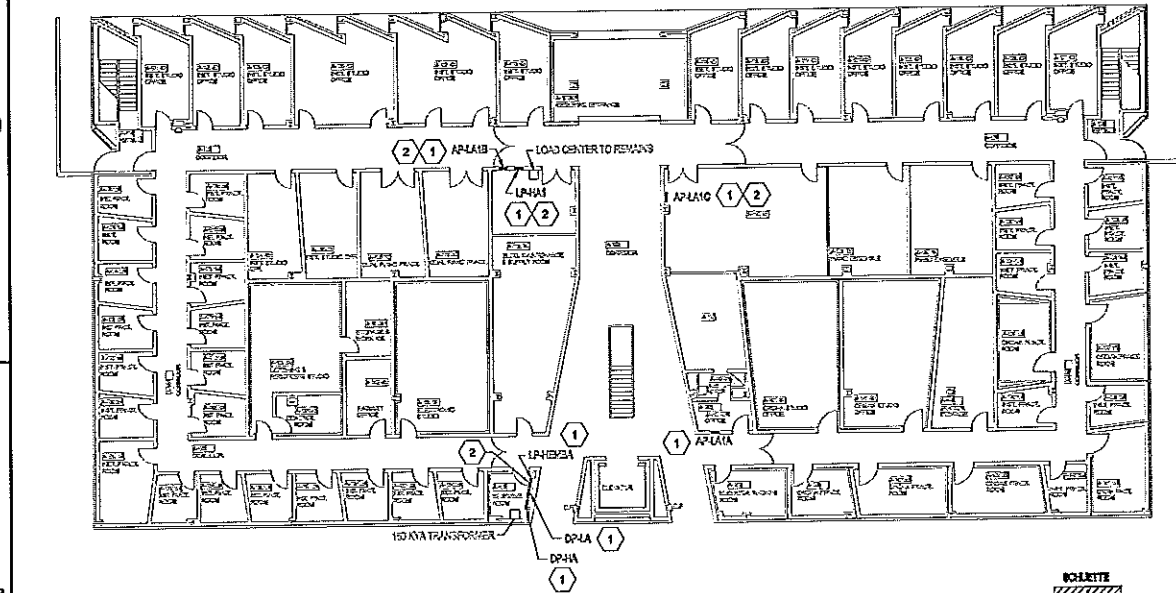
C1 CRANE MUSIC COMPLEX - SCHUETTE LOWER LEVEL PLAN  
SCALE 1/8" = 1'-0"

- DRAWING SPECIFICATIONS:
- 1 REMOVE EXISTING PANEL BOARD IN THIS LOCATION AND REPLACE WITH NEW PANEL BOARD AS SHOWN.
  - 2 SEE DETAIL D5-A-601 FOR ARCHITECTURAL WORK.

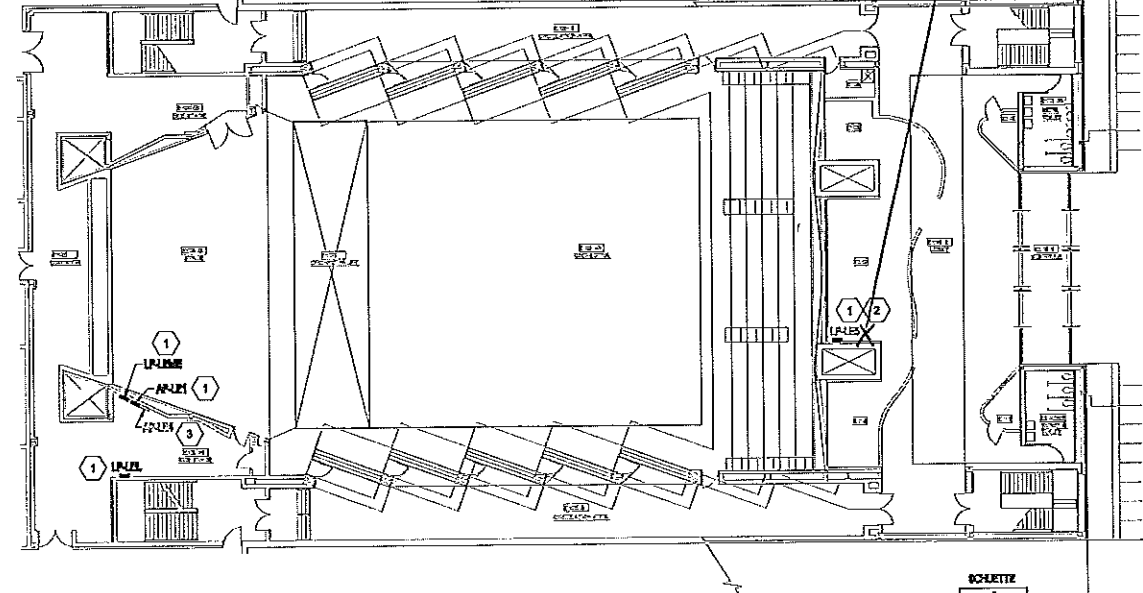
C3 CRANE MUSIC COMPLEX - HOSMER ORCHESTRA LEVEL FLOOR PLAN  
SCALE 1/8" = 1'-0"

- DRAWING SPECIFICATIONS:
- 1 REMOVE EXISTING PANEL BOARD IN THIS LOCATION AND REPLACE WITH NEW PANEL BOARD AS SHOWN.
  - 2 REMOVE TO 100 AMP.
  - 3 REMOVE.

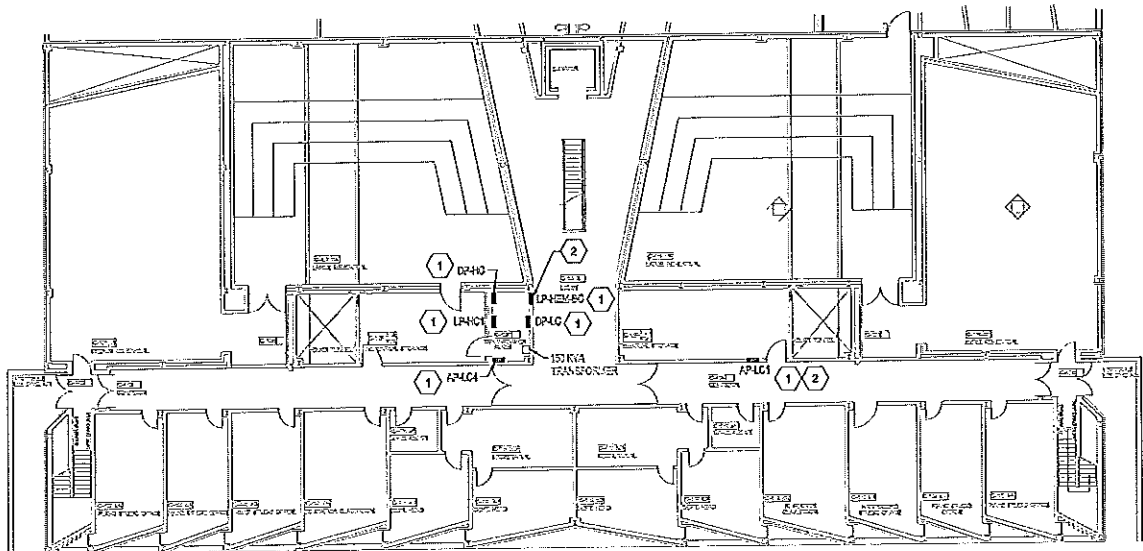
A1 CRANE MUSIC COMPLEX - BISHOP LOWER LEVEL FLOOR PLAN  
SCALE 1/8" = 1'-0"

- DRAWING SPECIFICATIONS:
- 1 REMOVE EXISTING PANEL BOARD IN THIS LOCATION AND REPLACE WITH NEW PANEL BOARD AS SHOWN.
  - 2 SEE DETAIL D5-A-601 FOR ARCHITECTURAL WORK.

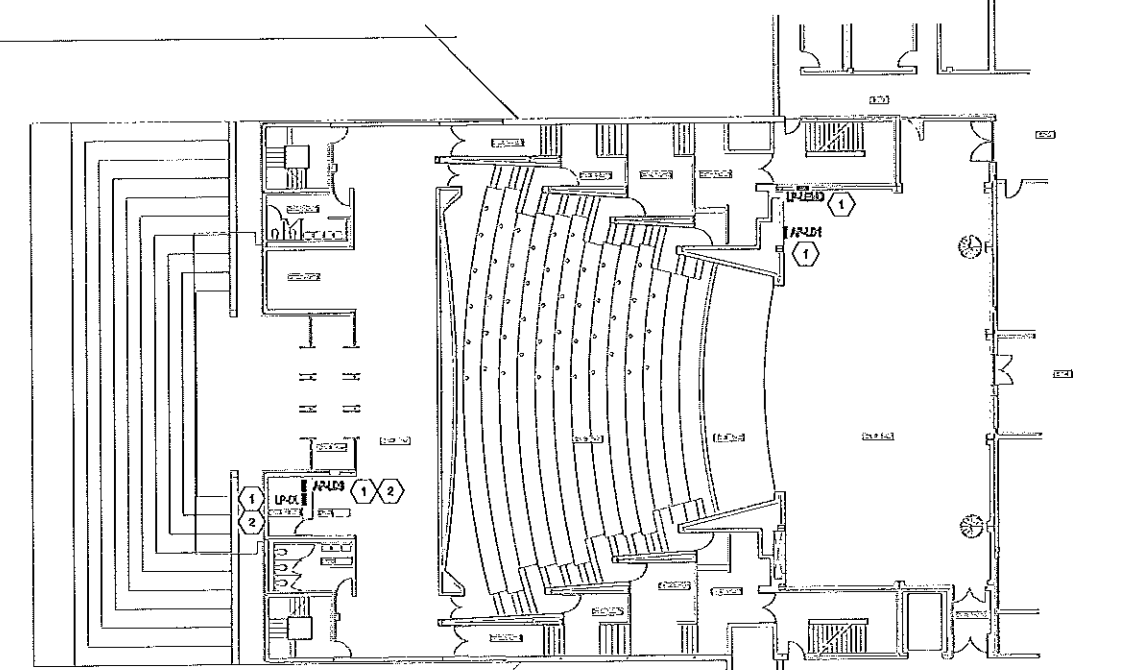
A3 CRANE MUSIC COMPLEX - SNELL ORCHESTRA LEVEL FLOOR PLAN  
SCALE 1/8" = 1'-0"

- DRAWING SPECIFICATIONS:
- 1 REMOVE EXISTING PANEL BOARD IN THIS LOCATION AND REPLACE WITH NEW PANEL BOARD AS SHOWN.
  - 2 SEE DETAIL D5-A-601 FOR ARCHITECTURAL WORK.

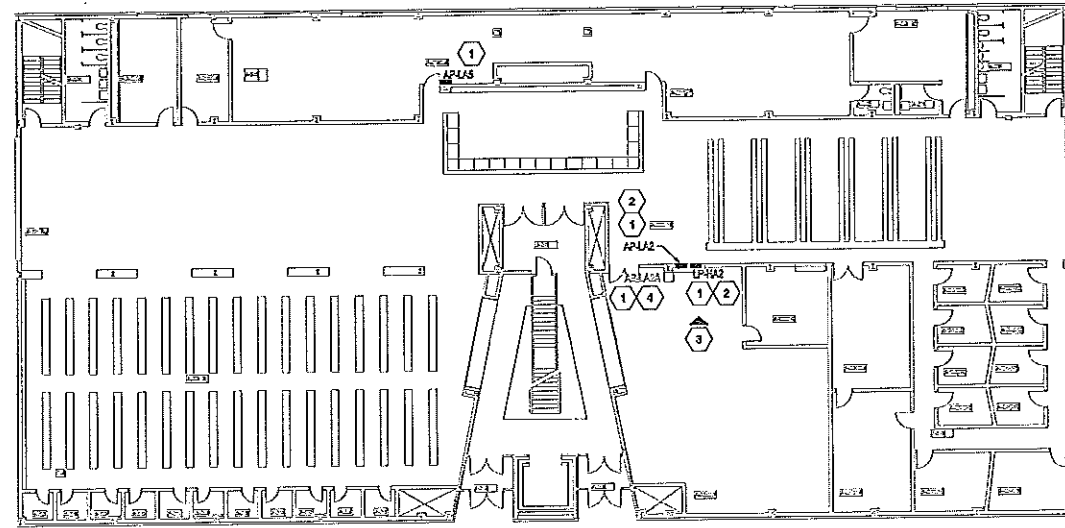
**C1 CRANE MUSIC COMPLEX - SCHUETTE PLAZA LEVEL FLOOR PLAN**  
SCALE: 1/8" = 1'-0"

- DRAWING SPECIFIC NOTES:**
- 1 REMOVE EXISTING PANEL BOARD IN THIS LOCATION AND REPLACE WITH NEW PANEL BOARD AS SHOWN.
  - 2 SEE DETAIL D3-551 FOR ARCHITECTURAL WORK.
  - 3 SEE PHOTO A1-551.
  - 4 REMOVE TO APPLA, EXISTING PANEL REMAINS.

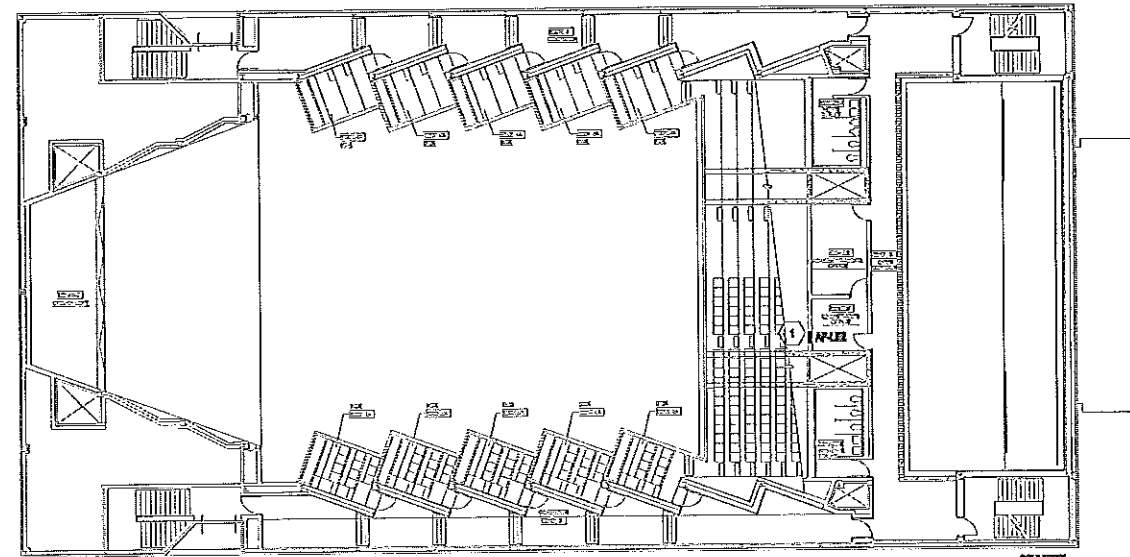
**C3 CRANE MUSIC COMPLEX - HOSMER SECOND FLOOR PLAN**  
SCALE: 1/8" = 1'-0"

- DRAWING SPECIFIC NOTES:**
- 1 REMOVE EXISTING PANEL BOARD IN THIS LOCATION AND REPLACE WITH NEW PANEL BOARD AS SHOWN.

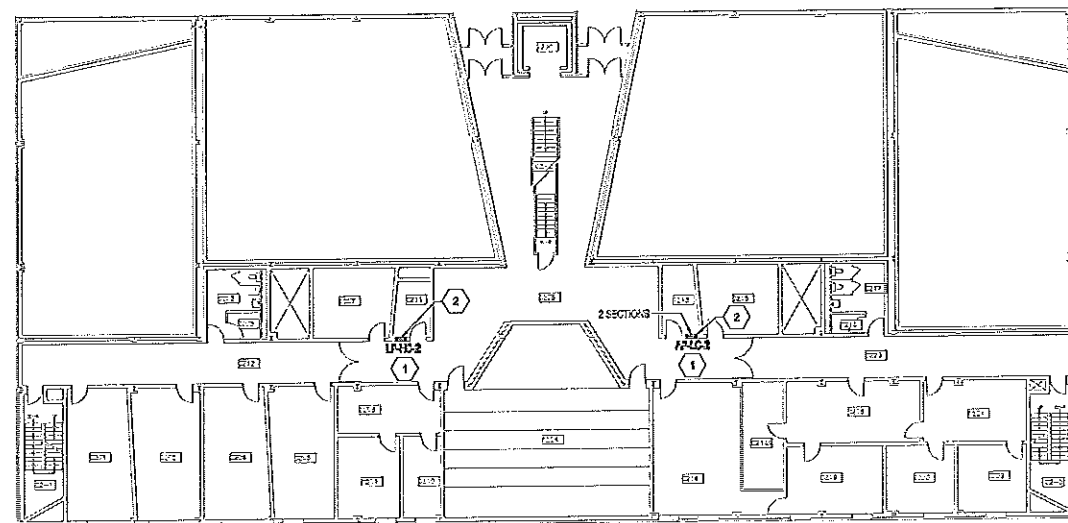
**A1 CRANE MUSIC COMPLEX - BISHOP PLAZA LEVEL FLOOR PLAN**  
SCALE: 1/8" = 1'-0"

- DRAWING SPECIFIC NOTES:**
- 1 REMOVE EXISTING PANEL BOARD IN THIS LOCATION AND REPLACE WITH NEW PANEL BOARD AS SHOWN.
  - 2 SEE DETAIL D3-551 FOR ARCHITECTURAL WORK.

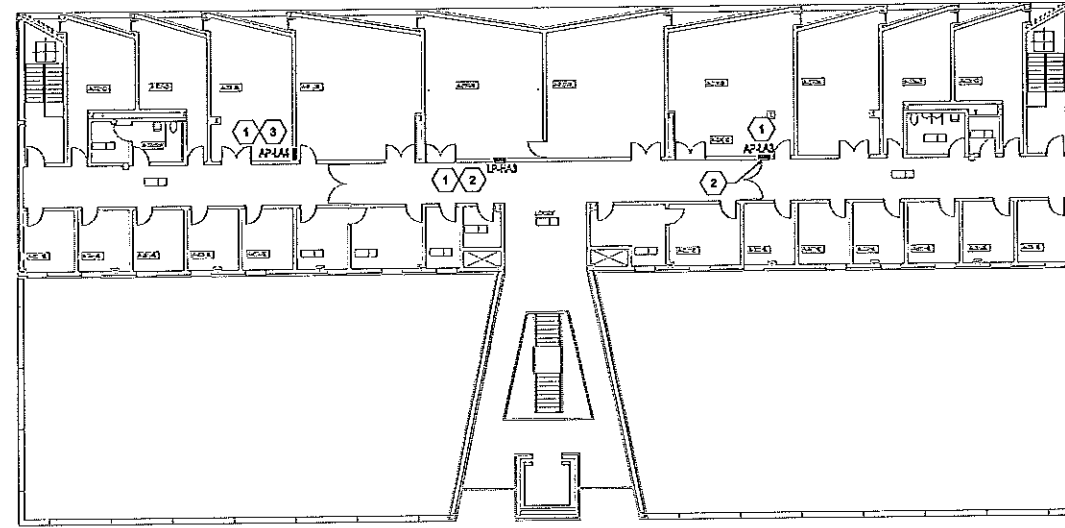
**C1 CRANE MUSIC COMPLEX - SCHUETTE UPPER LEVEL FLOOR PLAN**  
SCALE: 1/16" = 1'-0"

- DRAWING SPECIFIC NOTES:**
- 1 REMOVE EXISTING PANELBOARD IN THIS LOCATION AND REPLACE WITH NEW PANEL BOARD AS SHOWN.
  - 2 SEE DETAIL DASH-51 FOR ARCHITECTURAL WORK.
  - 3 SEE DETAIL DASH-51 FOR ARCHITECTURAL DRY WALL WORK.

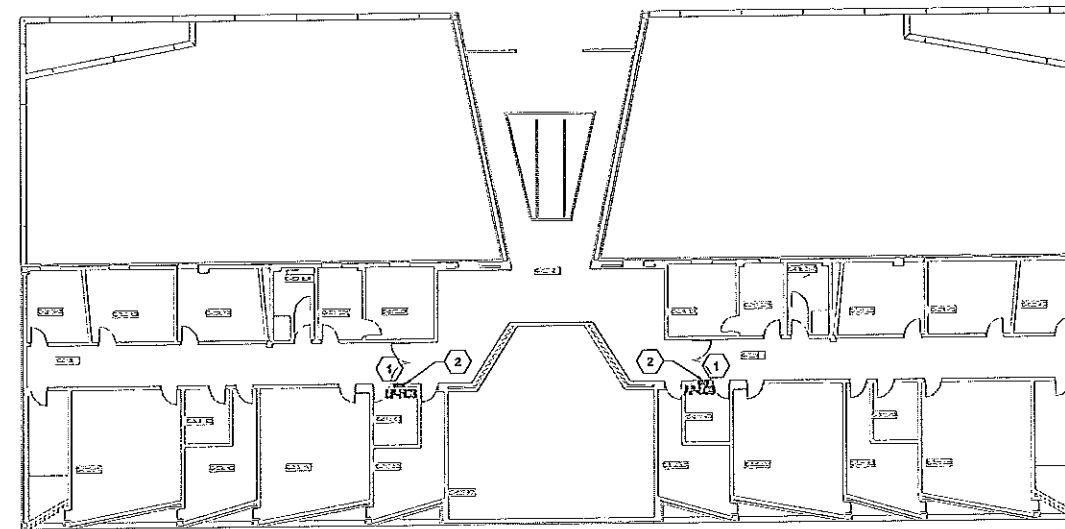
**A1 CRANE MUSIC COMPLEX - BISHOP UPPER LEVEL FLOOR PLAN**  
SCALE: 1/16" = 1'-0"

- DRAWING SPECIFIC NOTES:**
- 1 REMOVE EXISTING PANELBOARD IN THIS LOCATION AND REPLACE WITH NEW PANEL BOARD AS SHOWN.
  - 2 SEE DETAIL DASH-51 FOR ARCHITECTURAL WORK.

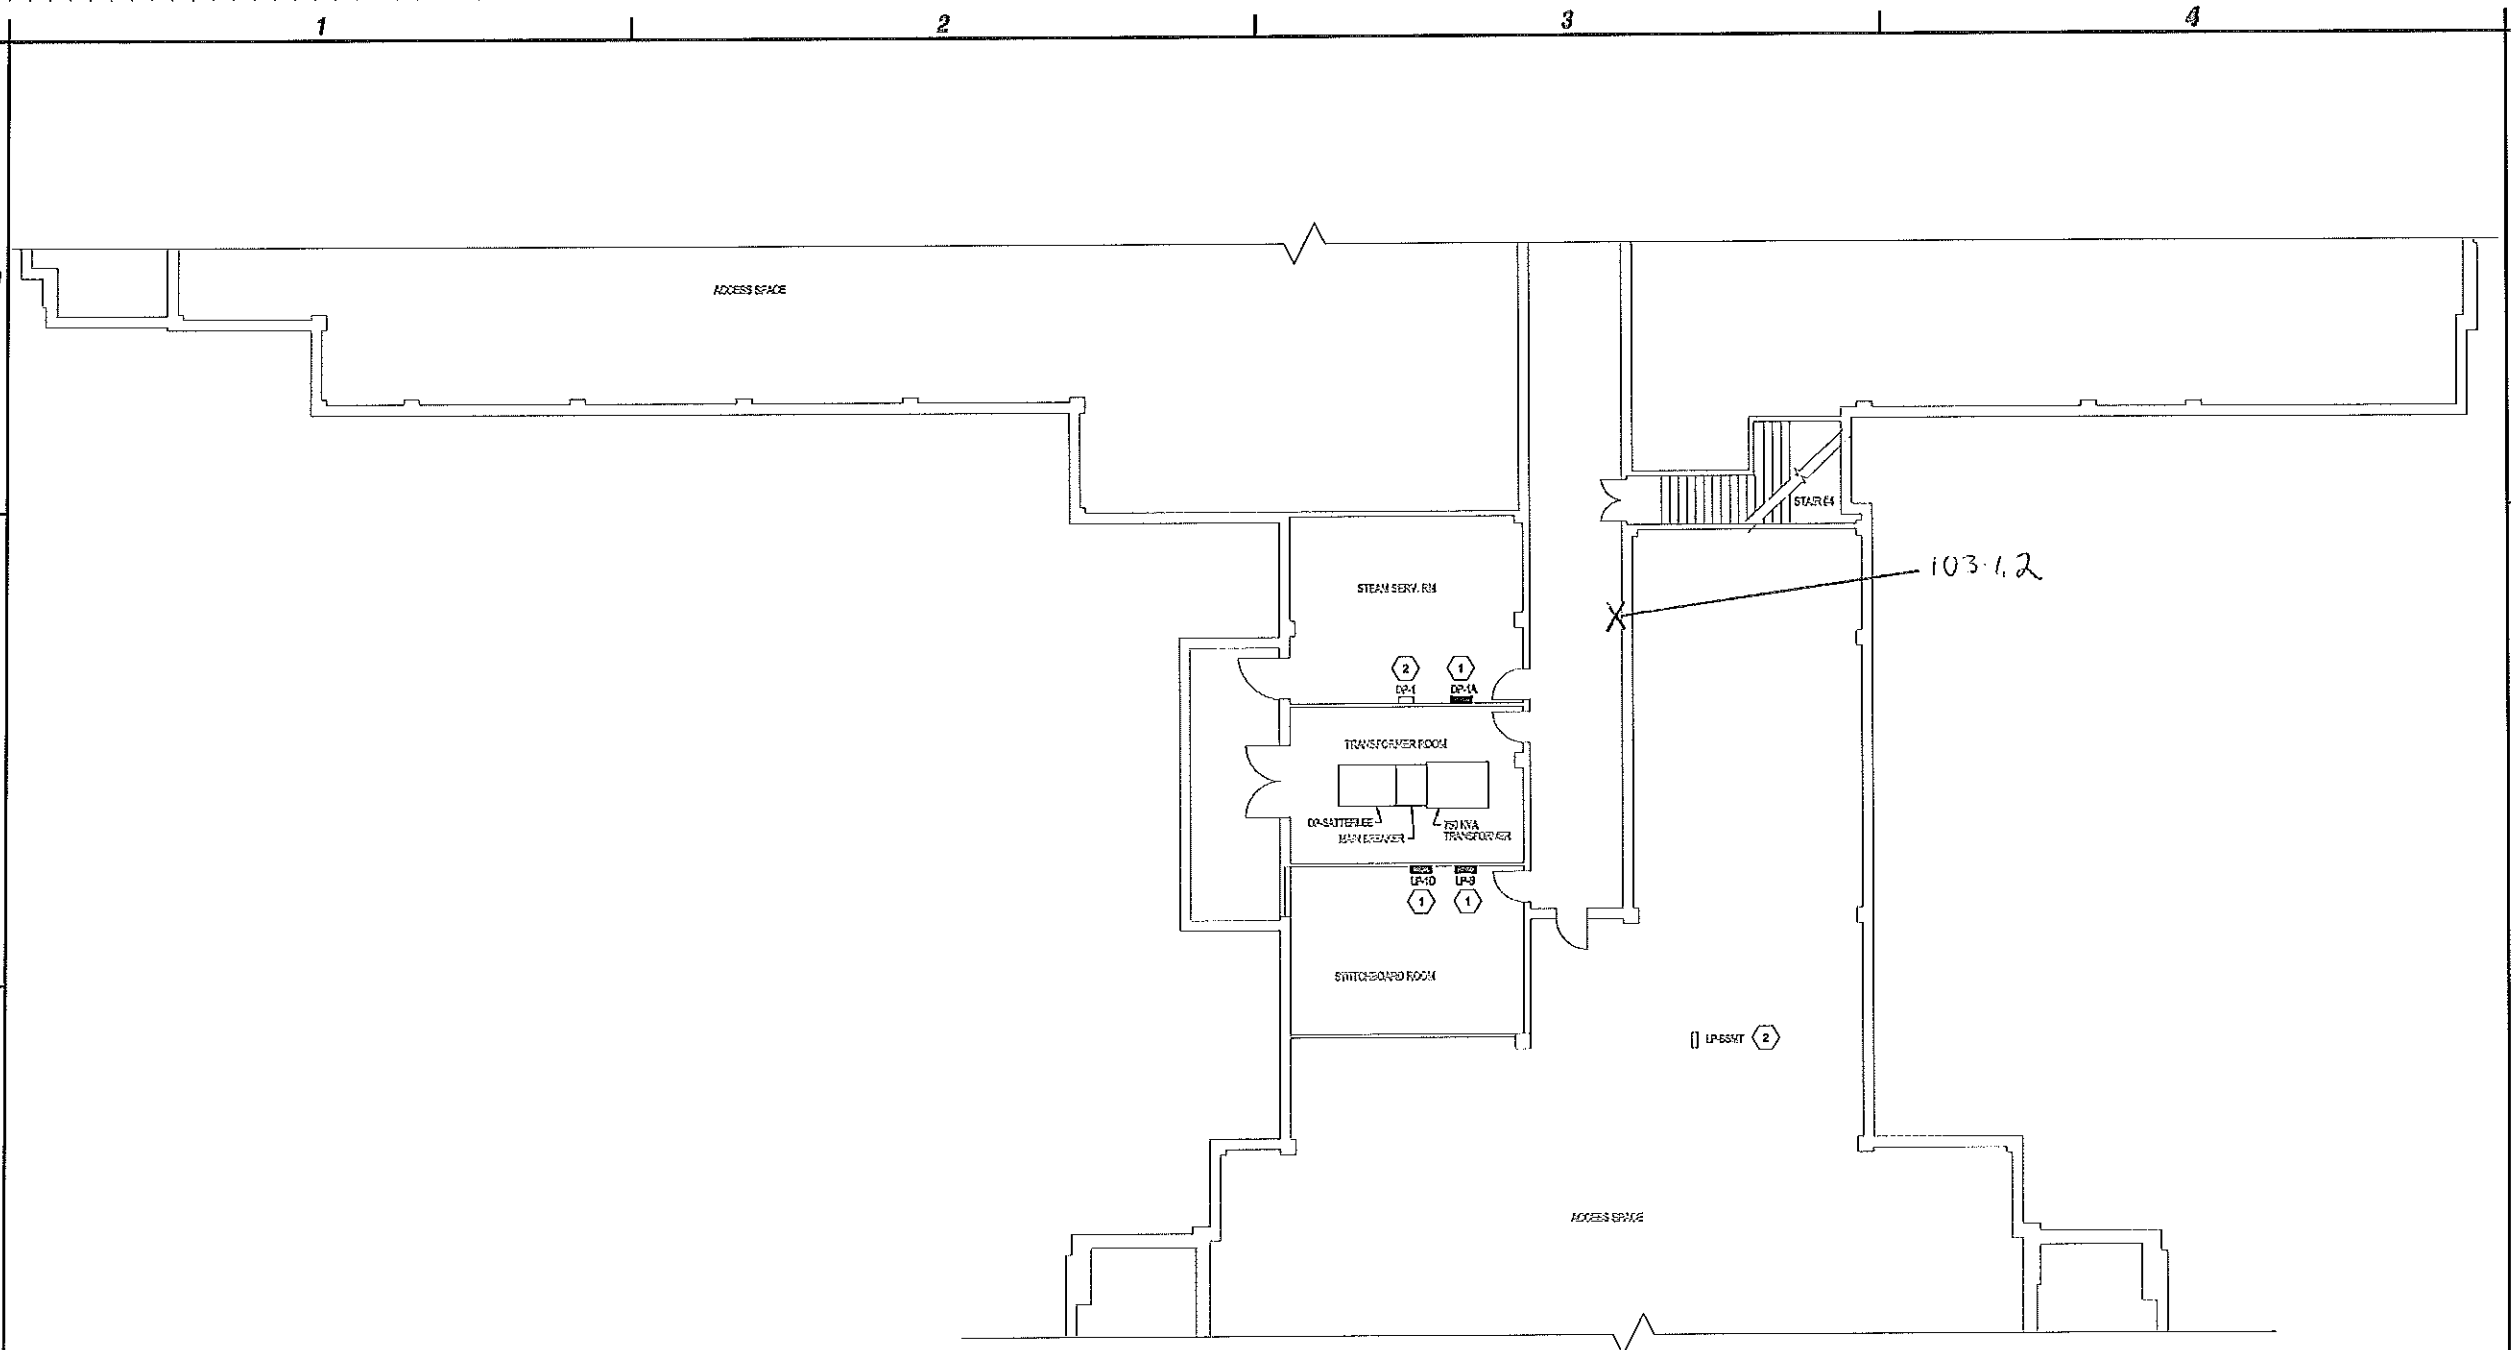
- DRAWING SPECIFICATIONS
- 1 REMOVE EXISTING PANELBOARDS IN THIS LOCATION AND REPLACE WITH NEW PANEL BOARDS AS SHOWN.
  - 2 REMAINS.

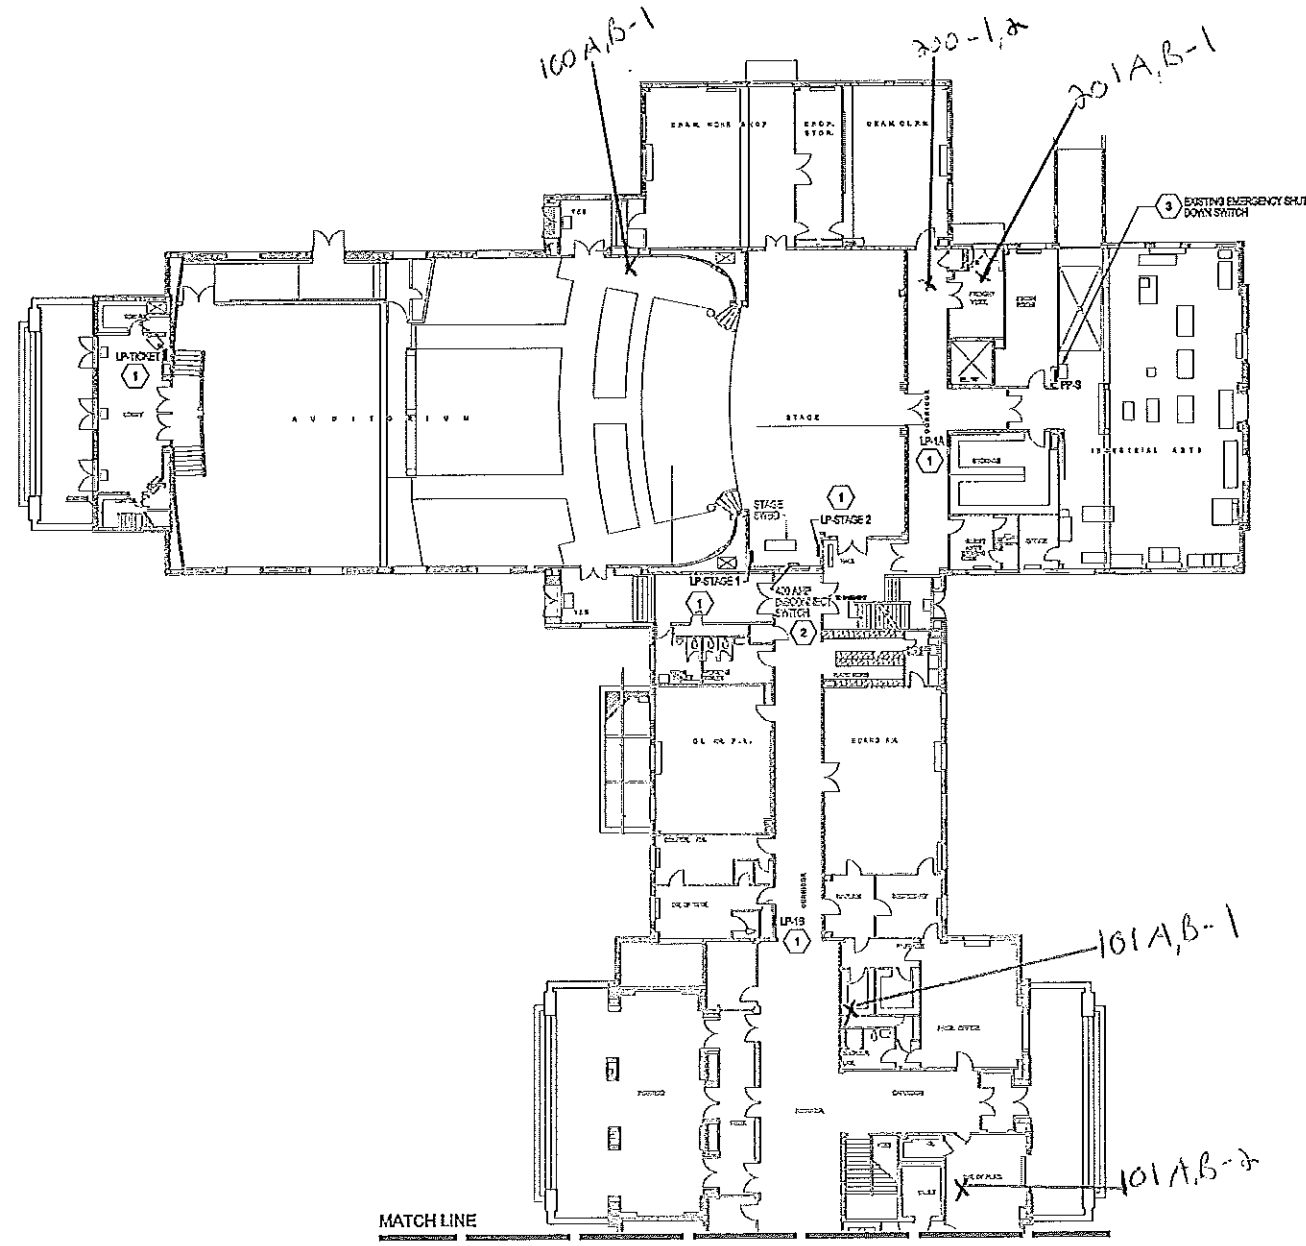
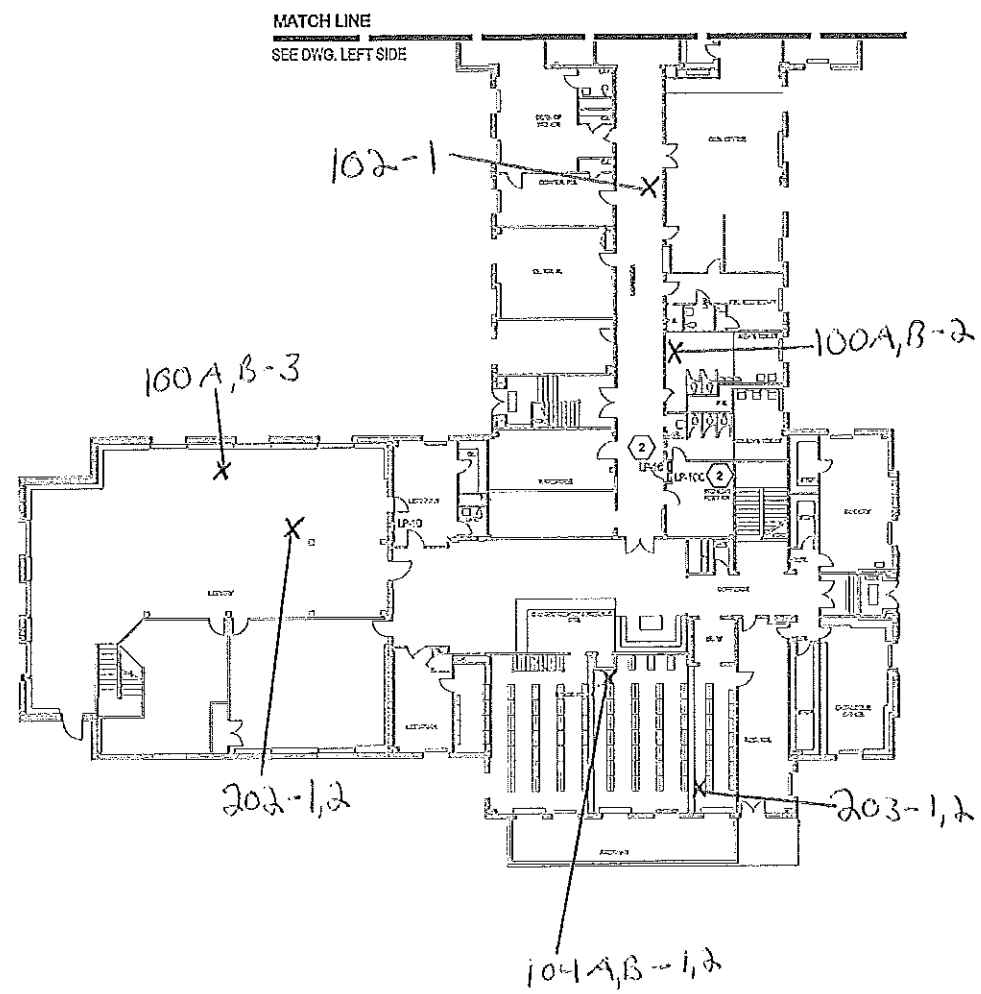
**E-100-10b**

- DRAWING SPECIFIC NOTES:**
- 1 REMOVE EXISTING PANELBOARD IN THIS LOCATION AND REPLACE WITH NEW PANELBOARD AS SHOWN.
  - 2 REMAIN.
  - 3 RELOCATE EXISTING EMERGENCY SHUT DOWN SWITCH TO SHUNT TRIP MAIN BREAKER IN PAB
