**Re: Summary of Asbestos Containing Materials by Building  
Upgrade Electrical Distribution System – Various Buildings  
SUCF Project No. 12290  
SUNY Potsdam  
Potsdam, New York**

## Summary of Asbestos Containing Materials

**Appendix D   Asbestos sample location maps**

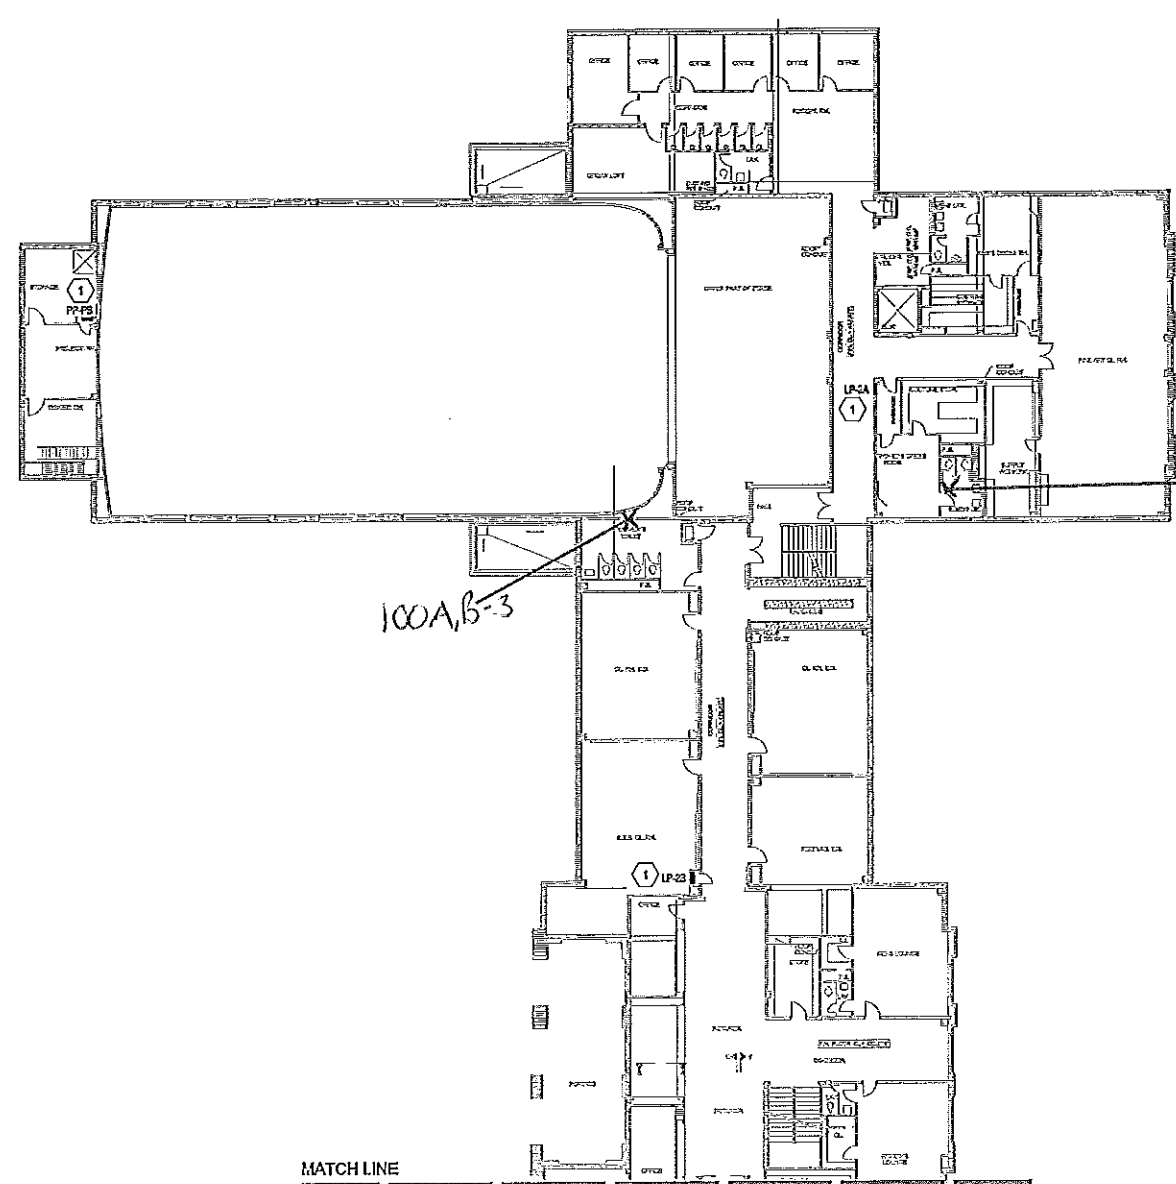
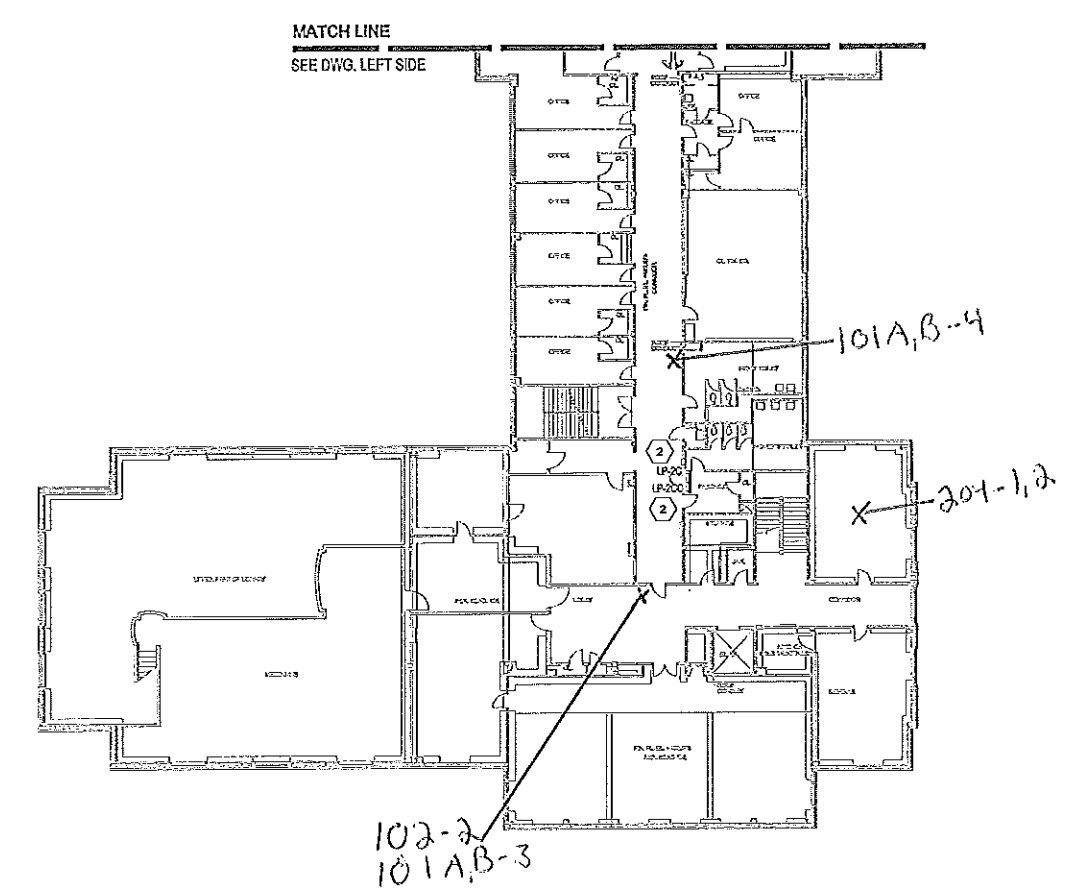
E-100-10c

- DRIVING SPECIFIC NOTES:
- (1) REMOVE EXISTING PANELS IN THIS LOCATION AND REPLACE WITH NEW PANELS SHOWN AS SHOWN (NOT USED)
  - (2) REMAINS

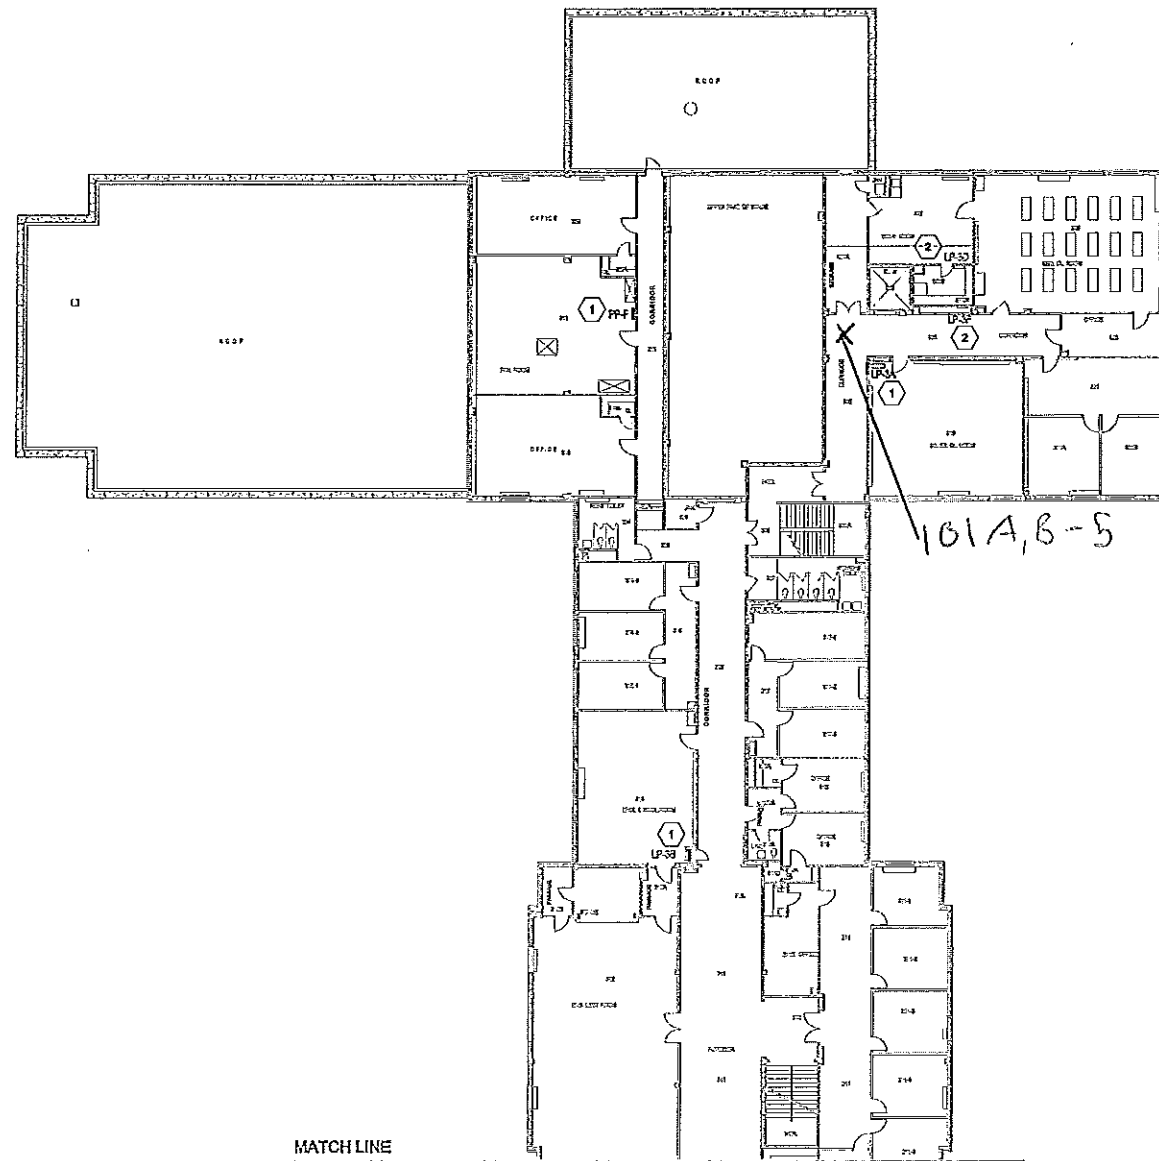
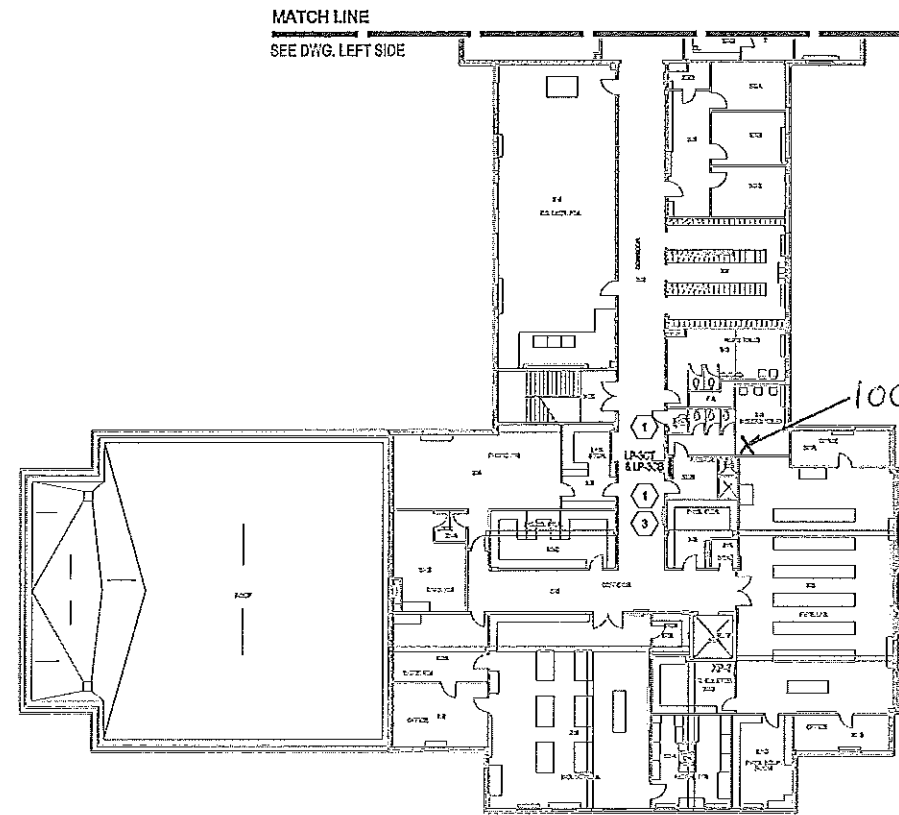
- DRAWING SPECIFIC NOTES:
- 1 REMOVE EXISTING PANEL BOARD IN THIS LOCATION AND REPLACE WITH NEW PANEL BOARD AS SHOWN (NOT USED).
  - 2 REMAINS.
  - 3 LP 300 IS NOT BEING REPLACED, REMOVED ONLY.

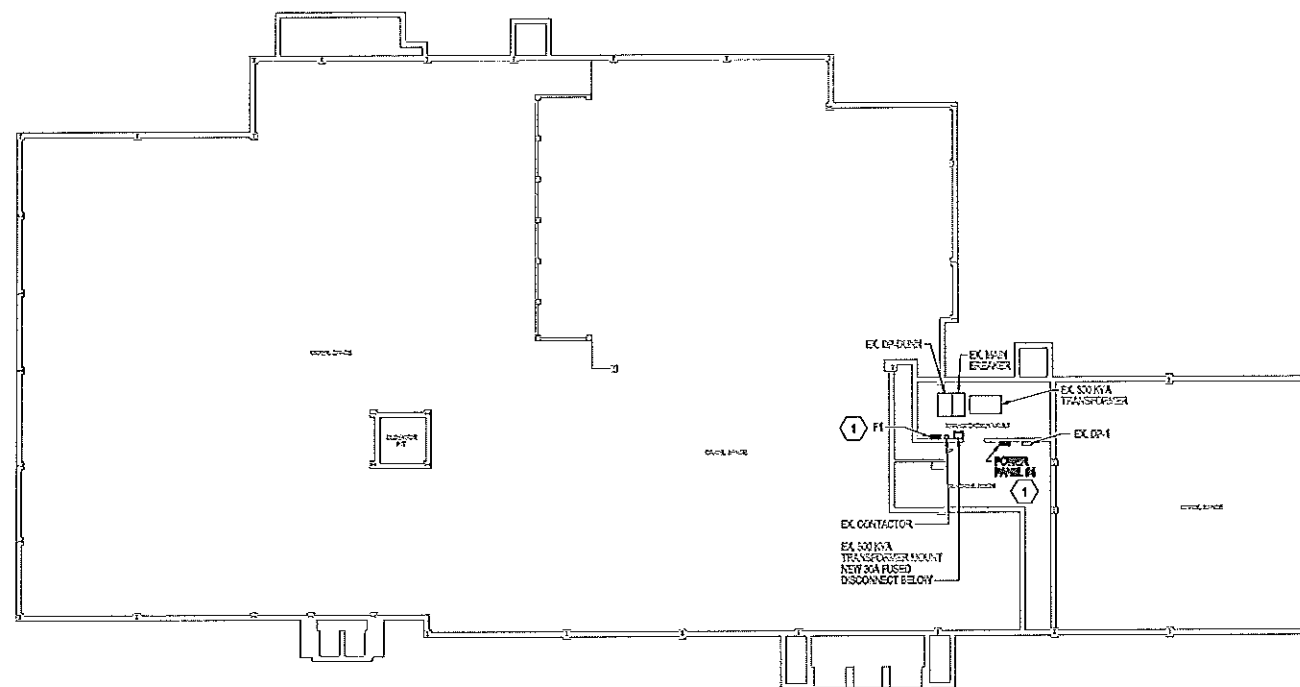
C1 DUNN - BASEMENT PLAN  
SCALE: 1/8" = 1'-0"

1 REMOVE EXISTING PANEL BOARD IN THIS LOCATION AND  
REPLACE WITH NEW PANEL BOARD AS SHOWN.

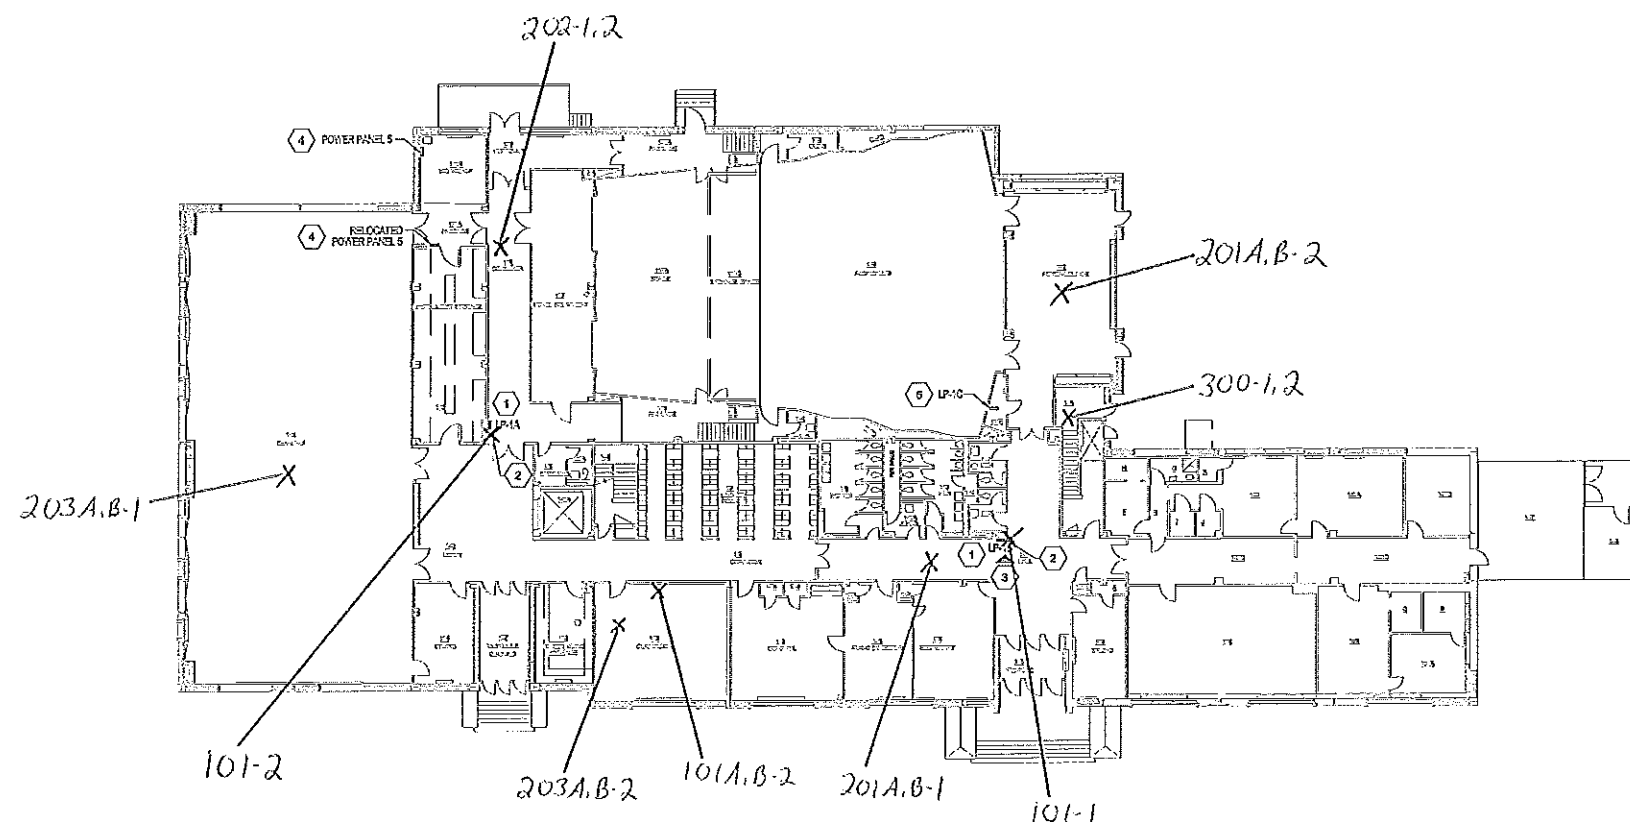
E-100-11a

- 1 REMOVE EXISTING PANEL BOARD IN THIS LOCATION AND  
REPLACE WITH NEW PANEL BOARD AS SHOWN.
- 2 SEE DETAIL AS SHOWN FOR ARCHITECTURAL WORK.
- 3 SEE PHOTO DUNN-1.
- 4 REMOVE EXISTING POWER PANEL 5, RELOCATE NEW PANEL  
AS SHOWN, REMOVE INNER BUS AND BREAKERS AND REUSE  
EXISTING PANEL BOX AS A 1/2" EXTEND MAIN POWER FEED  
AND CIRCUIT AS SHOWN AND REQUIRED.
- 5 REMAINS.

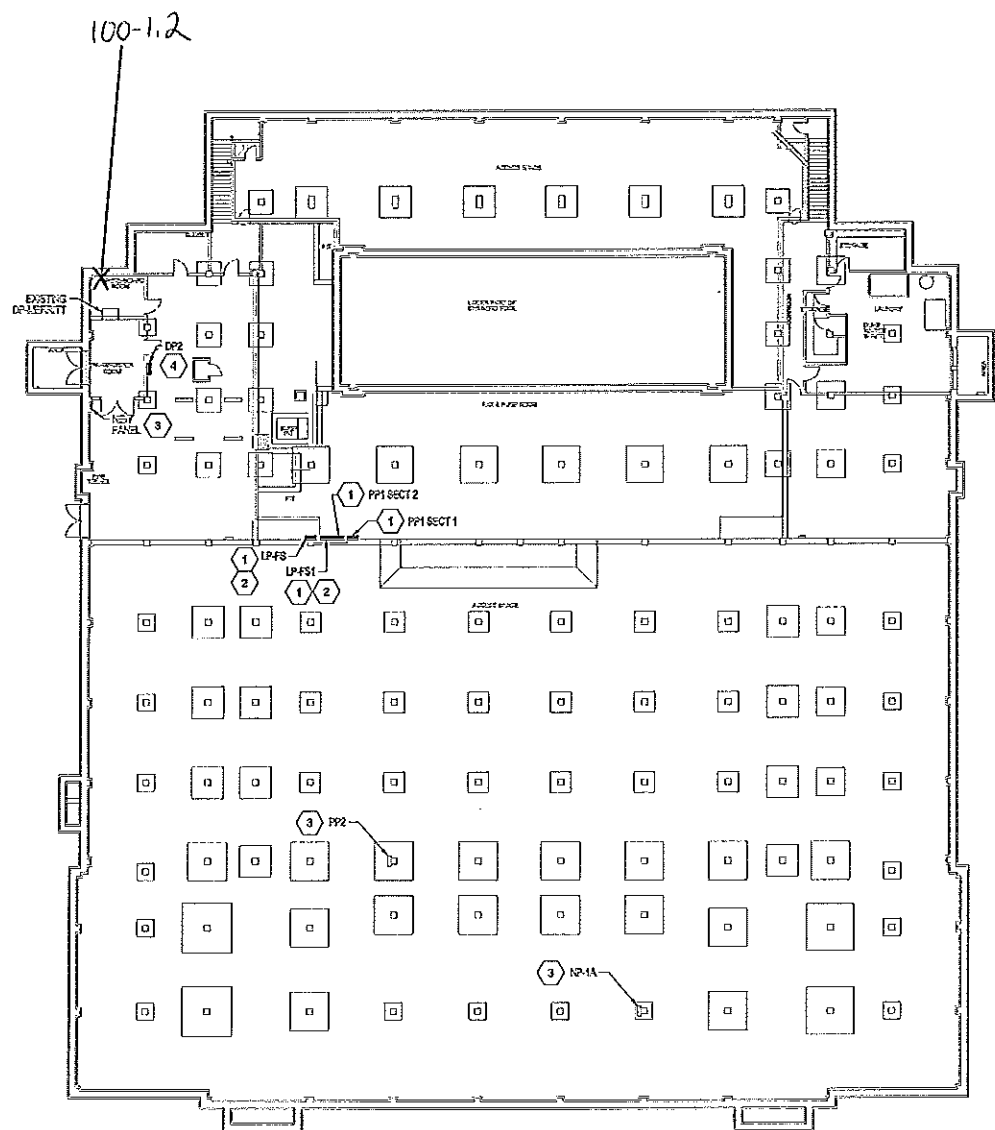
E-100-11b

- DRAWING SPECIFIC NOTES:**
- 1 REMOVE EXISTING PANEL BOARD IN THIS LOCATION AND REPLACE WITH NEW PANEL BOARD AS SHOWN
  - 2 REMOVE ALL DAMAGED FEEDER CONDUIT WITH UPS BENEATH PANEL UP-1A AND UP-1B
  - 3 REMAINS
  - 4 NEW DISTRIBUTION PANEL DP-2

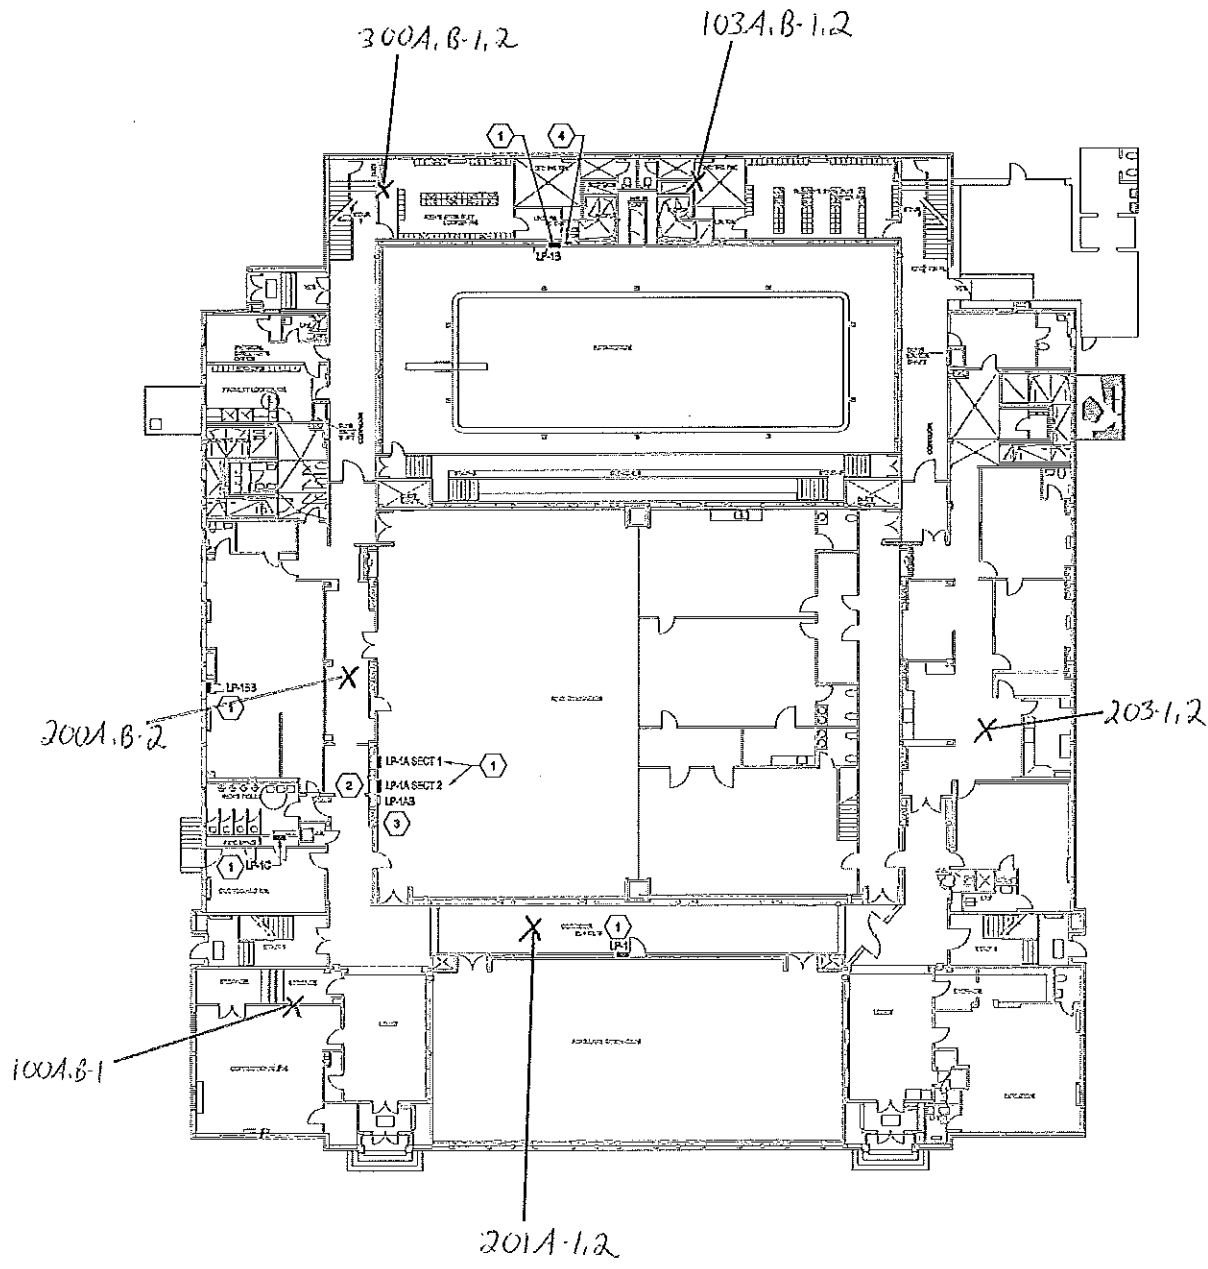
**A1 MERRITT - BASEMENT PLAN**  
SCALE: 1/8" = 1'-0"

- DRAWING SPECIFIC NOTES:**
- 1 REMOVE EXISTING PANEL BOARD IN THIS LOCATION AND REPLACE WITH NEW PANEL BOARD AS SHOWN
  - 2 REMOVE EXISTING PANEL BOARDS AND RELOCATE CIRCUITS TO NEW UP-1A SECTION 1 AND SECTION 2 PANELS AS SCHEDULED
  - 3 REMOVE EXISTING PANEL BOARD IN THIS LOCATION AND REPLACE CIRCUITS TO UP-1A SECTION 1 & 2 PANELS AS SHOWN
  - 4 EXISTING LIGHTING CONTROL SWITCH TO BE REMOVED TO NEW CONTROLLER AS NOTED ON UP-1B SCHEDULE ON DRAWINGS E-101-12

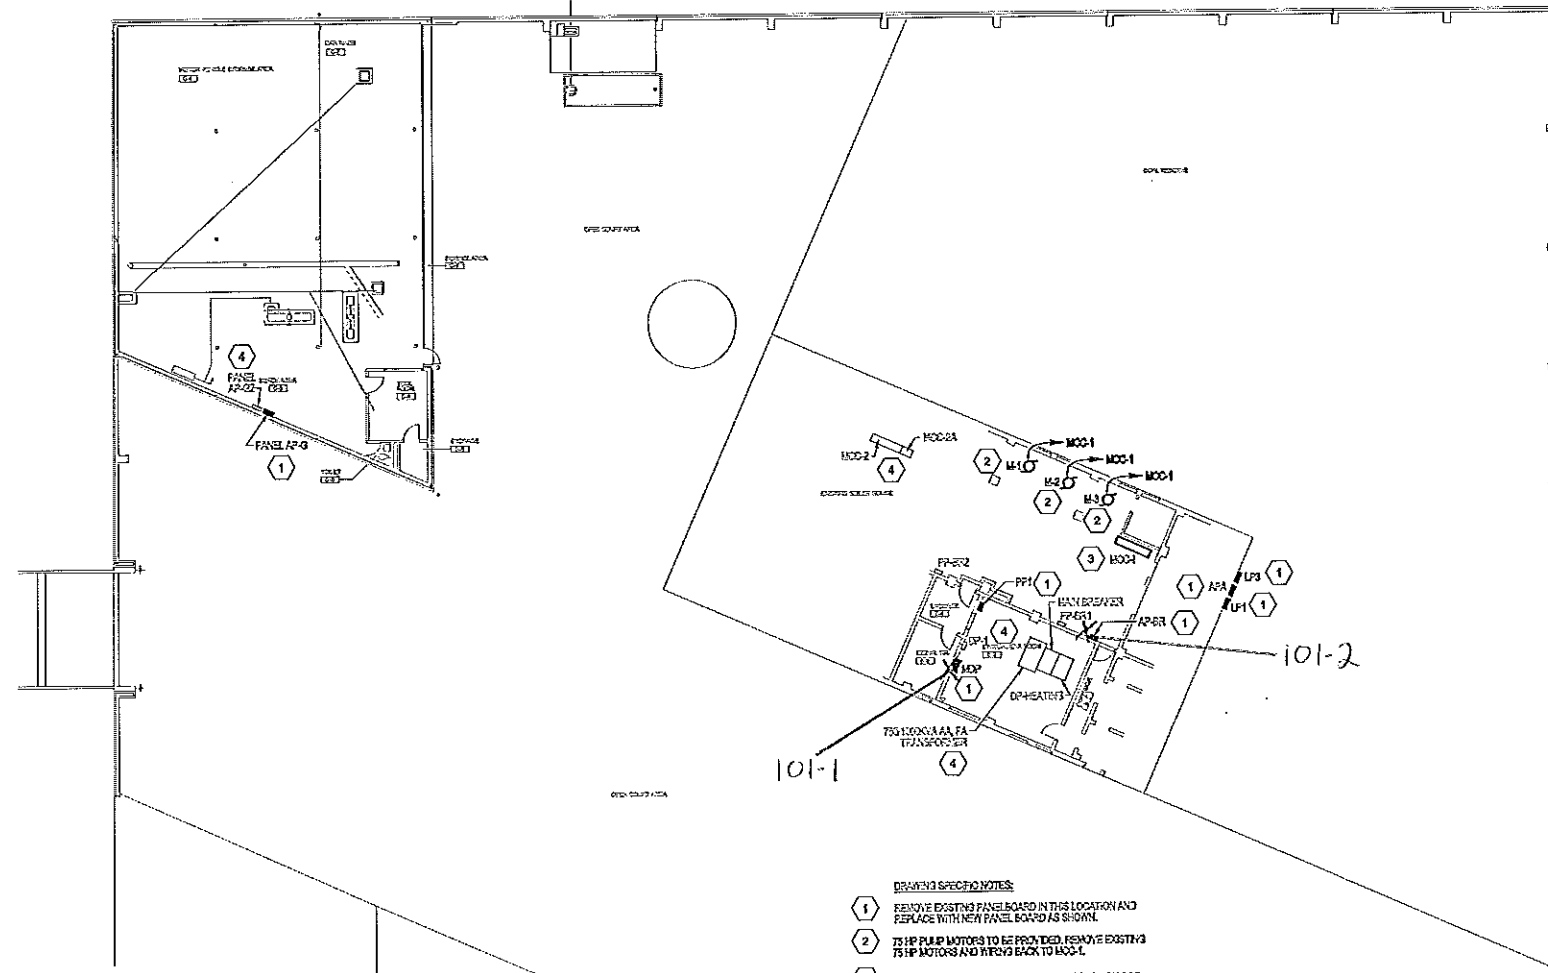
B1 HEATING PLANT - FIRST FLOOR PLAN  
SCALE: 1/8" = 1'-0"

- DRAWING SPECIFIC NOTES:
- 1 REMOVE EXISTING PANELBOARDS IN THIS LOCATION AND REPLACE WITH NEW PANEL BOARD AS SHOWN.
  - 2 75 HP PUMP MOTORS TO BE PROVIDED. REMOVE EXISTING 75 HP MOTORS AND REWIND BACK TO 480V.
  - 3 REMOVE EXISTING MOD IN THIS LOCATION AND REPLACE WITH NEW MOD AS SHOWN.
  - 4 REMAINS.

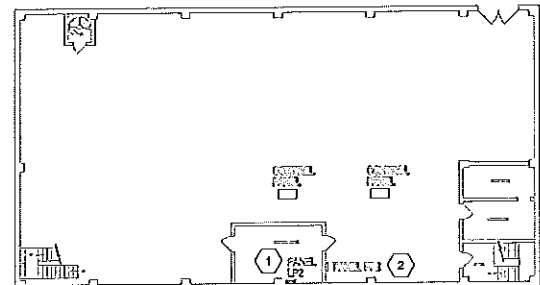
A1 HEATING PLANT - SECOND FLOOR PLAN (BOILER HOUSE)  
SCALE: 1/8" = 1'-0"

- DRAWING SPECIFIC NOTES:
- 1 REMOVE EXISTING PANELBOARDS IN THIS LOCATION AND REPLACE WITH NEW PANEL BOARD AS SHOWN.
  - 2 REMAINS.

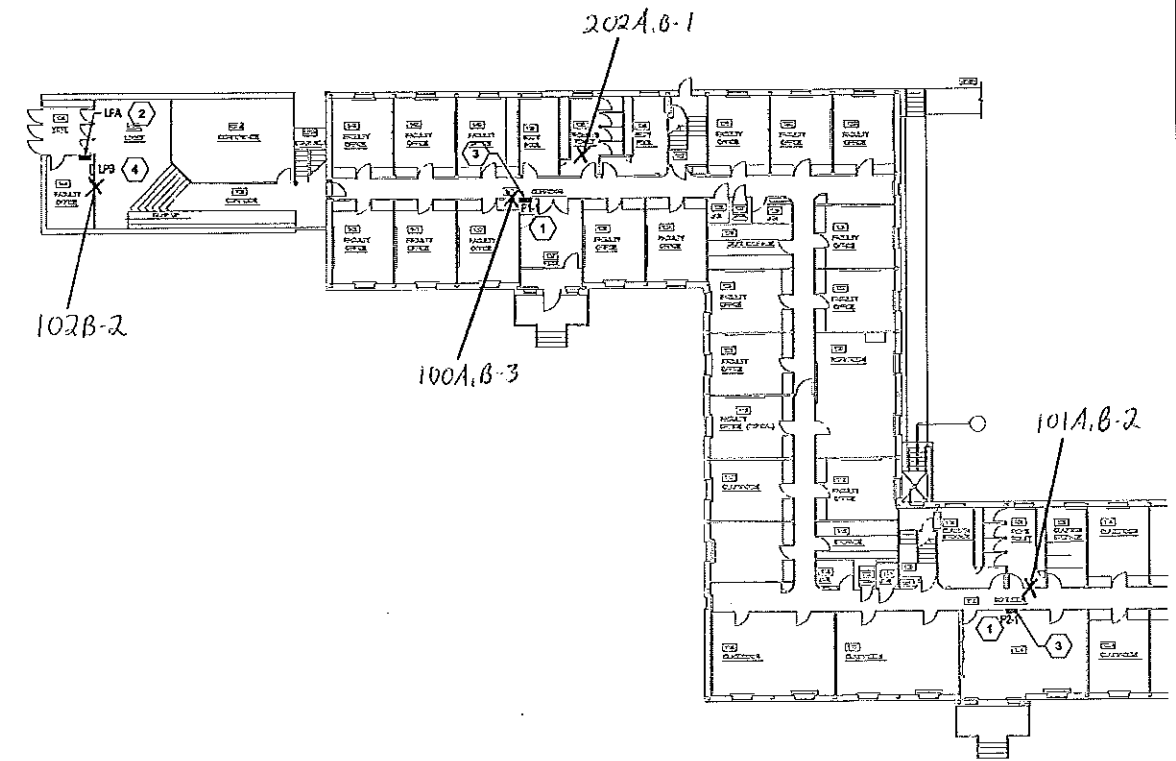
E-100-15A

- DRAWING SPECIFIC NOTES:
1. REMOVE EXISTING PANELBOARD IN THIS LOCATION AND REPLACE WITH NEW PANEL BOARD AS SHOWN.
  2. REMOVE PANELBOARD LPA AND LPA. RELOCATE BRANCH CIRCUITS FROM PANEL LPA INTO NEW PANEL LPA. DO NOT REPLACE LPA. REUSE EXISTING LPA POWER FEED CONDUITS AS SHOWN.
  3. SEE DETAIL A3-4-51 FOR ARCHITECTURAL WORK.
  4. REMAINS.

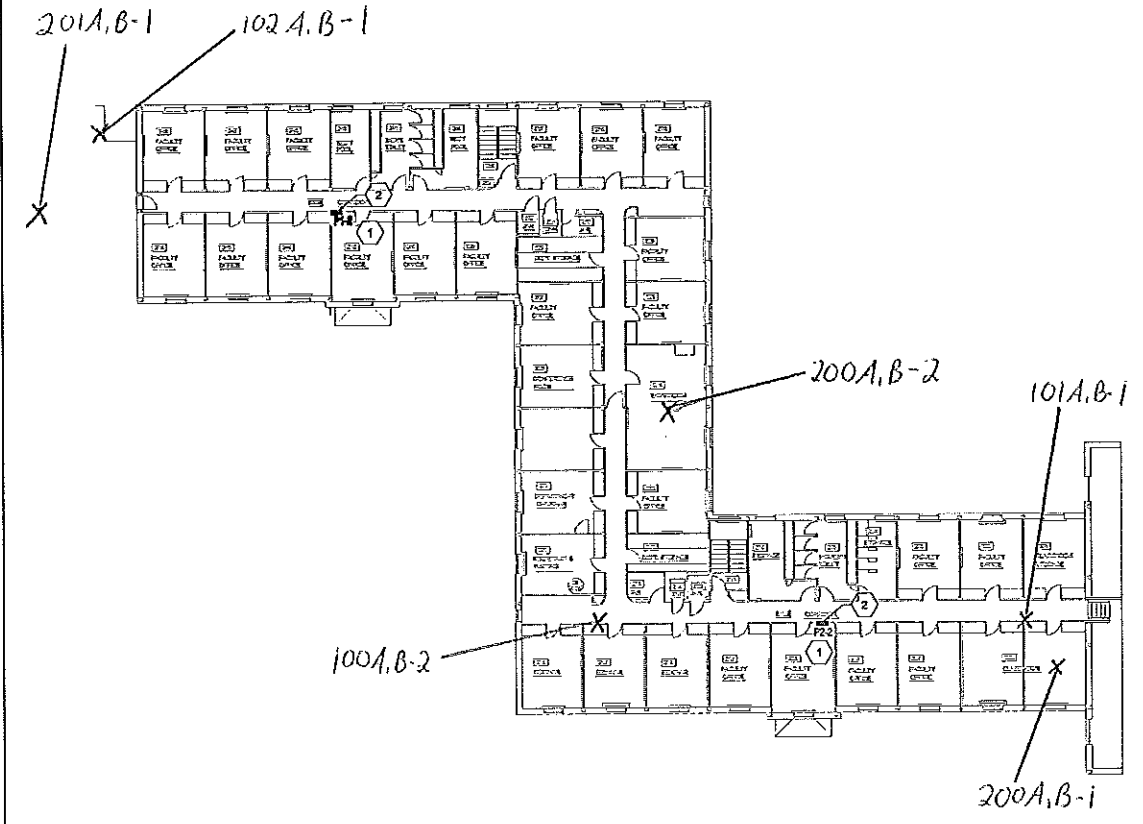
- DRAWING SPECIFIC NOTES:
1. REMOVE EXISTING PANELBOARD IN THIS LOCATION AND REPLACE WITH NEW PANEL BOARD AS SHOWN.
  2. SEE DETAIL A3-4-51 FOR ARCHITECTURAL WORK.

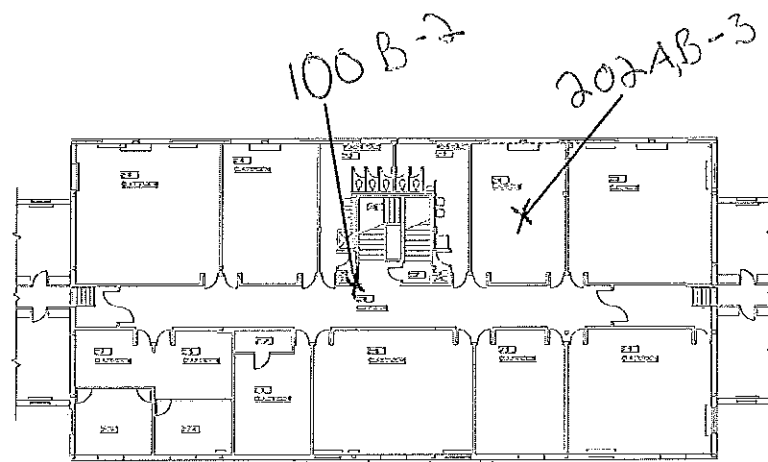
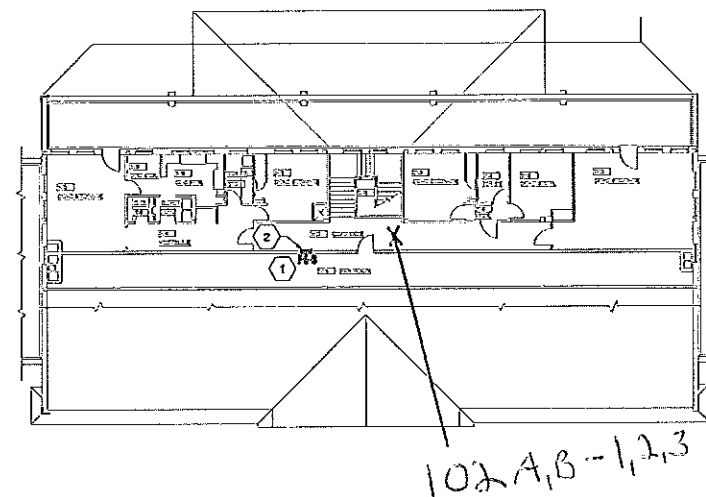
**A1 CARSON - SECOND FLOOR PLAN**  
SCALE: 1/8" = 1'-0"

- DRAWING SPECIFIC NOTES**
- ① REMOVE EXISTING PANEL BOARD IN THIS LOCATION AND REPLACE WITH NEW PANEL BOARD AS SHOWN.
  - ② SEE DETAIL E2A-S1 FOR ARCHITECTURAL WORK.

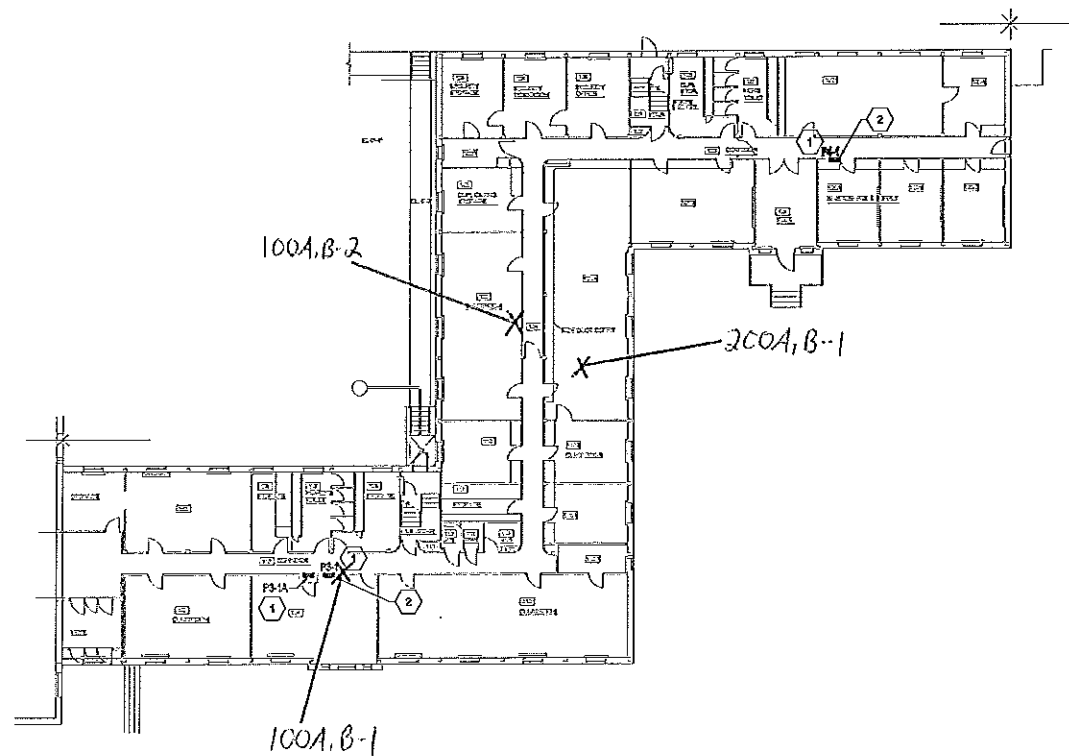
**E-100-15Bb**

- DRAWING SPECIFIC NOTES:**
1. REMOVE EXISTING PANELBOARD IN THIS LOCATION AND REPLACE WITH NEW PANELBOARD AS SHOWN.
  2. SEE DETAIL A3-1 FOR ARCHITECTURAL WORK.

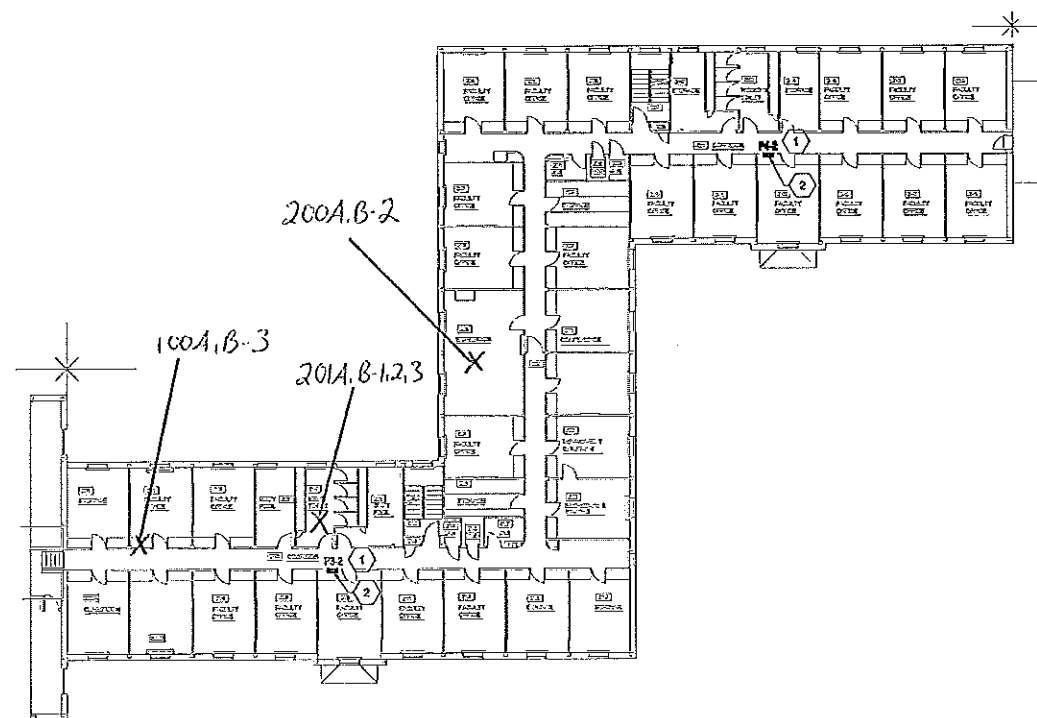
**A1 MACVICAR - FIRST FLOOR PLAN**  
SCALE: 1/8" = 1'-0"

- DRAWING SPECIFIC NOTES:**
1. REMOVE EXISTING PANELBOARD IN THIS LOCATION AND REPLACE WITH NEW PANELBOARD AS SHOWN.
  2. SEE DETAIL A3-1 FOR ARCHITECTURAL WORK.

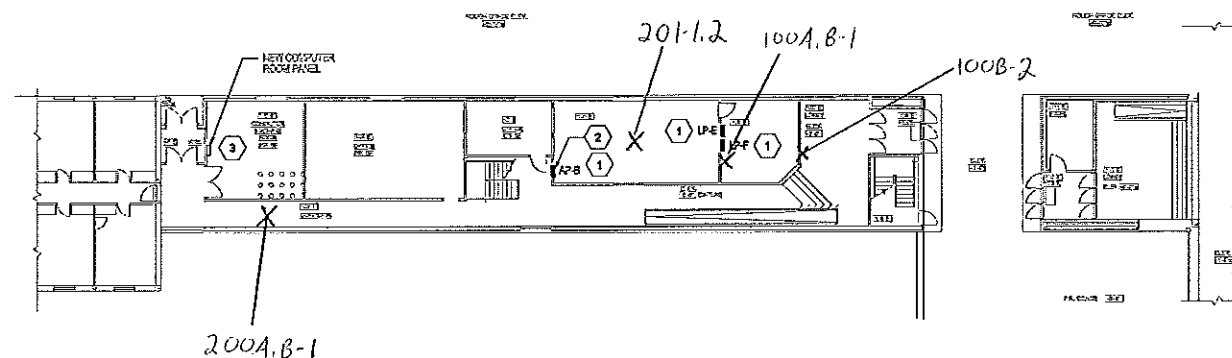
C1 STILLMAN - FIRST FLOOR PLAN  
SCALE: 1/8" = 1'-0"

- DRAWING SPECIFIC NOTES:
- 1 REMOVE EXISTING PANELBOARD IN THIS LOCATION AND REPLACE WITH NEW PANEL BOARD AS SHOWN.
  - 2 SEE DETAIL A2A-501 FOR ARCHITECTURAL WORK.
  - 3 REMAINS.

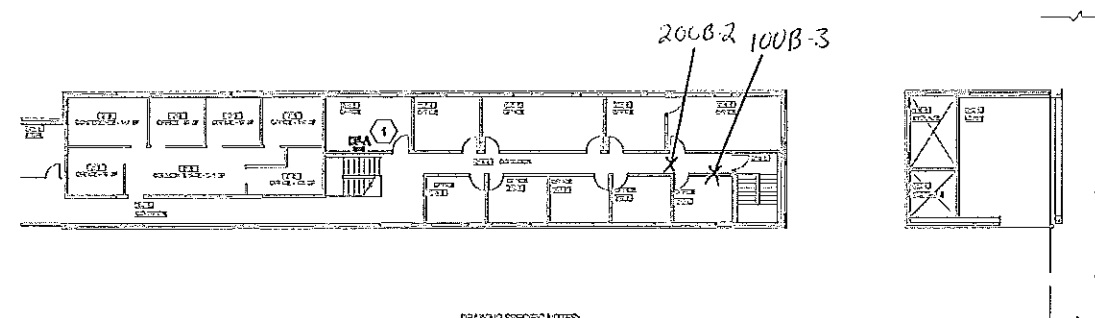
A1 STILLMAN - SECOND FLOOR PLAN  
SCALE: 1/8" = 1'-0"

- DRAWING SPECIFIC NOTES:
- 1 REMOVE EXISTING PANELBOARD IN THIS LOCATION AND REPLACE WITH NEW PANEL BOARD AS SHOWN.

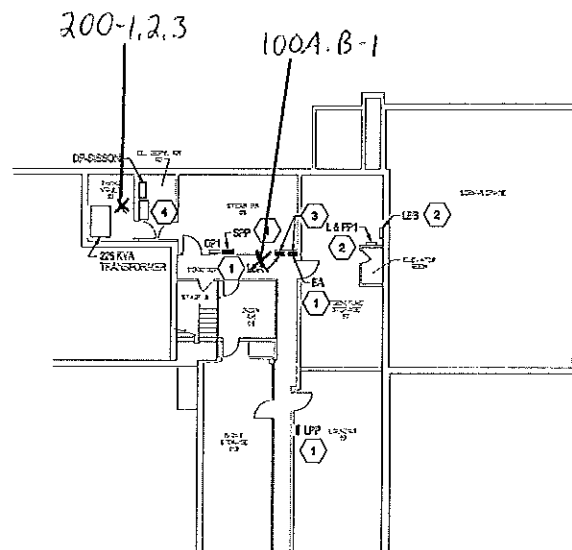
- DRAWING SPECIFIC NOTES**
- 1 REMOVE EXISTING PANELBOARD IN THIS LOCATION AND REPLACE WITH NEW PANEL BOARD AS SHOWN.
  - 2 REMAINS.
  - 3 SEE DETAIL A5A-511 FOR ARCHITECTURAL WORK.
  - 4 OLD PANEL ENCLOSURE UTILIZED AS JUNCTION BOX.

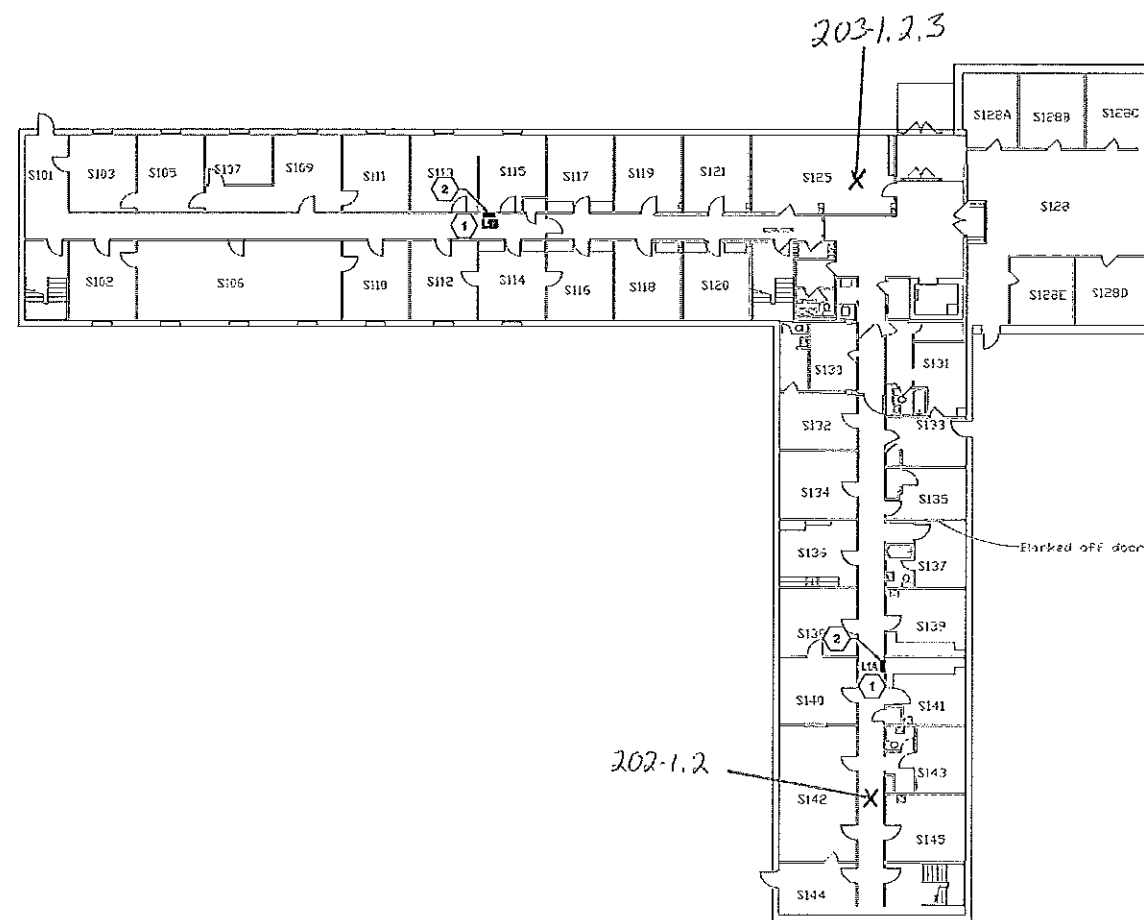
- DRAWING SPECIFIC NOTES**
- 1 REMOVE EXISTING PANELBOARD IN THIS LOCATION AND REPLACE WITH NEW PANEL BOARD AS SHOWN.
  - 2 SEE DETAIL A5A-511 FOR ARCHITECTURAL WORK.

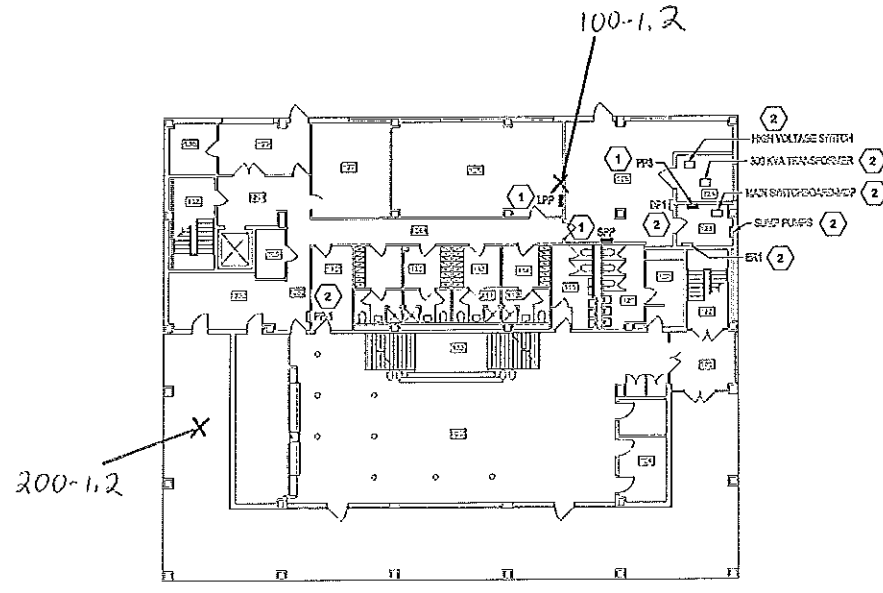
A1 THATCHER - FIRST FLOOR PLAN  
SCALE: 1/8" = 1'-0"

- DRAWING SPECIFIC NOTES:
- 1 REMOVE EXISTING PANEL BOARDS IN THIS LOCATION AND REPLACE WITH NEW PANEL BOARD AS SHOWN.
  - 2 REMAINS.

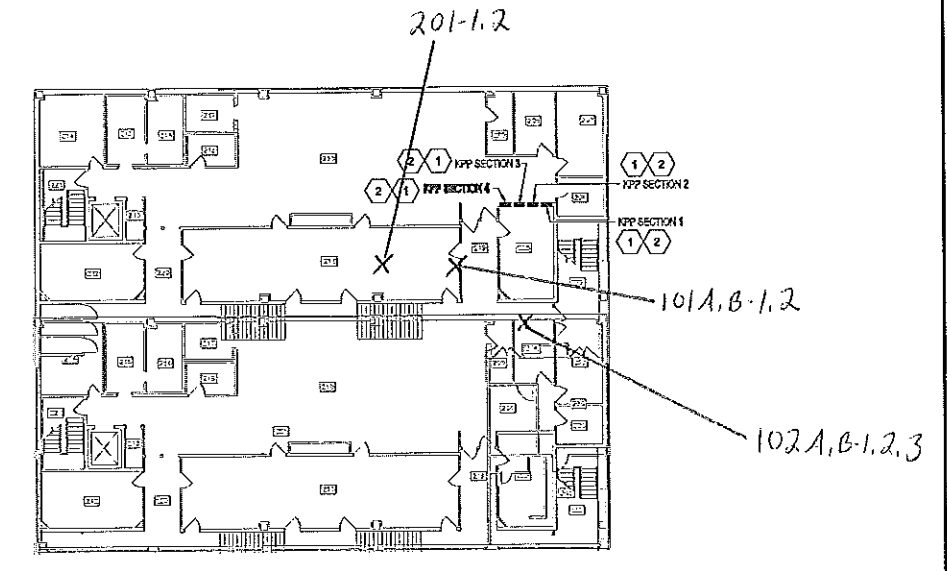
A3 THATCHER - SECOND FLOOR PLAN  
SCALE: 1/8" = 1'-0"

- DRAWING SPECIFIC NOTES:
- 1 REMOVE EXISTING PANEL BOARD IN THIS LOCATION AND REPLACE WITH NEW PANEL BOARD AS SHOWN.
  - 2 SEE DETAIL 02A-5/1 FOR ARCHITECTURAL WORK.

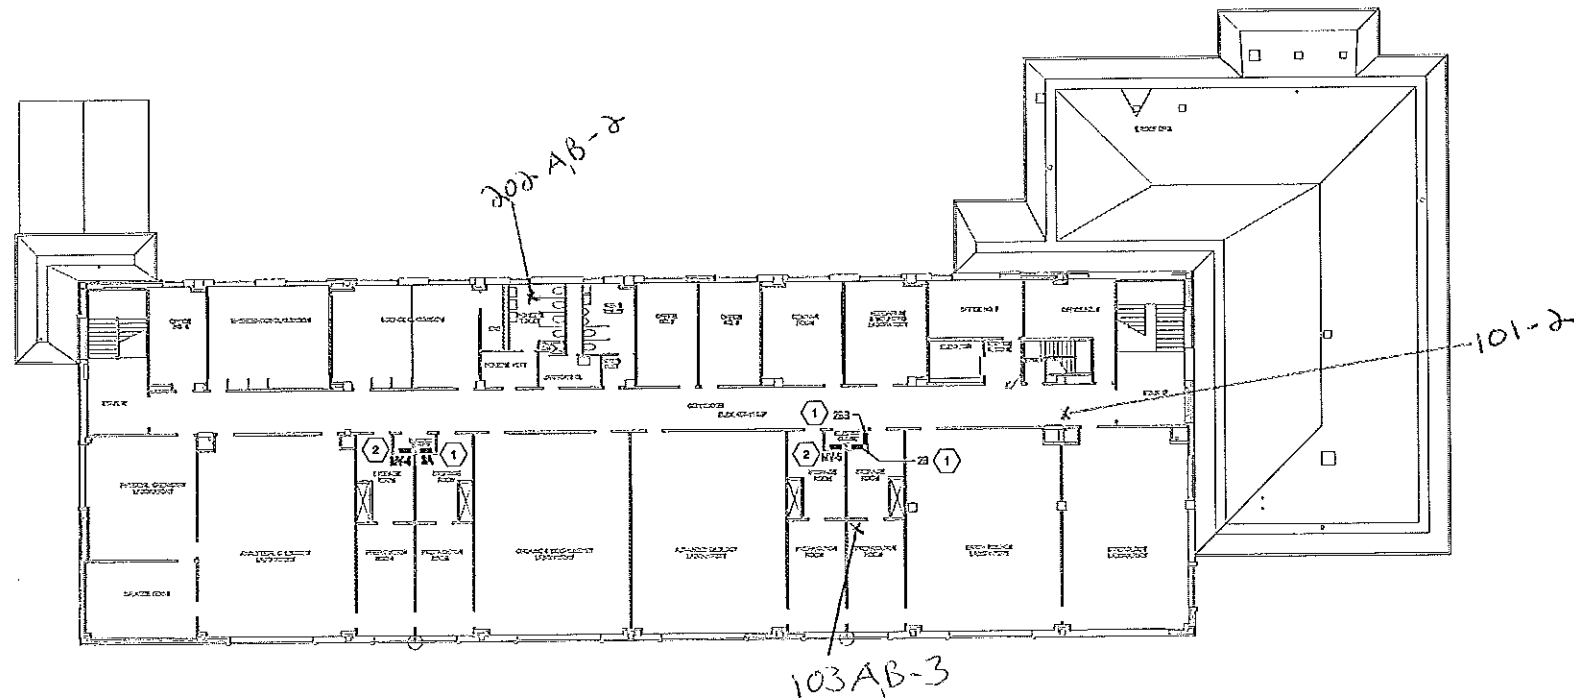
- DRAWING SPECIFIC NOTES:**
- 1 REMOVE EXISTING PANELBOARD IN THIS LOCATION AND REPLACE WITH NEW PANEL BOARD AS SHOWN.
  - 2 REMOVE EXISTING PANELBOARD AND DO SECTION 2 AND REPLACE WITH PANELBOARD AS SHOWN.

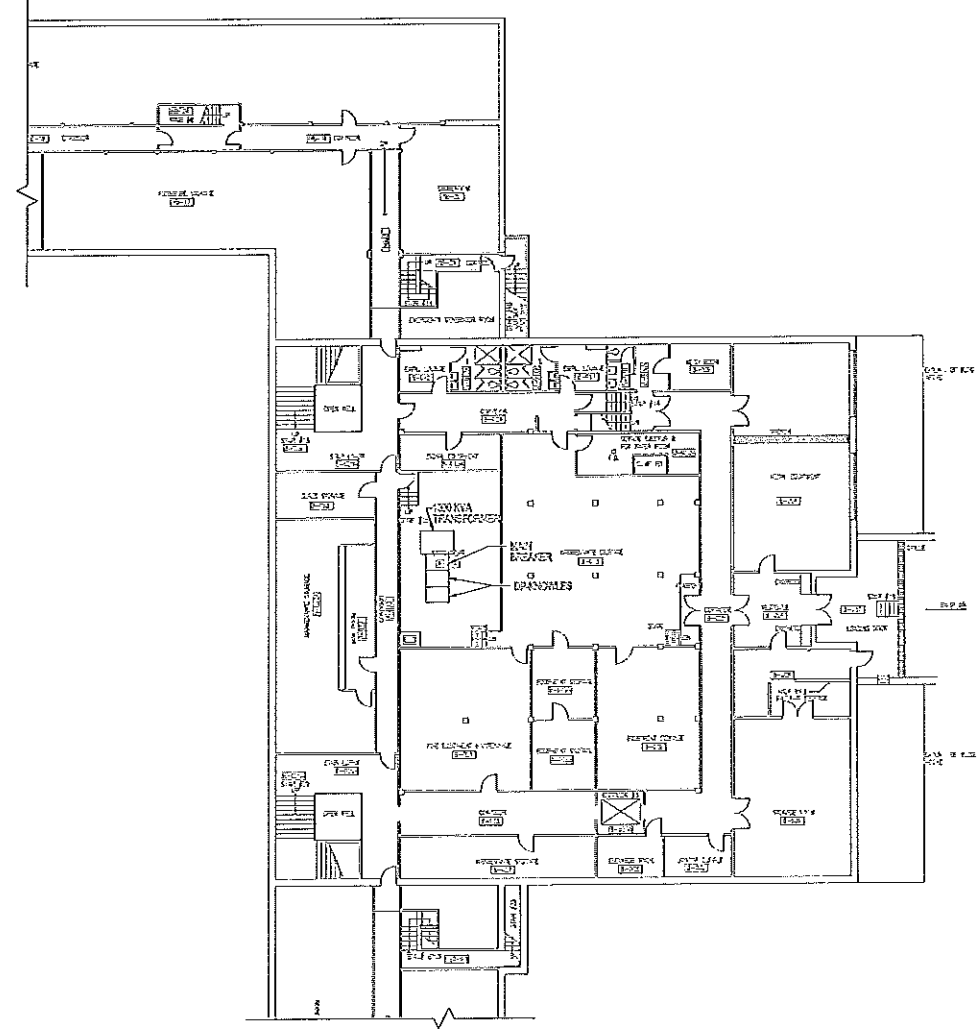
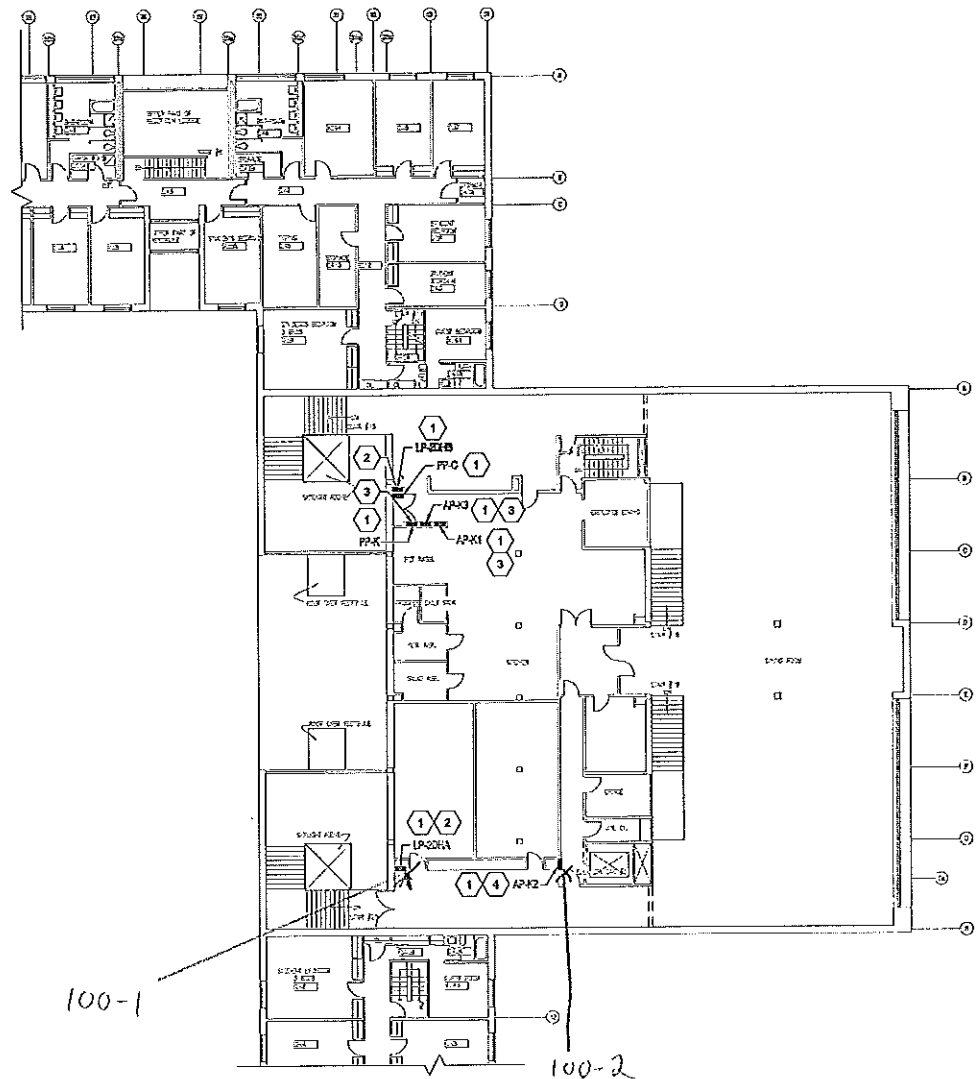
E-100-22

- DRAWING SPECIFIC NOTES:
- 1 REMOVE EXISTING PANEL BOARD IN THIS LOCATION AND REPLACE WITH NEW PANEL BOARD AS SHOWN.
  - 2 SEE DETAIL C24001 FOR ARCHITECTURAL WORK.
  - 3 SEE DETAIL D24001 FOR ARCHITECTURAL WORK.
  - 4 SEE DETAIL A24001 FOR ARCHITECTURAL WORK.
