**Re: Summary of Asbestos Containing Materials by Building  
Upgrade Electrical Distribution System – Various Buildings  
SUCF Project No. 12290  
SUNY Potsdam  
Potsdam, New York**

## Summary of Asbestos Containing Materials

**Appendix D   Asbestos sample location maps**

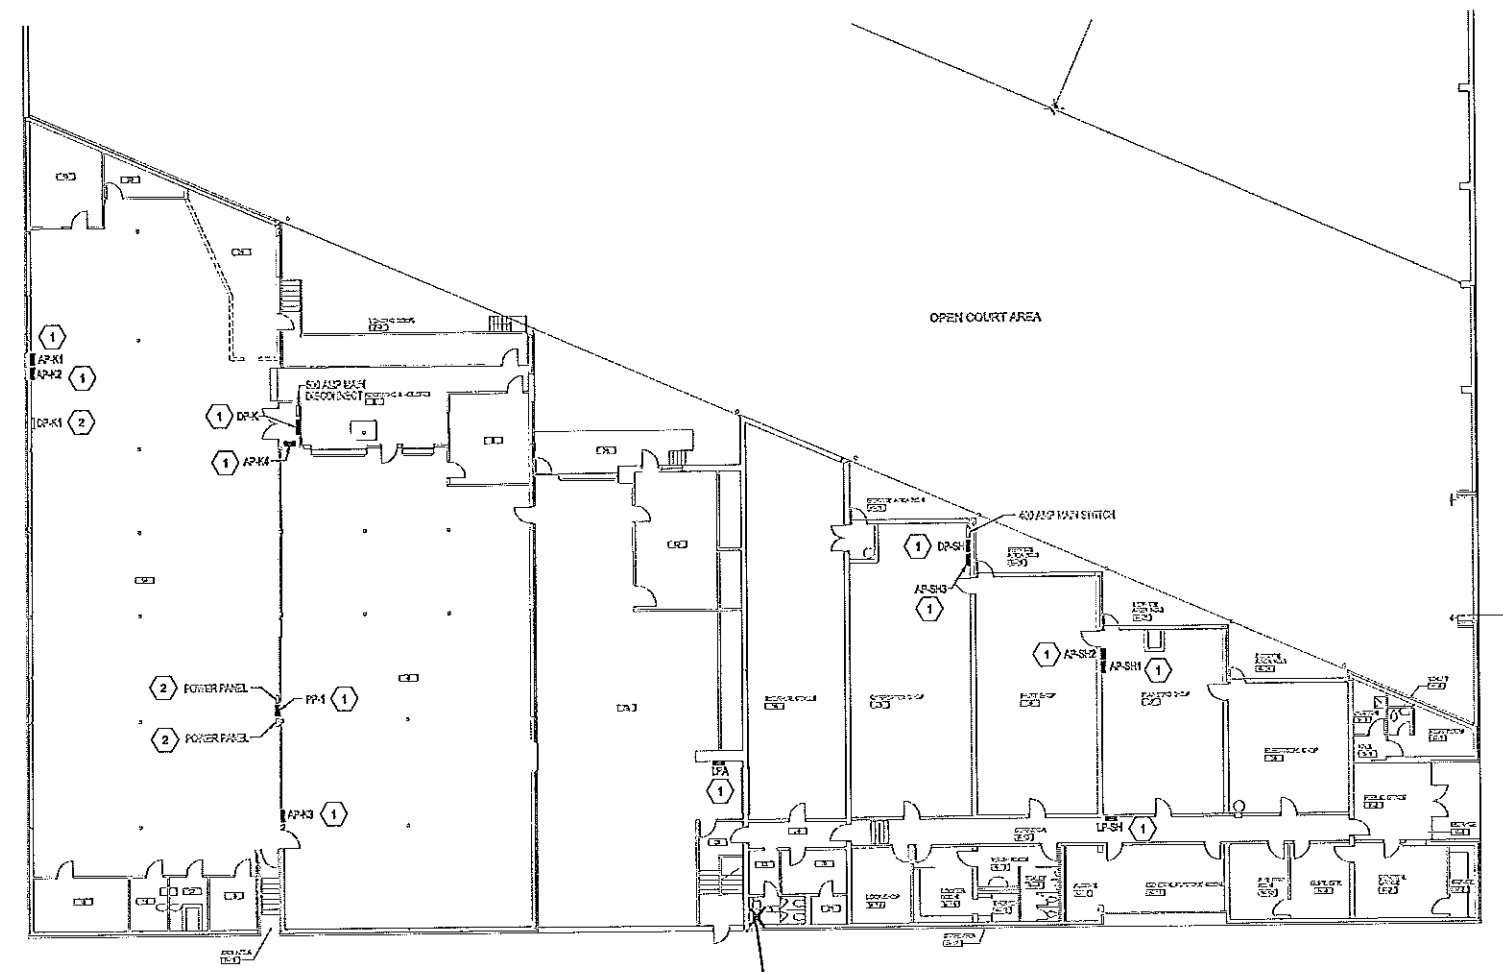
E-100-24

- DRAWING SPECIFIC NOTES:
- 1 REMOVE EXISTING PANELS AS SHOWN IN THIS LOCATION AND  
REPLACE WITH NEW PANEL BOARD AS SHOWN.
  - 2 REMAINS.

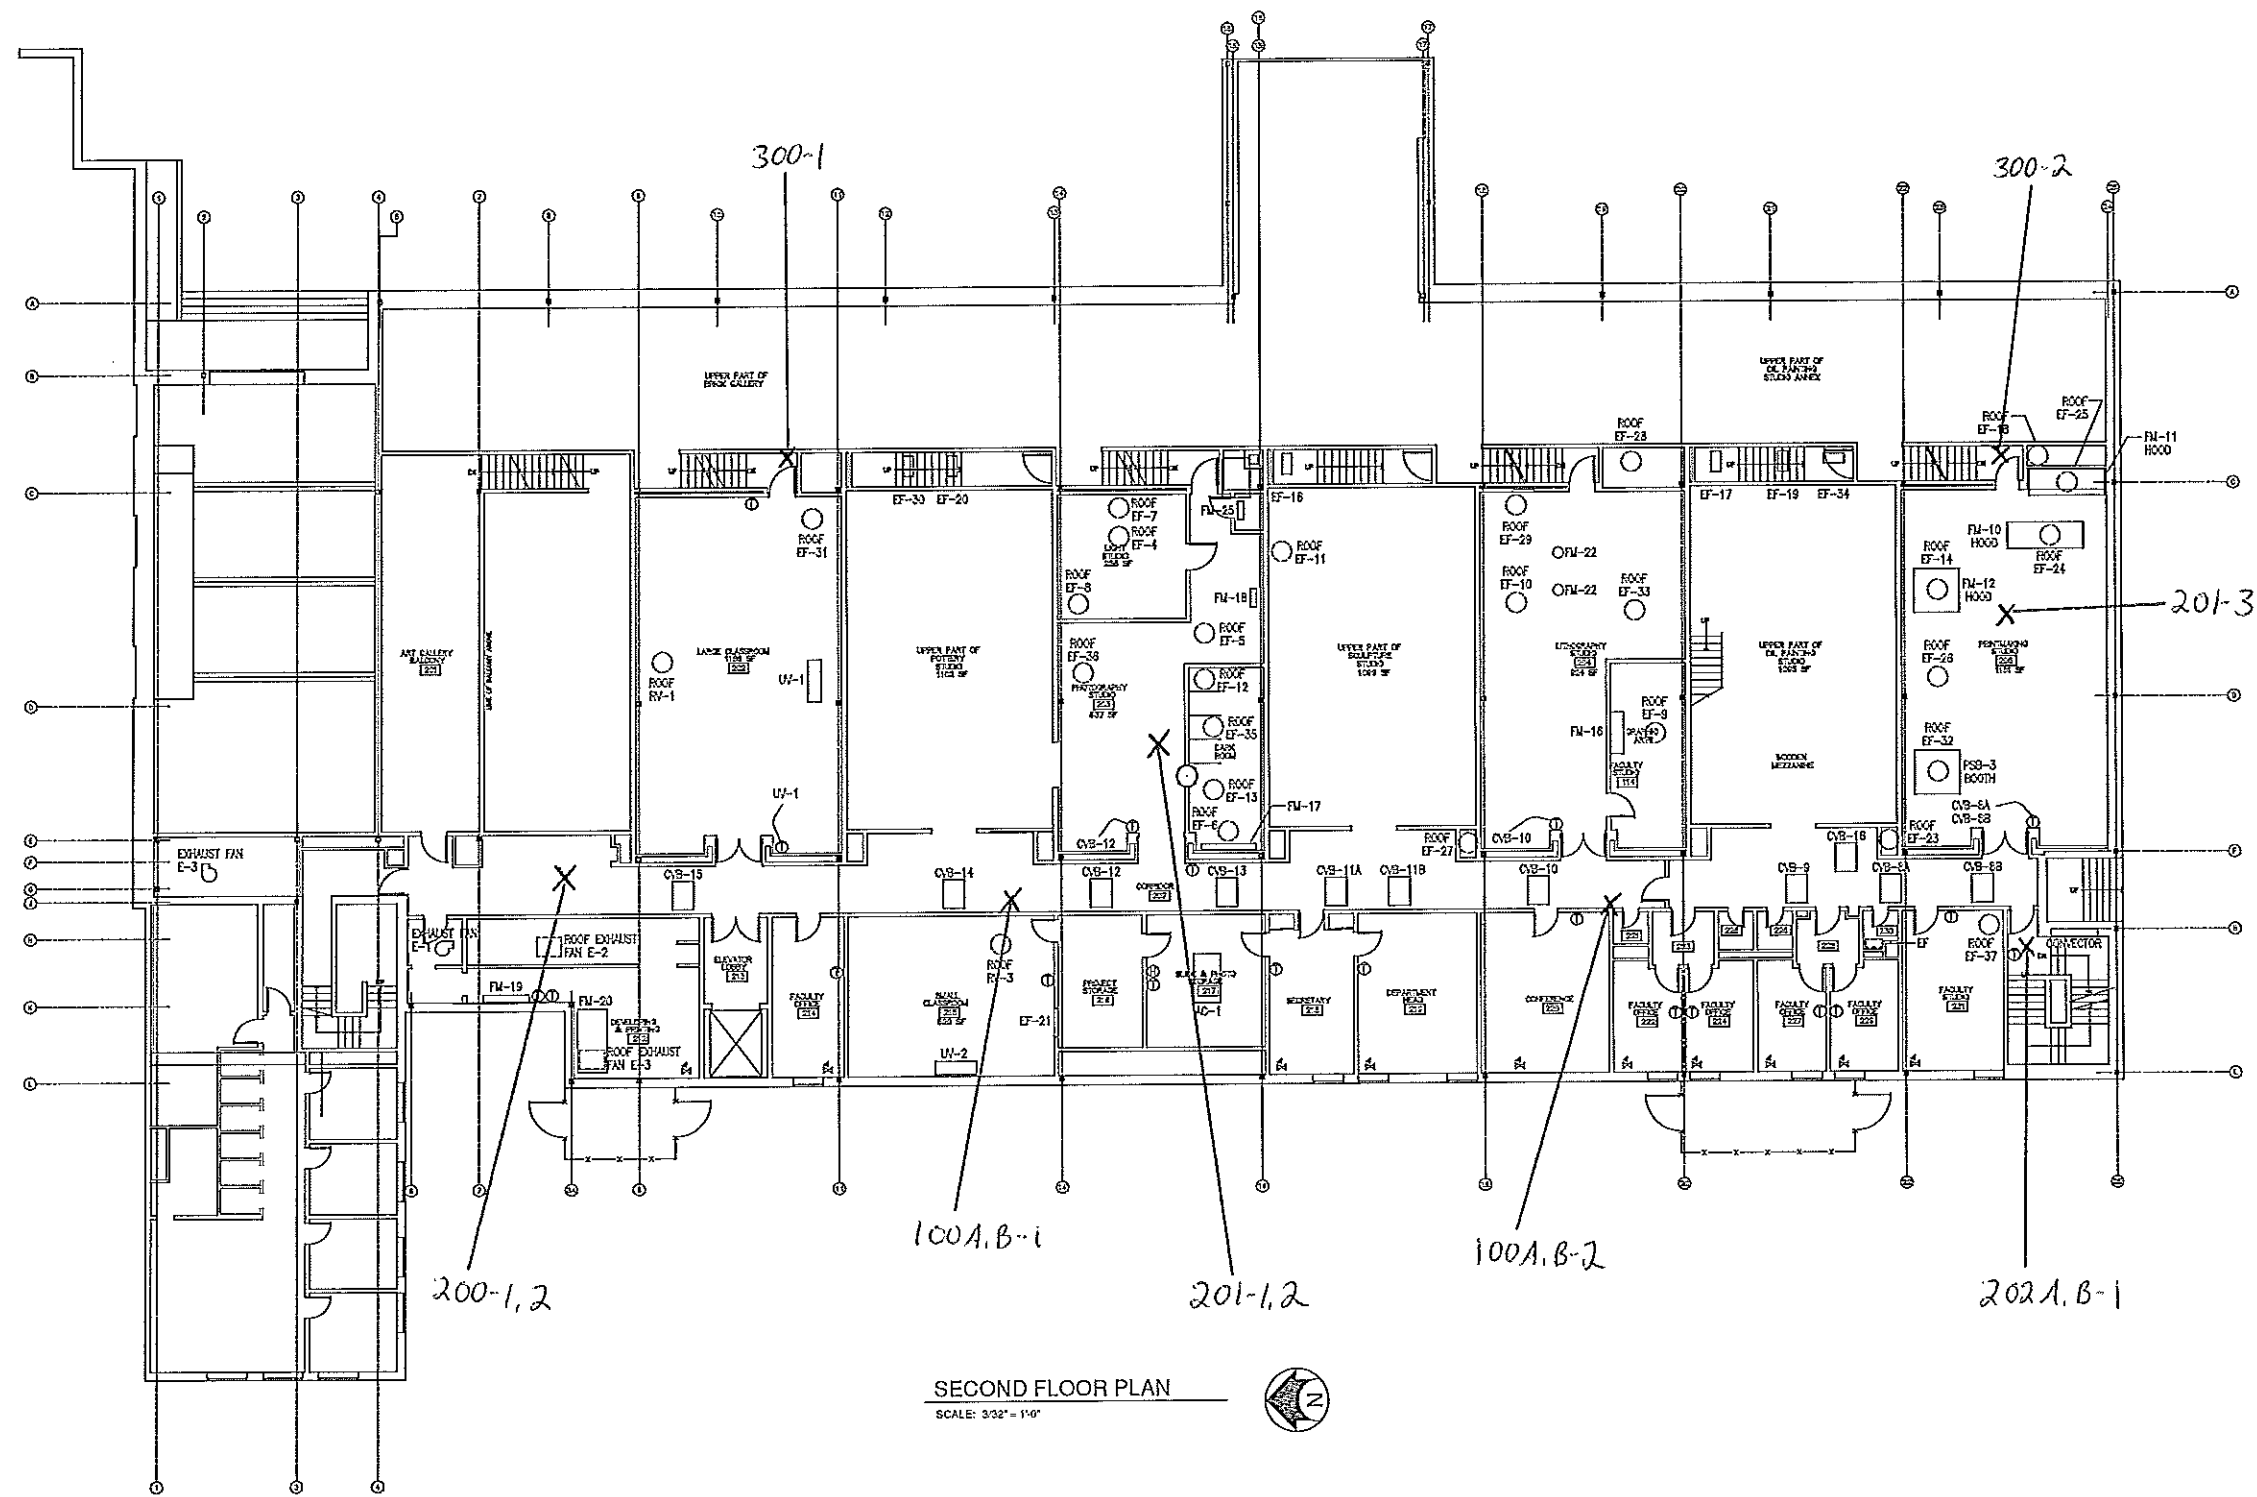
- EXISTING SENSORS ARE NOT COMPARABLE WITH NEW DOCS. REPLACE ALL SENSORS WITH NEW. REUSE WIRELESS SENSORS UNLESS OTHERWISE INDICATED. VERIFY INTEGRITY OF WIRELESS SENSORS. SENSOR LOCATIONS SHOWN BASED ON AS-BUILT DRAWINGS. ACTUAL LOCATION MAY VARY SLIGHTLY.
- EXISTING POINT UPW POINT D/S ARE BASED ON AS-BUILT DRAWINGS. FIELD VERIFICATION HAS SHOWN MOST TO BE ACCURATE HOWEVER APPROXIMATELY 10% WERE FOUND TO BE IMPRECISE LOCATIONS. EACH POINT WILL REQUIRE VERIFICATION PRIOR TO REUSE. ADVISE IF DEVICE IS REPAIRABLE OR WIRELESS CANNOT BE REUSED.

1. EXISTING SENSORS ARE NOT COMPARABLE WITH NEW DOG, REPLACE ALL SENSORS WITH NEW, REUSE W/NO UNLESS OTHERWISE INDICATED. VERIFY INTEGRITY OF W/NO BEFORE REUSE. SENSOR LOCATIONS SHOWN BASED ON AS-BUILT DRAWINGS, ACTUAL LOCATION MAY VARY SLIGHTLY.
2. EXISTING POINT UPW POINT ID'S ARE BASED ON AS BUILT DRAWINGS. FIELD VERIFICATION HAS SHOWN MOST TO BE ACCURATE HOWEVER APPROXIMATELY 10% WERE FOUND TO BE TENETIVE LOCATIONS. EACH POINT WILL REQUIRE VERIFICATION PRIOR TO REUSE. ADVISE IF DEVICE IS IMPERFABLE OR W/NO CANNOT BE REUSED.

4. DETCON U48 ENFORCER OUTSIDE AIRFLOW METER TO RETURN.
5. DESTROY DAW PUMP STARTER PROVIDE COLLECTION METER STARTER WITH H-0-A SELECTOR SWITCH. PROVIDE CURRENT SWITCH, STATUS POINTS AND RESET START/STOP CAPABILITIES. REPLACE TEMP SENSOR.

12. REPLACE TEMP SENSOR WITH NEW, REUSE VALVE ACTUATOR, ACTUATOR.
13. DESTROY POWER QUALITY METER. PROVIDE TE-NS TO DOG PANEL. REFER TO WIRING DIAGRAM #20 ON DRAWING ADO-054.

16. CW METER, REPLACE RESISTOR WITH NEW PURGE TYPE, REFER TO METER SCHEDULE.
17. PROVIDE CURRENT SWITCHES AND STATUS POINTS FOR P-14, P-18, P-2A AND P-20. PROVIDE H-0-A SELECTOR SWITCHES IN DESTROY VESSEL LOCATED IN WSG. REFER TO POINTS LIST FOR QUANTITIES.

20. FIELD VERIFY LOCATION OF SUPPLY FAN S-8. PROVIDE H-0-A SELECTOR SWITCH IN SEPARATE ENCLOSURE PROVIDE CURRENT SWITCH AND STATUS POINTS. REFER TO POINTS LIST FOR QUANTITIES.

21. FIELD VERIFY THE LOCATION OF THE FOLLOWING EQUIPMENT: AC-1, AC-2, CORRIDOR GUN, UH-101A, FAN COIL 1, UH-123, UH-131, UH-132 AND SUPPLY FAN SET. REPLACE DEVICES ON POINTS LIST. TRANSFER WIRING.

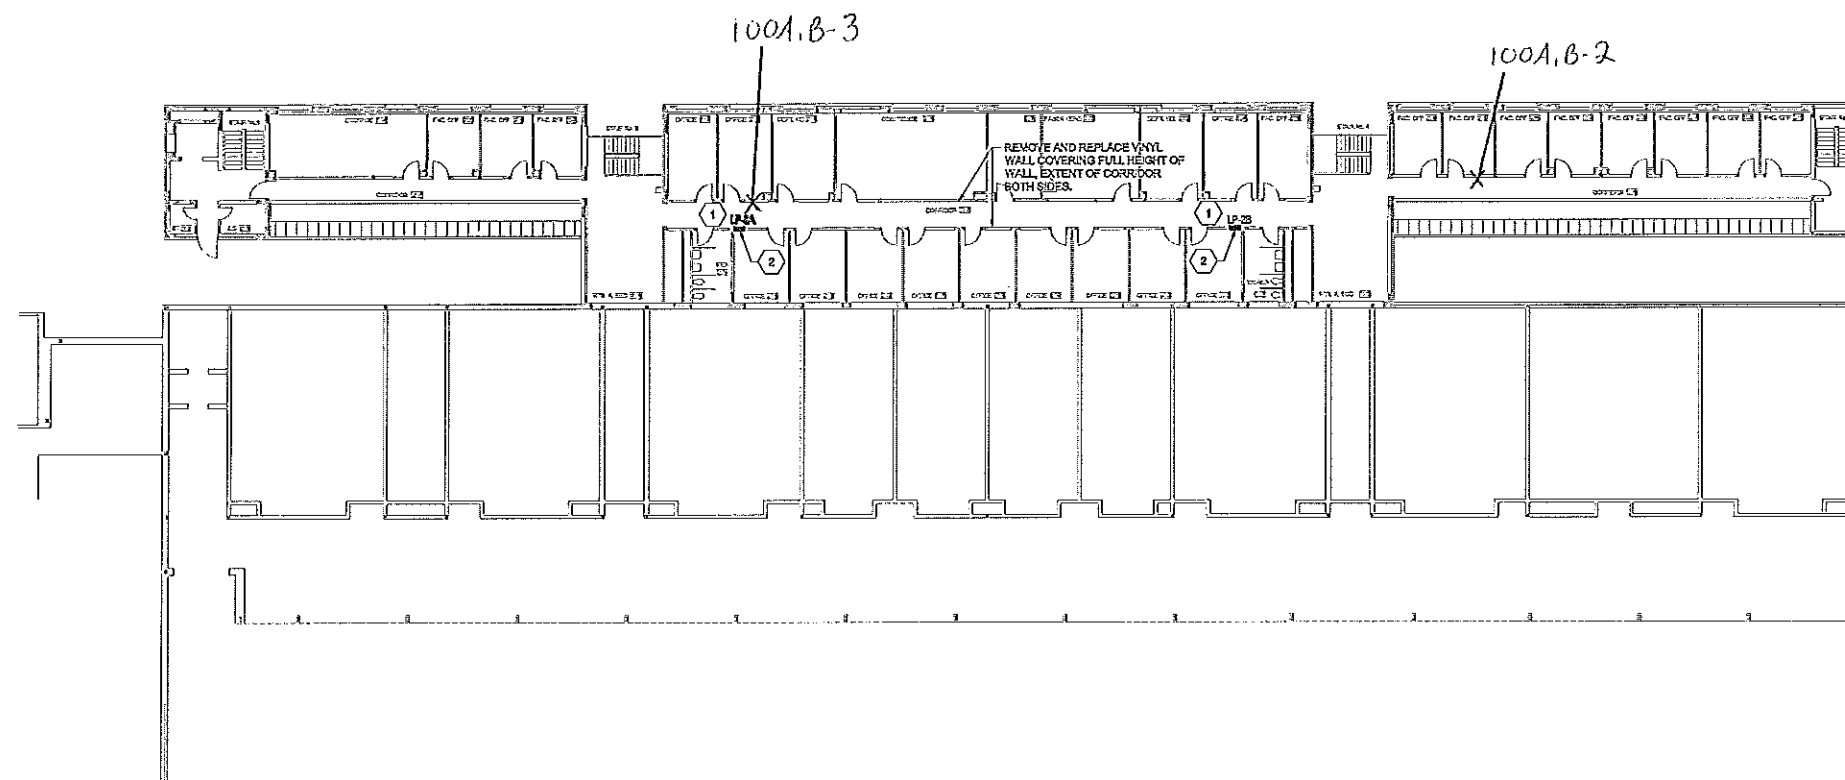
**A1** **TIMMERMAN - SECOND FLOOR PLAN**  
SCALE: 1/8" = 1'-0"

- DRAWING SPECIFIC NOTES**
- 1 REMOVE EXISTING PANELBOARD IN THIS LOCATION AND REPLACE WITH NEW PANEL BOARD AS SHOWN.
  - 2 SEE DETAIL E2-A-511 FOR ARCHITECTURAL WORK

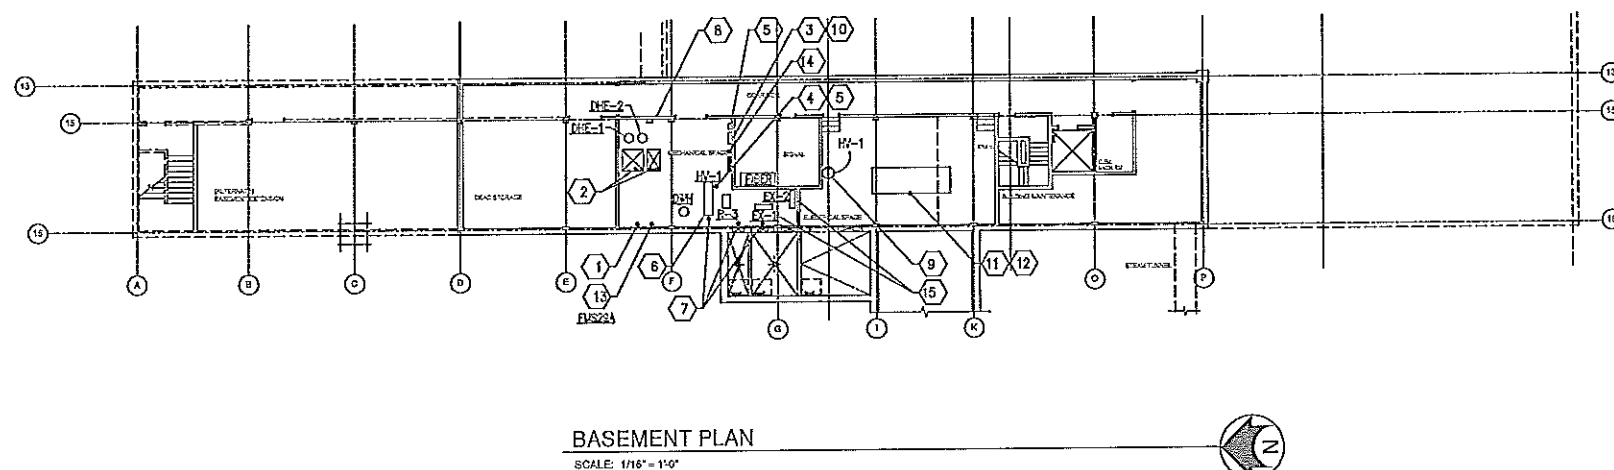
**ATC100-29**

- EXISTING WATER METER.
- EXISTING SLUMP PITS.
- HONEYWELL CONTROL PANEL TO BE REMOVED. TRANSFER 110V POWER TO NEW PANEL IN SAME LOCATION. PROVIDE 3/4" EMT CONDUIT WITH (2) MULTI-WIRE PEXOR OPTIC CABLES FROM FLOOR PATCH PANEL TO NEW CONTROL PANEL.

- REMOVE EXISTING SENSORS AND INSTALL NEW TEMPERATURE, HUMIDITY AND LOW LIMIT SENSORS FOR HY-1. REFER TO FLOW DIAGRAM AND POINTS LIST. CONNECT TO NEW CONTROL PANEL IN THIS ROOM. PATCH HOLES IN DUCTWORK FROM SENSOR REMOVALS.

- EXISTING TEMPERATURE SENSOR ON WALL. REMOVE AND REPLACE WITH NEW SENSOR AND REUSE TO NEW CONTROL PANEL.
- SUGGESTED LOCATION FOR NEW CONTROL PANEL.
- EXISTING 3 PHASE TEMPERATURE MONITOR. PROVIDE TIE-INS TO DOO PANEL.

- PROVIDE OUTLET HUMIDITY POWER QUALITY METER. PROVIDE TIE-INS TO DOO PANEL. SEE WIRING DIAGRAM #19 ON DRAWING AIG-06A.
- EXISTING STEAM ENTRY. PROVIDE NEW FLOW METER FMS-22A. PROVIDE 3/4" EMT CONDUIT WITH 2-#12 AND 1-#12 GROUND FROM 110V POWER SUPPLY IN KEYNOTE #3.

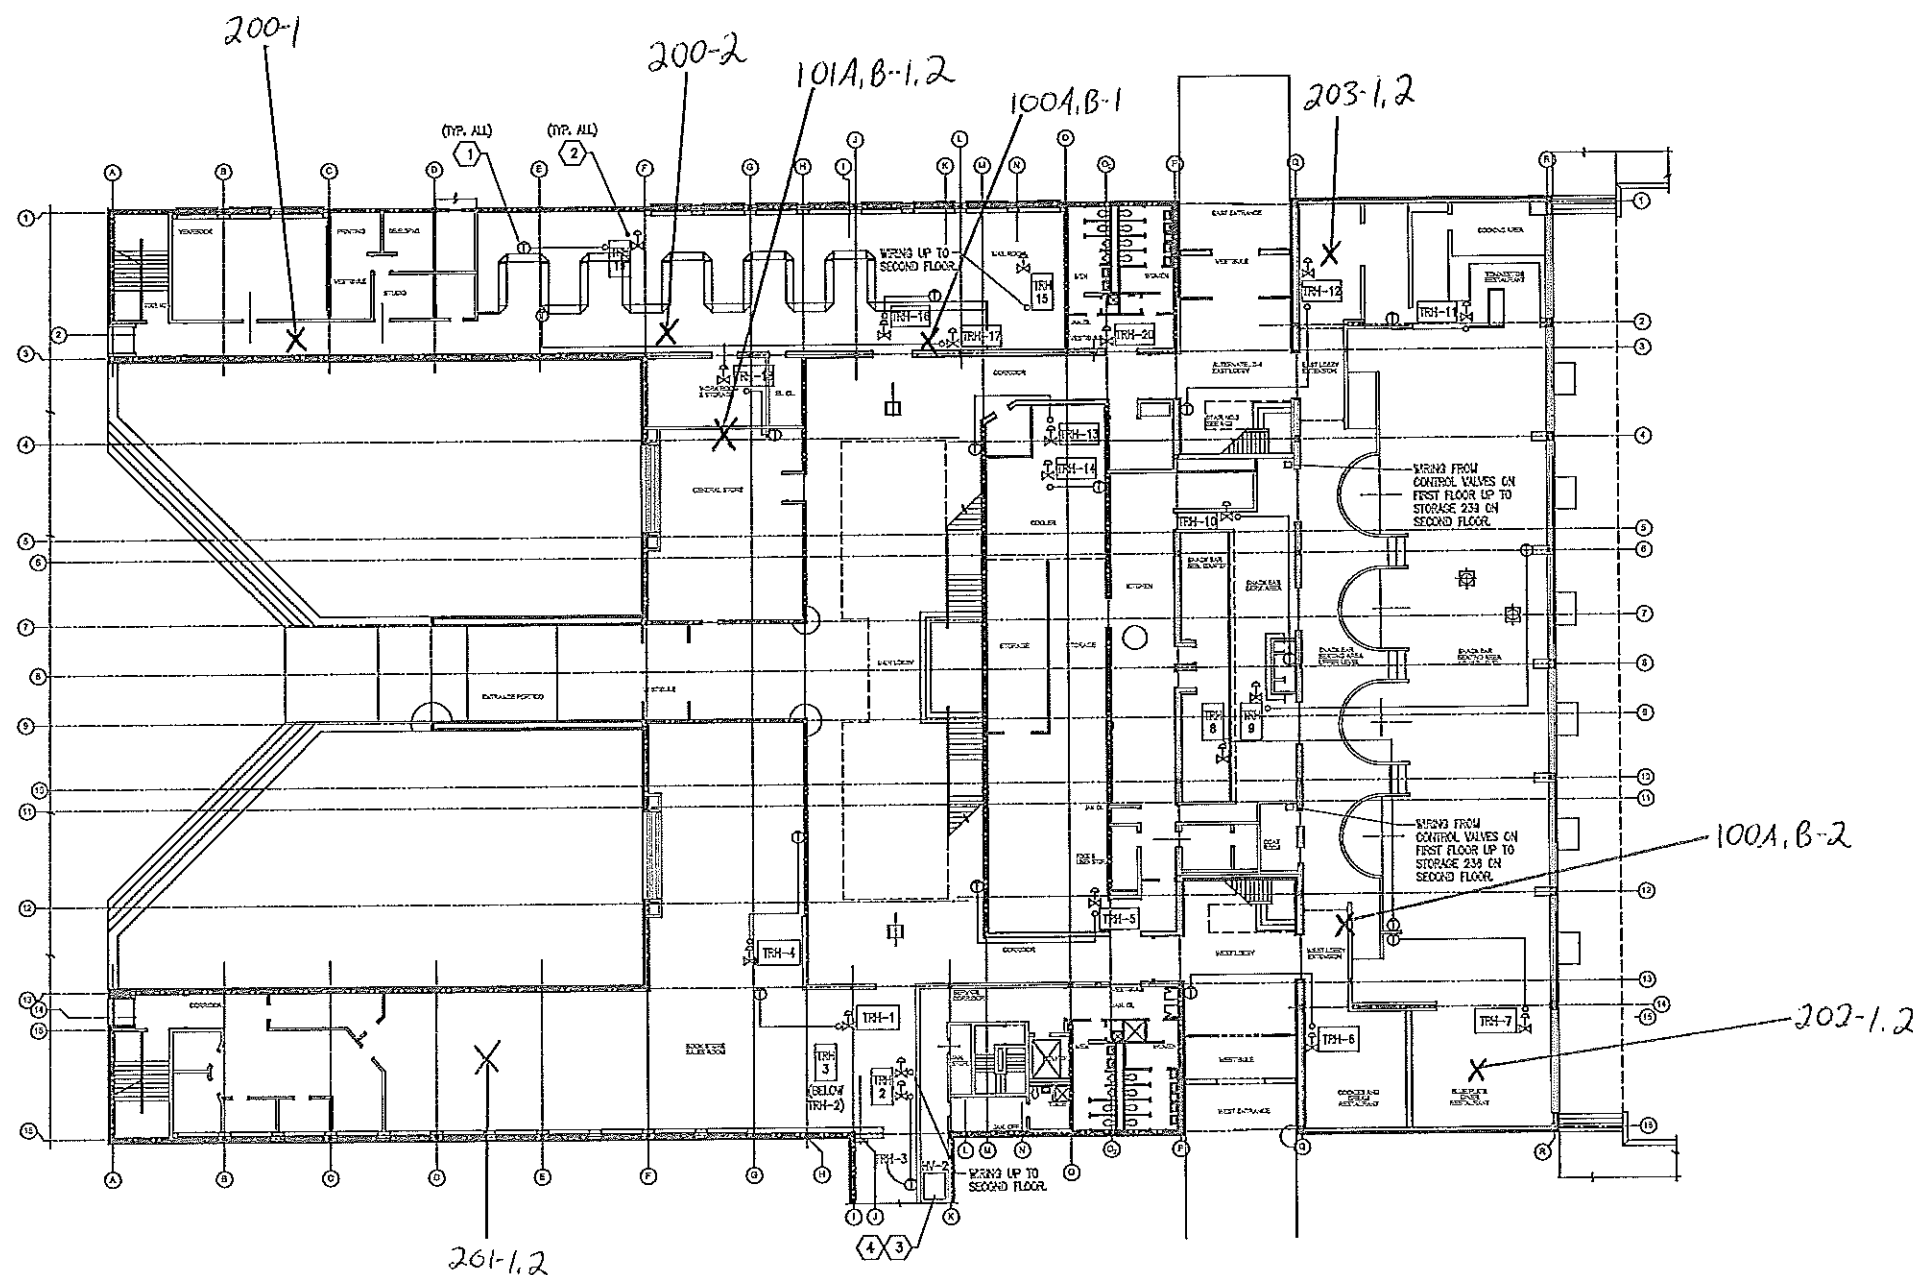
**FIRST FLOOR PLAN**  
SCALE: 1/16" = 1'-0"

1. EXISTING TEMPERATURE SENSOR FOR SPACE. REMOVE AND REPLACE WITH NEW SENSOR. RUN WIRELOID IN NEW WIRELOID IN FINISHED SPACES. CONNECT TO NEW EP TRANSDUCER AT CONTROL VALVE AND NEW CONTROL PANEL IN MECHANICAL ROOM IN ATTIC.
2. EXISTING REHEAT VALVE ABOVE CEILING. REUSE EXISTING ACTUATOR. INSTALL EP TRANSDUCER AND CONNECT TO NEW CONTROL PANEL IN MECHANICAL ROOM IN ATTIC.
3. PROVIDE H-O-A SELECTOR SWITCH IN EXISTING OILBURNER MOTOR STARTER FOR H-2. PROVIDE STATUS POINTS AND REMOTE START/STOP CAPABILITIES. SEE FLOW DIAGRAM.
4. PROVIDE TEMPERATURE SENSORS AND EP TRANSDUCER FOR H-2. REUSE EXISTING PNEUMATIC VALVE ACTUATOR. REFER TO FLOW DIAGRAM AND POINTS LIST FOR DETAILS.

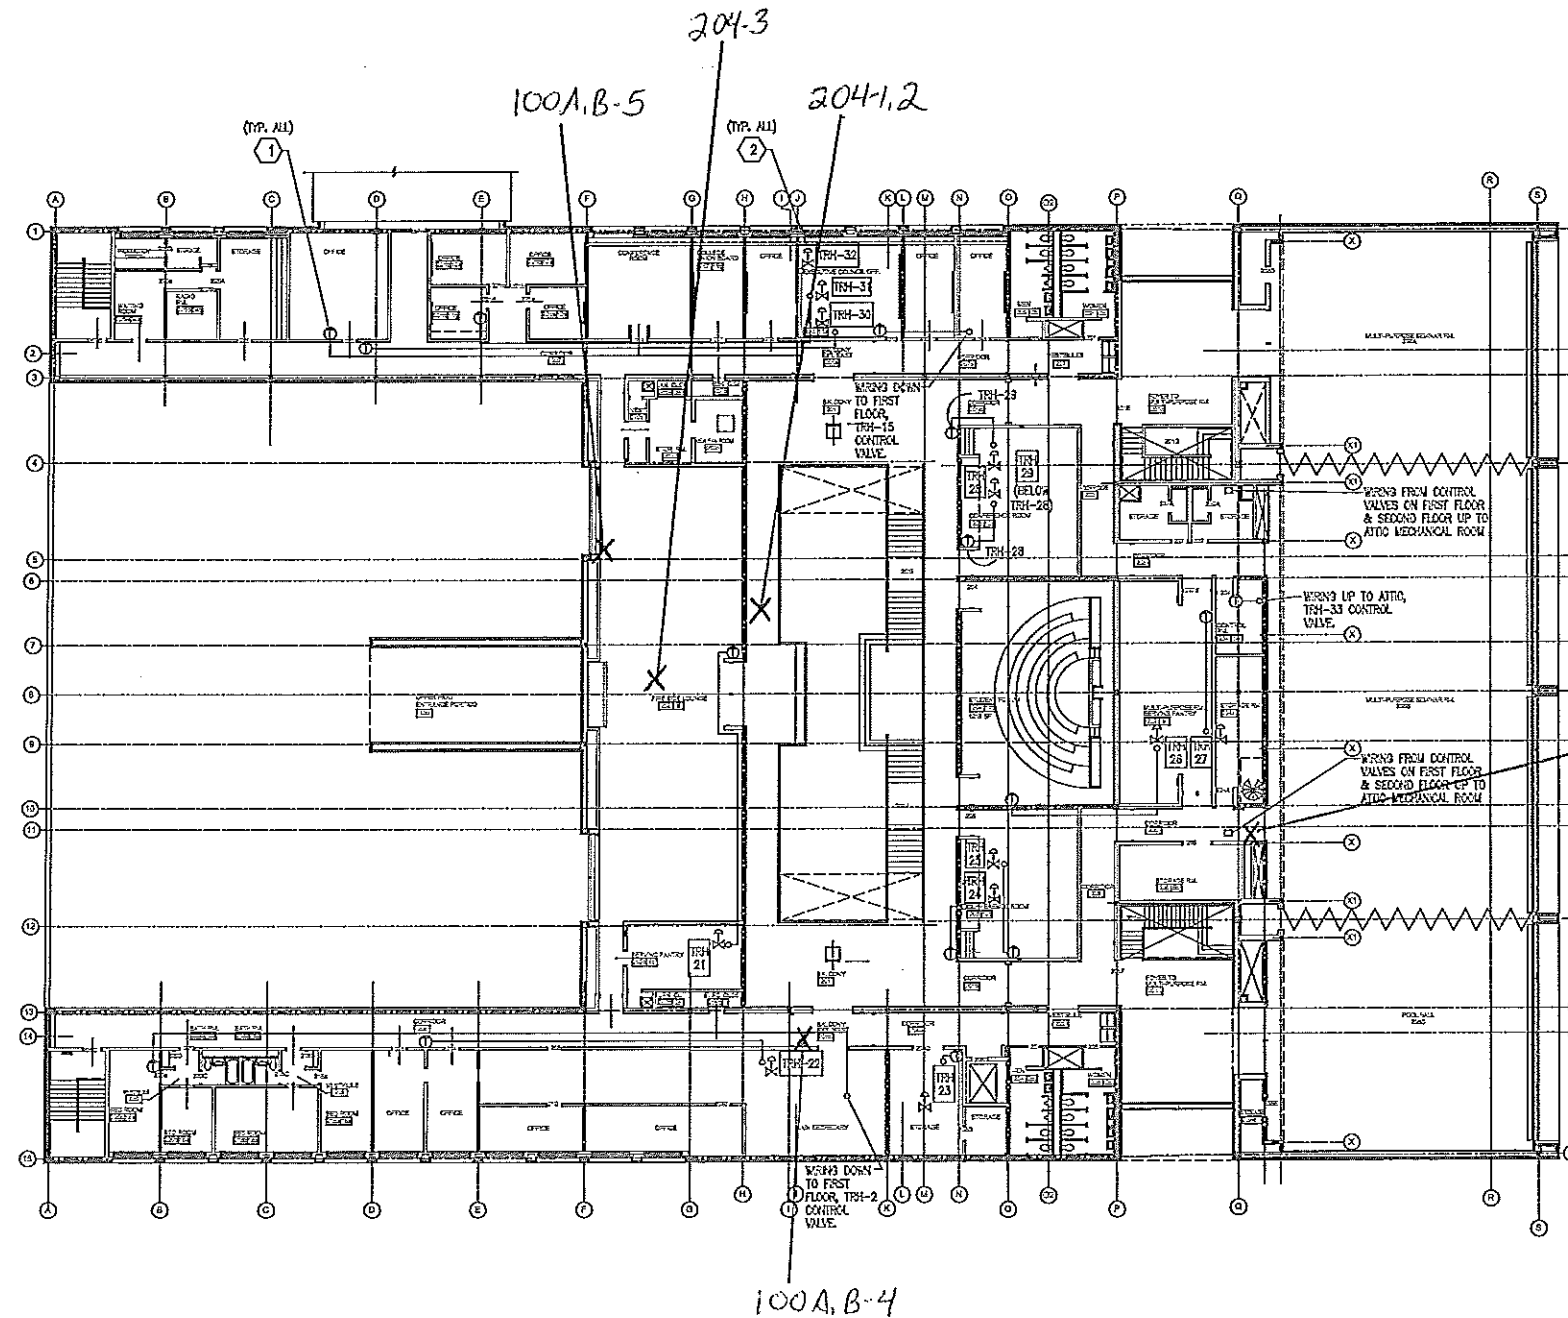
**SECOND FLOOR PLAN**  
SCALE: 1/16" = 1'-0"

1. EXISTING TEMPERATURE SENSOR FOR SPACE, REMOVE AND REPLACE WITH NEW SENSOR. RUN WIRING IN NEW WIREMOLD IN FINISHED SPACES. CONNECT TO NEW EP TRANSDUCER AT CONTROL VALVE AND NEW CONTROL PANEL IN MECHANICAL ROOM IN ATTIC.
2. EXISTING REHEAT VALVE ABOVE CEILING. REMOVE EXISTING ACTUATOR. INSTALL EP TRANSDUCER AND CONNECT TO NEW CONTROL PANEL IN MECHANICAL ROOM IN ATTIC.
