Re: Limited Asbestos and Lead-Based Paint Inspection Services  
Upgrade Electrical Distribution System – Various Buildings  
SUCF Project No. 12290  
SUNY Potsdam  
Potsdam, New York

# Limited Asbestos and Lead-Based Paint Inspection

SUNY Potsdam  
Upgrade Electrical Distribution System – Various Buildings  
SUCF Project No. 12290  
Potsdam, New York

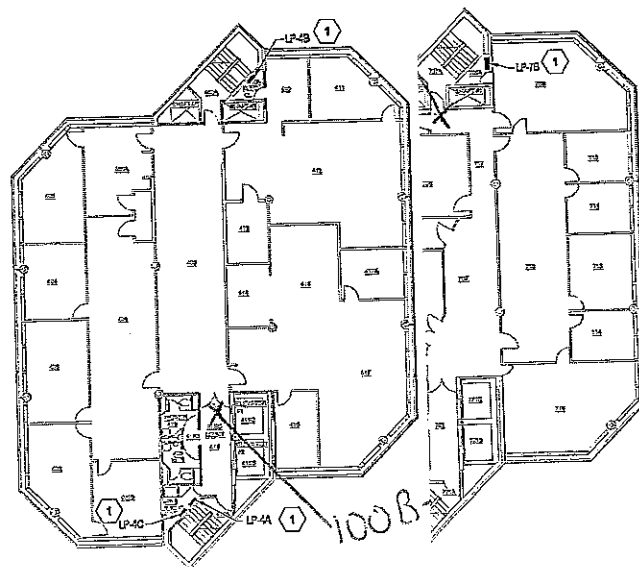
E-100-1b

RAYMOND  
4TH, 5TH, 6TH, 7TH  
& 8TH FLOOR PLANS

DRAWING SPECIFIC NOTES

1 REMOVE EXISTING PANELBOARD IN THIS LOCATION AND  
REPLACE WITH NEW PANEL BOARD AS SHOWN.

C1 RAYMOND - FOURTH FLOOR PLAN  
SCALE: 1/8" = 1'-0"

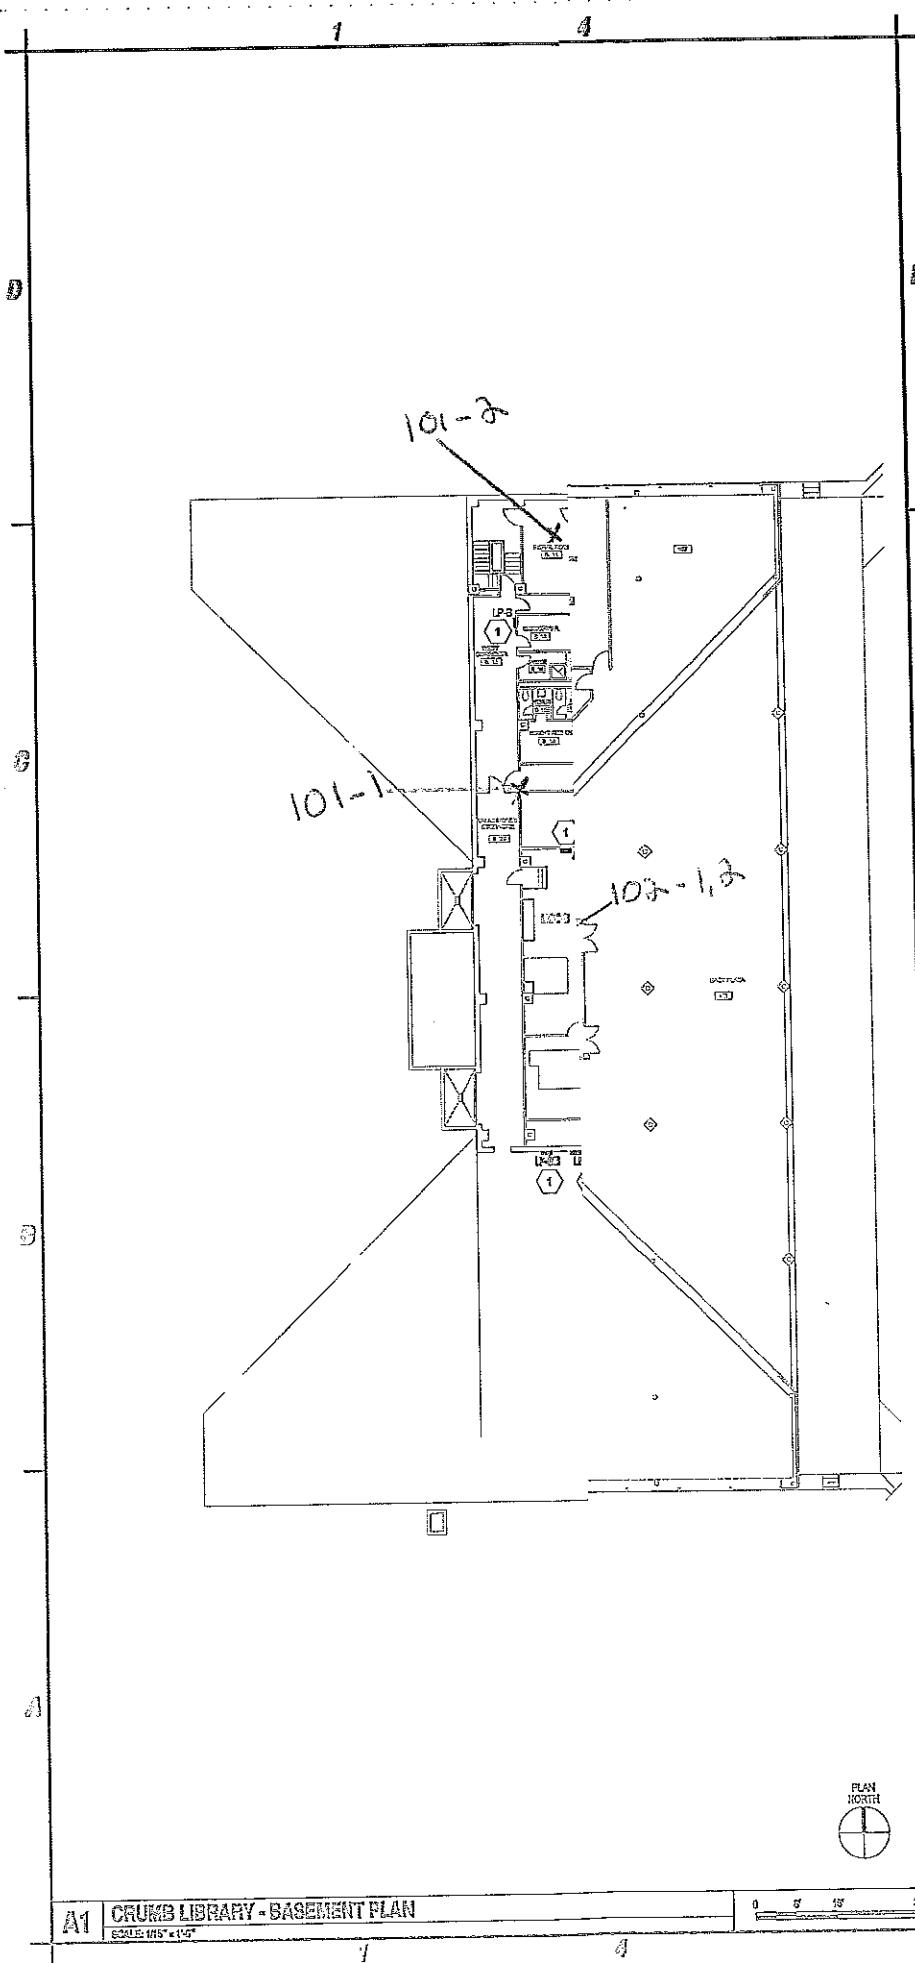
**A1 CRUMB LIBRARY - BASEMENT PLAN**  
SCALE: 1/8" = 1'-0"

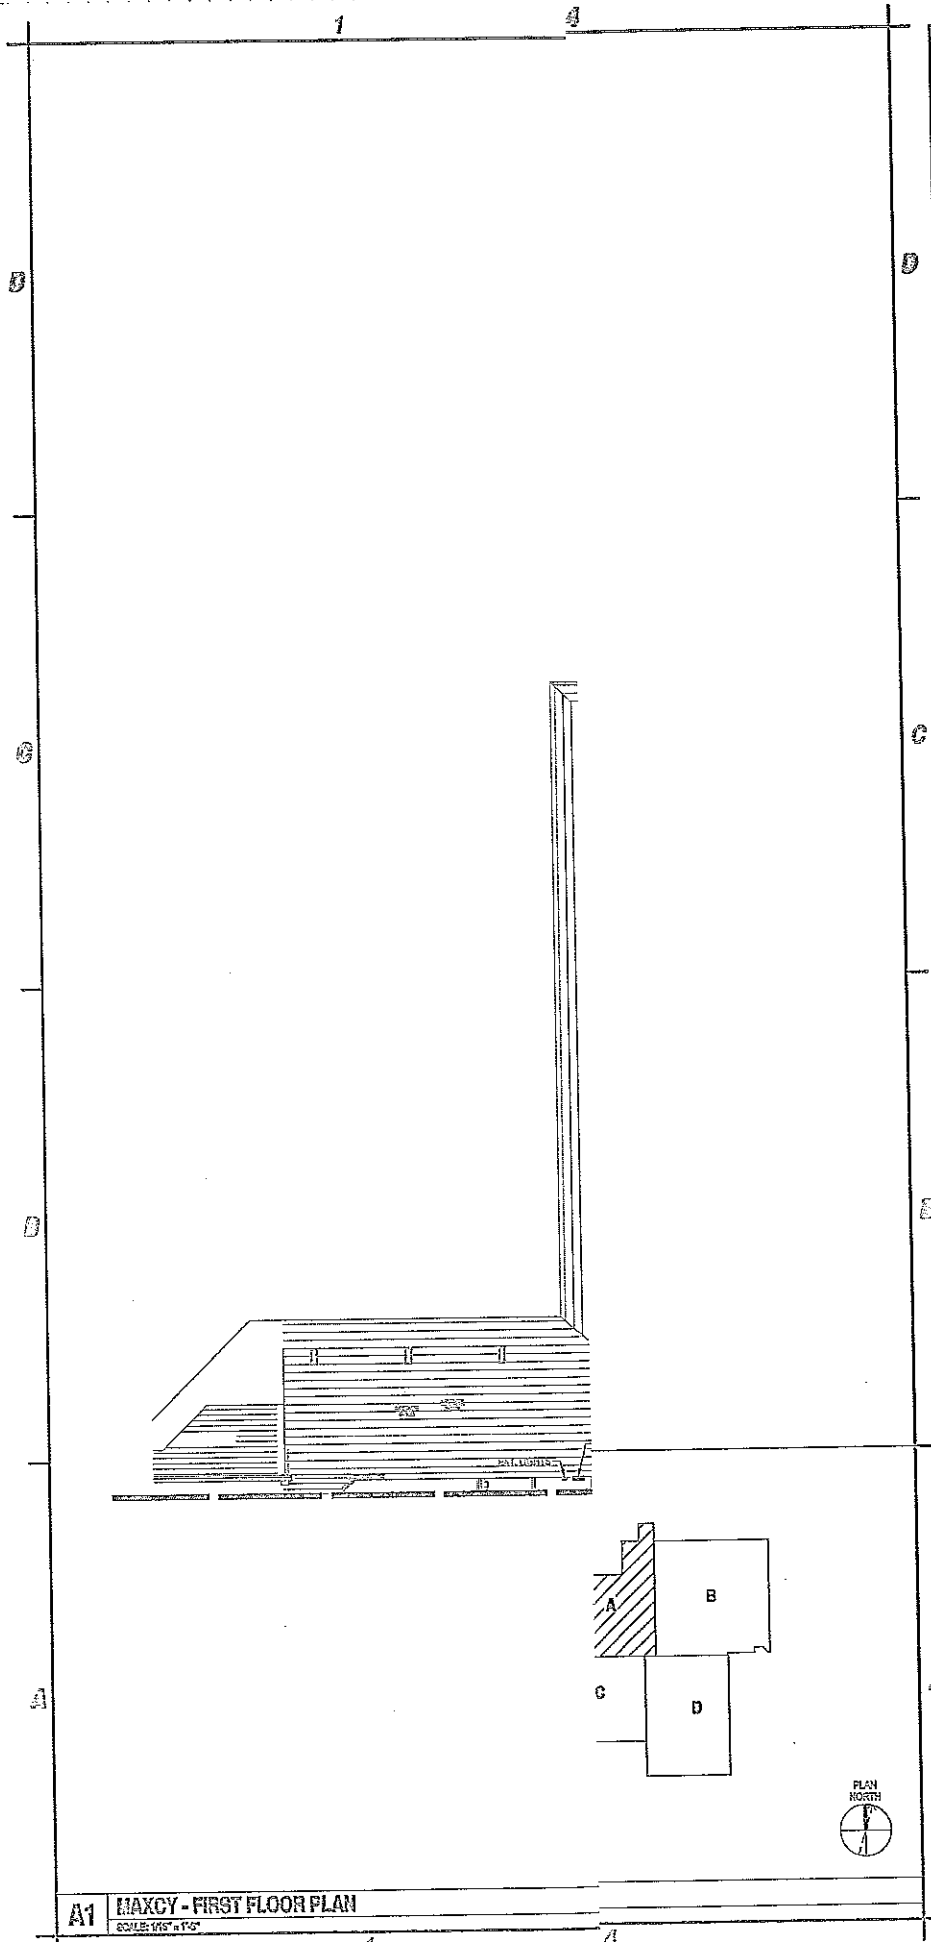
**A1 MAXCY - FIRST FLOOR PLAN**  
SCALE: 1/8" = 1'-0"

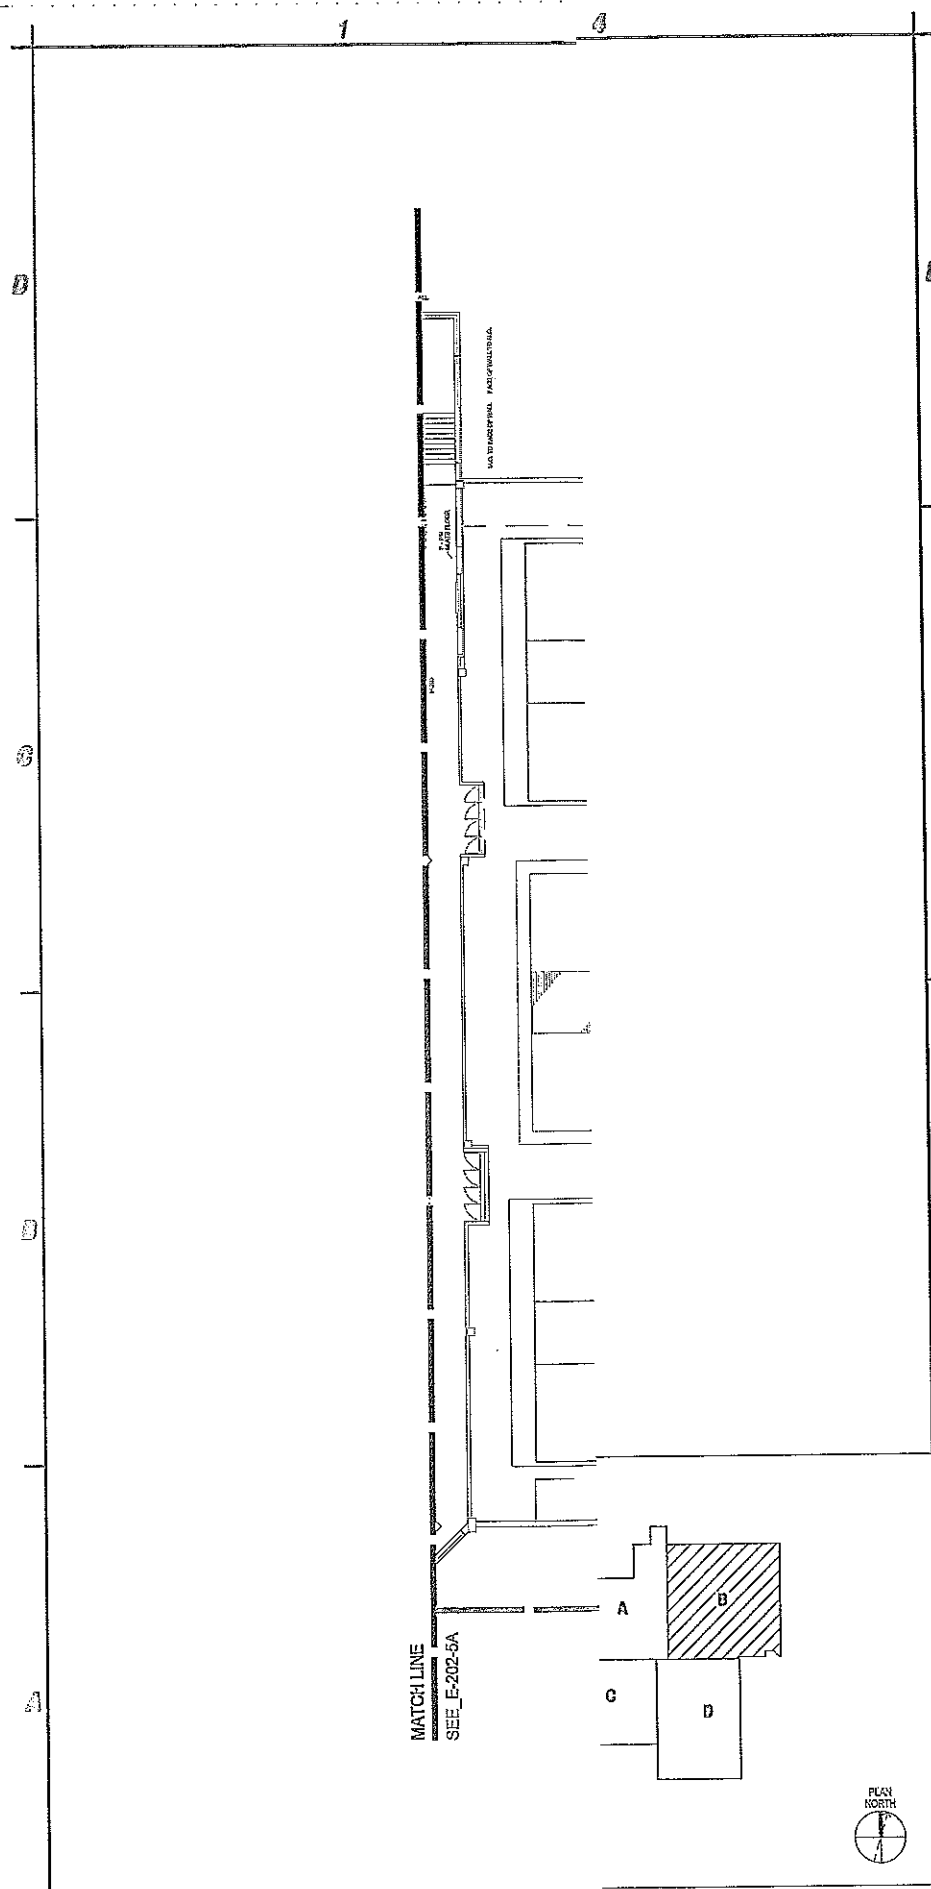
**A1 MAXCY - SECOND FLOOR PLAN**  
SCALE: 1/8" = 1'-0"

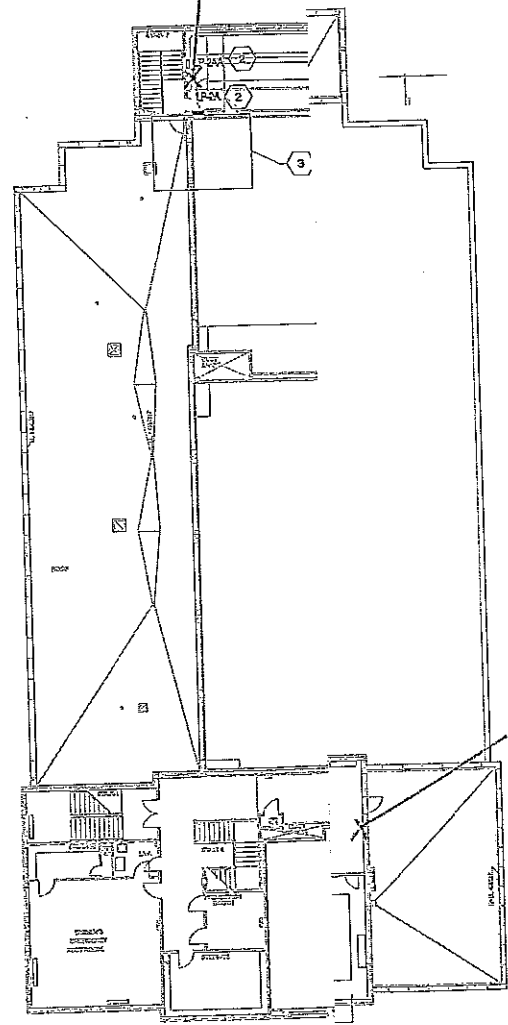
E-100-12b

A1 MERRITT - SECOND FLOOR PLAN  
SCALE: 1/8" = 1'-0"

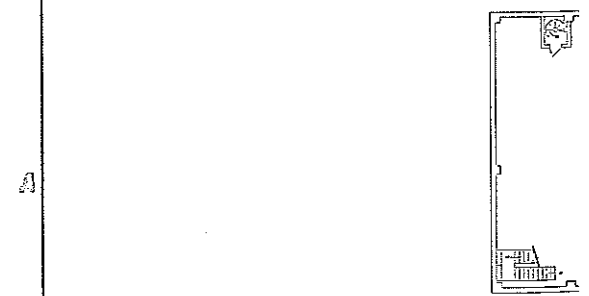
A1 HEATING PLANT - SECOND FLOOR PLAN (BOILER HOUSE)  
SCALE: 1/8" = 1'-0"

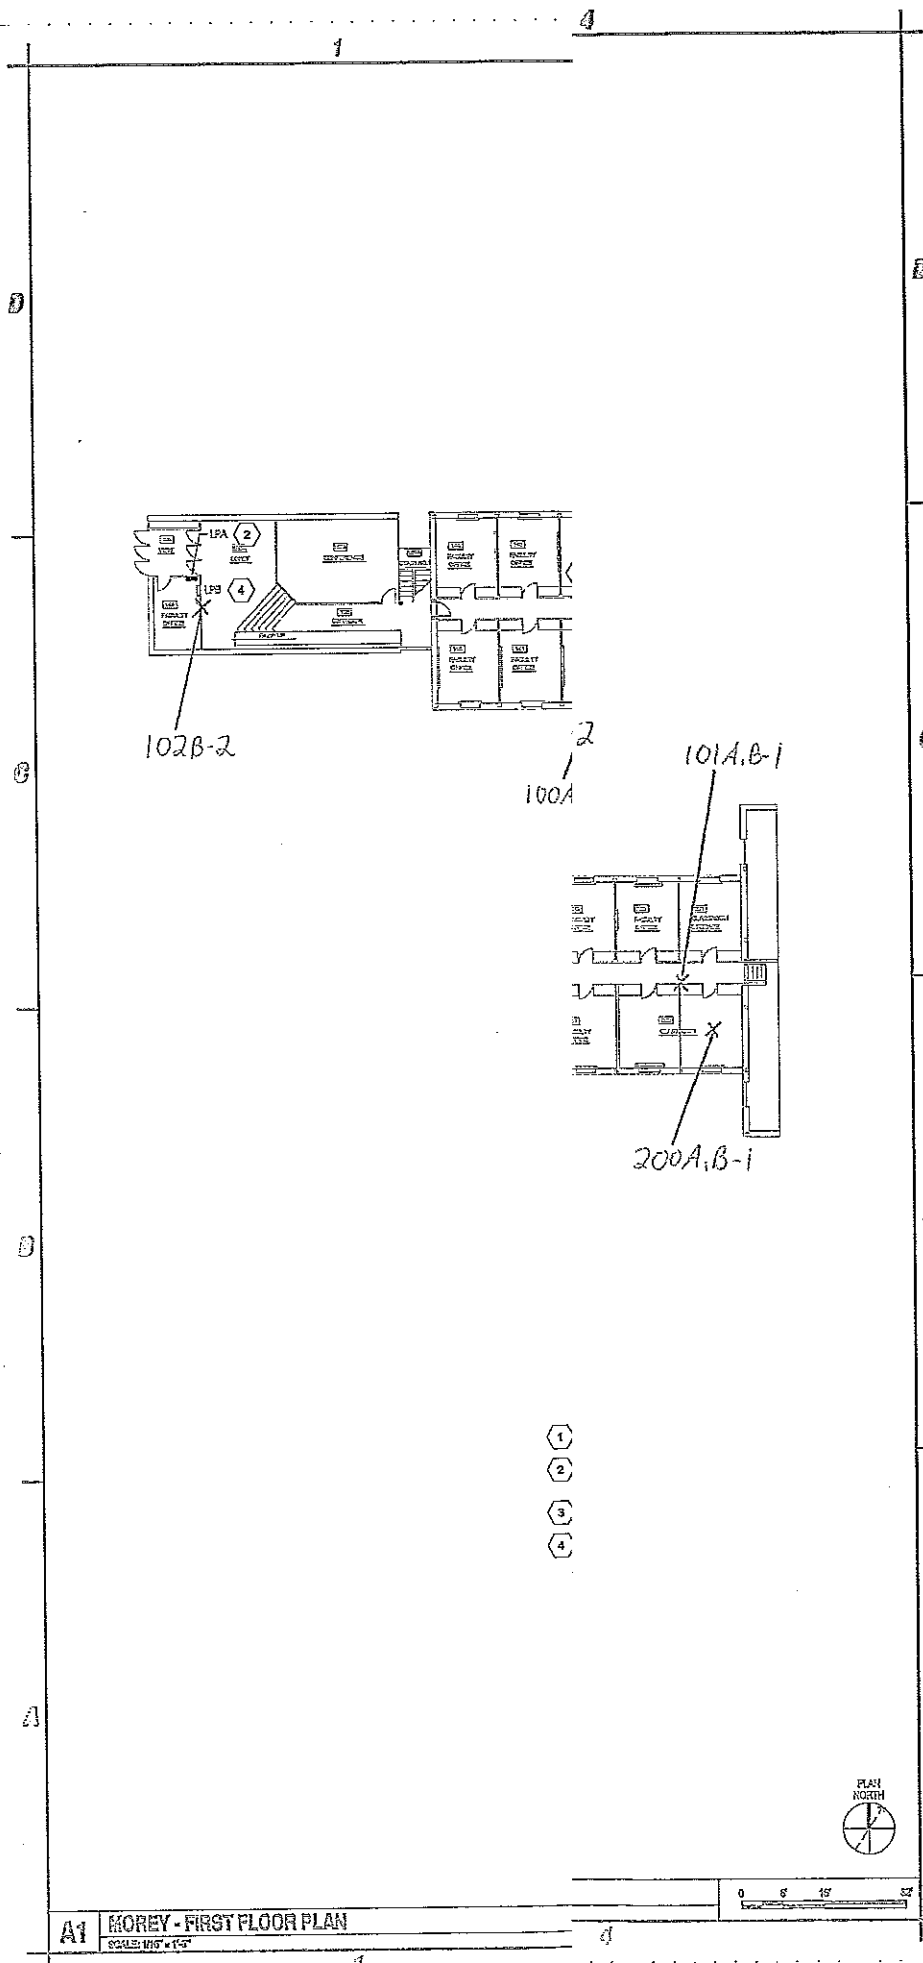
**A1 MOREY - FIRST FLOOR PLAN**  
SCALE: 1/8" = 1'-0"

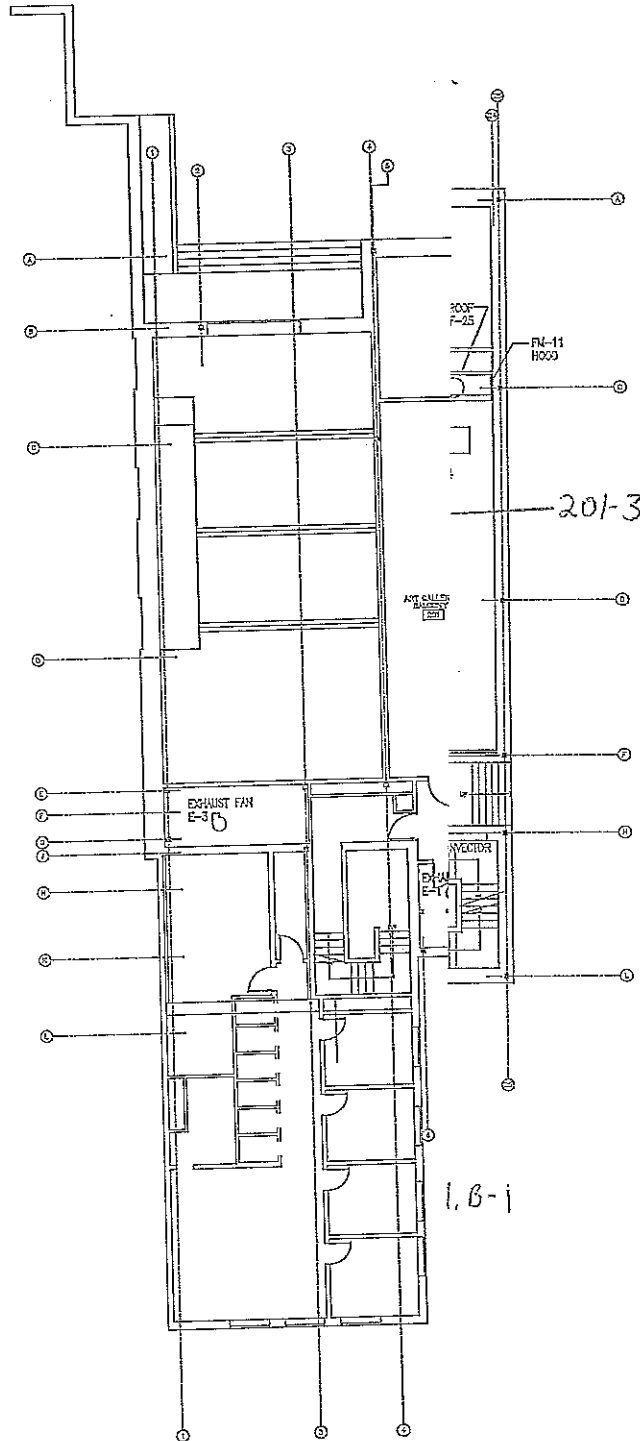
**ATC100-26**

#### GENERAL NOTES:

- EXISTING SENSORS ARE NOT COMPATIBLE WITH NEW DDC, REPLACE ALL SEN WITH NEW, REUSE WIRING UNLESS OTHERWISE INDICATED, VERIFY INTEGRITY C WIRING BEFORE REUSE. SENSOR LOCATIONS SHOWN BASED ON AS-BUILT DRAWINGS, ACTUAL LOCATION MAY VARY SLIGHTLY.
- EXISTING POINT UP/LI POINT D'S ARE BASED ON AS BUILT DRAWINGS, FIELD VERIFICATION HAS SHOWN MOST TO BE ACCURATE HOWEVER APPROXIMATELY WERE FOUND TO BE TENUOUS LOCATIONS. EACH POINT WILL REQUIRE VERIFICATION PRIOR TO REUSE, ADVISE IF DEVICE IS INOPERABLE OR WIRING CANNOT BE REUSED.

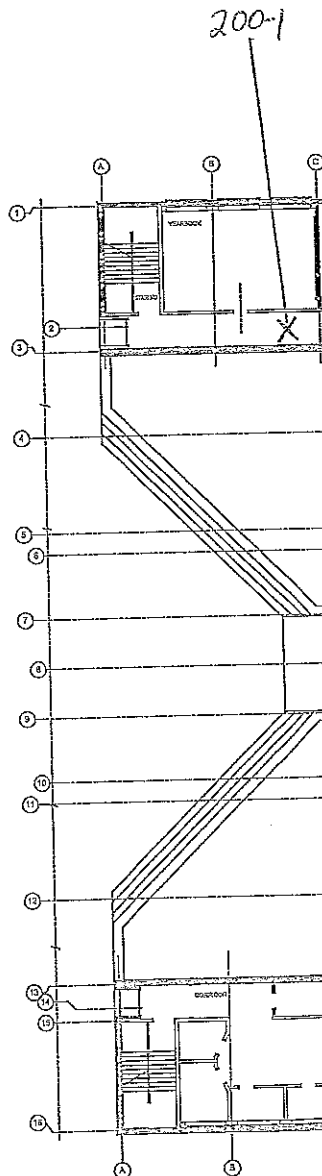
**ATC100-29**

#### KEYNOTES:

FOR SPACE, REMOVE AND REPLACE WITH NEW  
REINOLD IN FINISHED SPACES, CONNECT TO NEW  
LIVE AND NEW CONTROL PANEL IN MECHANICAL
