Re: Limited Asbestos and Lead-Based Paint Inspection Services  
Upgrade Electrical Distribution System – Various Buildings  
SUCF Project No. 12290  
SUNY Potsdam  
Potsdam, New York

# Limited Asbestos and Lead-Based Paint Inspection

SUNY Potsdam  
Upgrade Electrical Distribution System – Various Buildings  
SUCF Project No. 12290  
Potsdam, New York

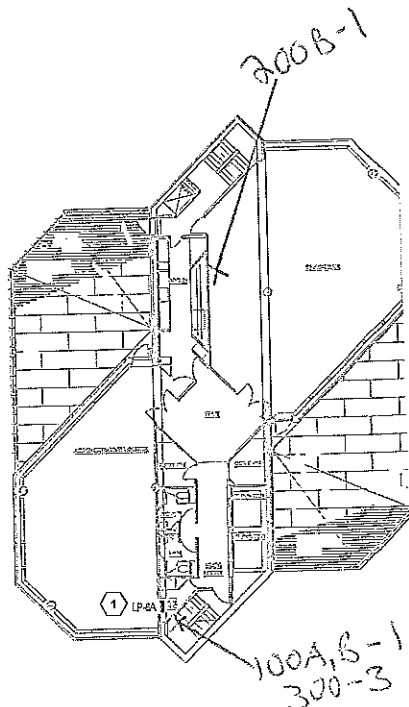
A1 RAYMOND - EIGHTH FLOOR PLAN  
SCALE: 1/8" = 1'-0"

DRAWING SPECIFIC NOTES

1 REMOVE EXISTING PANELBOARD IN THIS LOCATION AND  
REPLACE WITH NEW PANEL BOARD AS SHOWN.

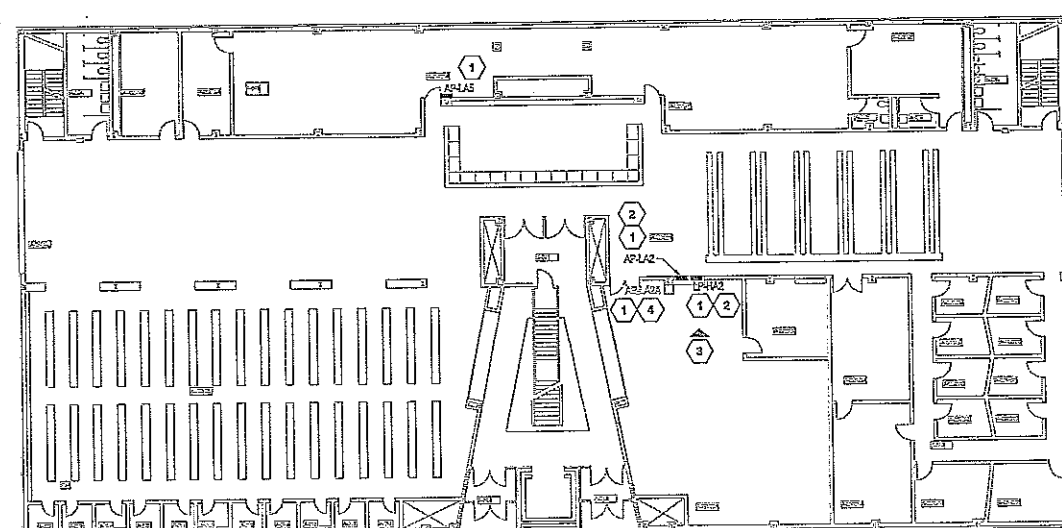
C1 CRANE MUSIC COMPLEX - SCHUETTE PLAZA LEVEL FLOOR PLAN  
SCALE: 1/8" = 1'-0"

- DRAWING SPECIFIC NOTES:
- 1 REMOVE EXISTING PANEL BOARD IN THIS LOCATION AND REPLACE WITH NEW PANEL BOARD AS SHOWN.
  - 2 SEE DETAIL D31A-601 FOR ARCHITECTURAL WORK.
  - 3 SEE PHOTO A1A-501.
  - 4 REMOVE TO AP-1A2A, EXISTING PANEL REMAINS.

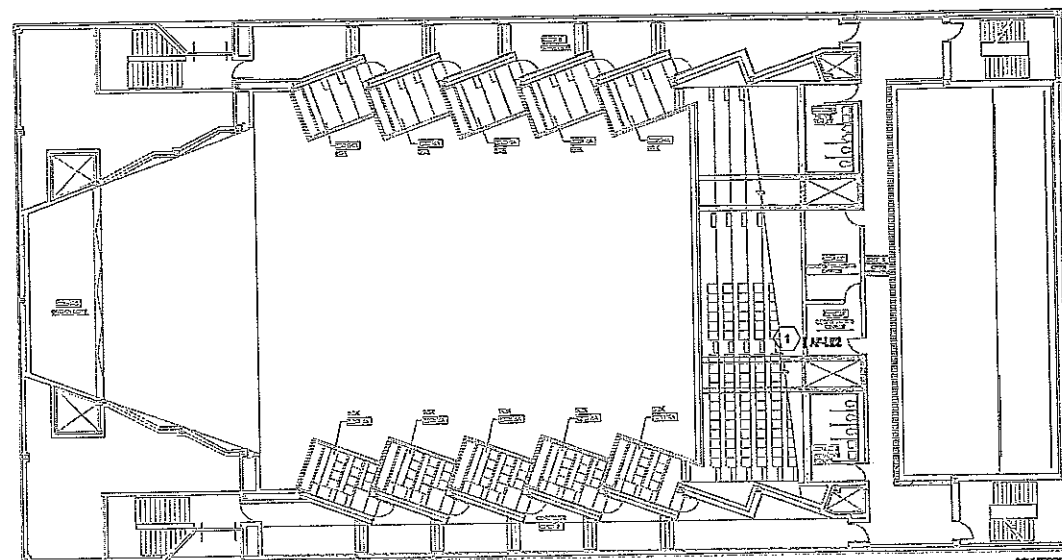
C3 CRANE MUSIC COMPLEX - HOSMER SECOND FLOOR PLAN  
SCALE: 1/8" = 1'-0"

- DRAWING SPECIFIC NOTES:
- 1 REMOVE EXISTING PANEL BOARD IN THIS LOCATION AND REPLACE WITH NEW PANEL BOARD AS SHOWN.

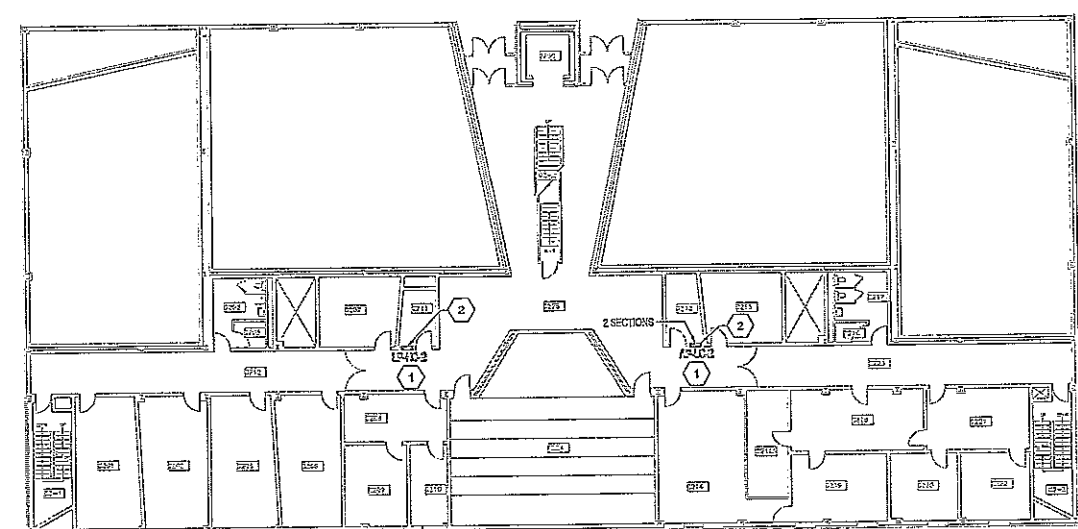
A1 CRANE MUSIC COMPLEX - BISHOP PLAZA LEVEL FLOOR PLAN  
SCALE: 1/8" = 1'-0"

- DRAWING SPECIFIC NOTES:
- 1 REMOVE EXISTING PANEL BOARD IN THIS LOCATION AND REPLACE WITH NEW PANEL BOARD AS SHOWN.
  - 2 SEE DETAIL D31A-601 FOR ARCHITECTURAL WORK.

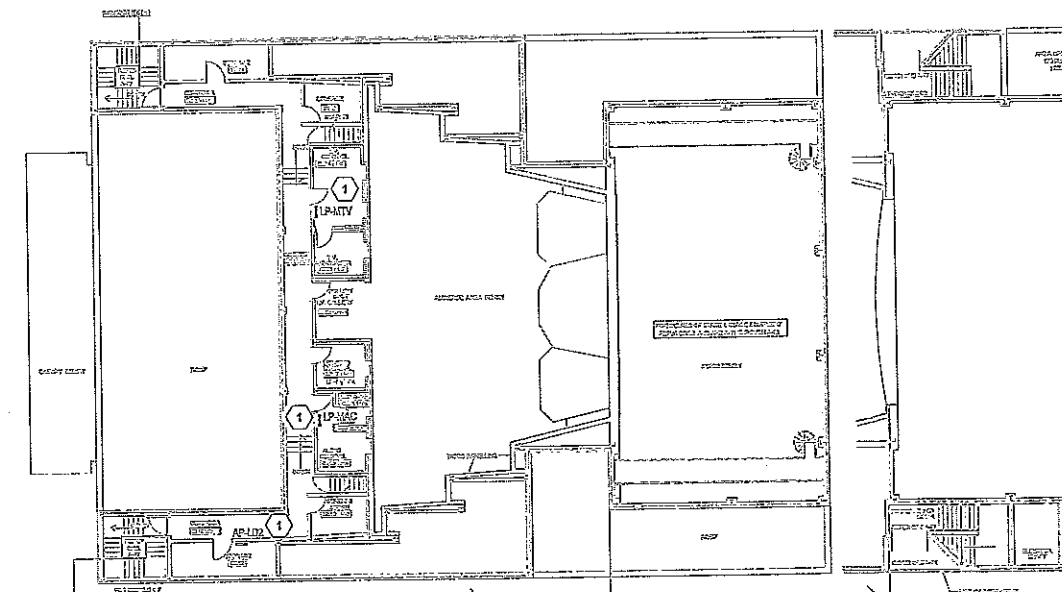
A3 CRANE MUSIC COMPLEX - SNELL UPPER LEVEL FLOOR PLAN  
SCALE: 1/8" = 1'-0"

- DRAWING SPECIFIC NOTES:
- 1 REMOVE EXISTING PANEL BOARD IN THIS LOCATION AND REPLACE WITH NEW PANEL BOARD AS SHOWN.

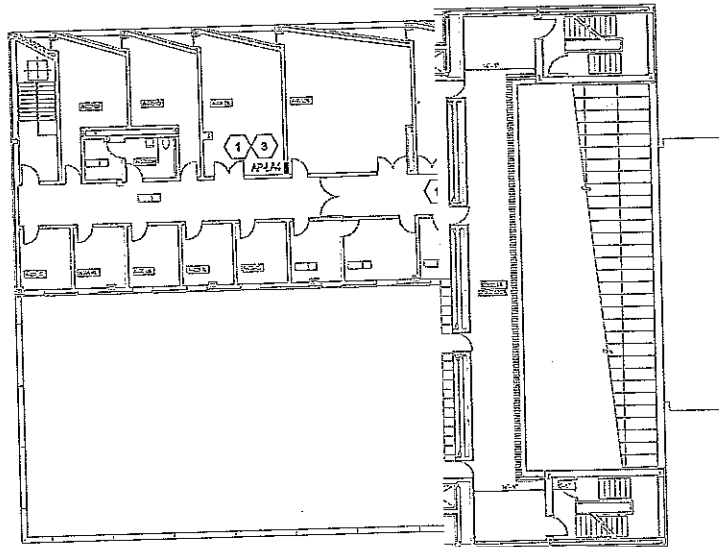
**C1 CRANE MUSIC COMPLEX - SCHUETTE UPPER LEVEL FL.**  
SCALE: 1/8" = 1'-0"

- DRAWING SPECIFIC NOTES:**
- 1 REMOVE EXISTING PANELBOARD IN THIS LOCATION AND REPLACE WITH NEW PANEL BOARD AS SHOWN.
  - 2 SEE DETAIL A2/A-501 FOR ARCHITECTURAL WORK.
  - 3 SEE DETAIL A2/A-501 FOR ARCHITECTURAL GRY WALL WORK.

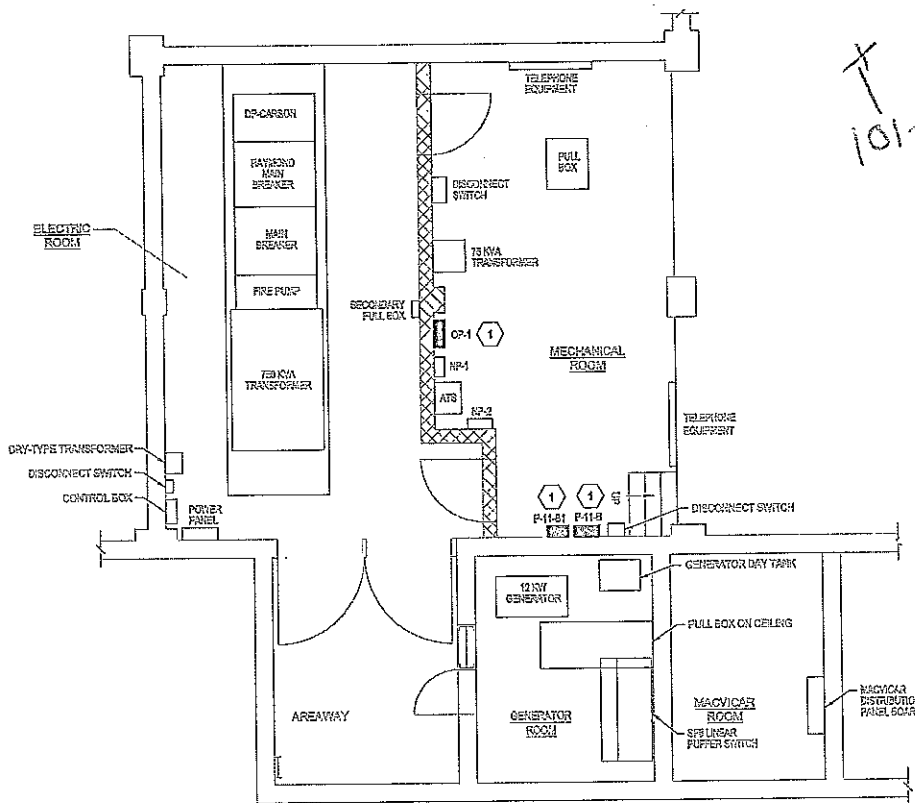
**A1 MOREY - FIRST FLOOR PLAN**  
 SCALE: 1/8" = 1'-0"

1  
DRAWING SPECIFIC NOTES:  
REMOVE EXISTING PANEL BOARD IN THIS LOCATION AND  
REPLACE WITH NEW PANEL BOARD AS SHOWN.

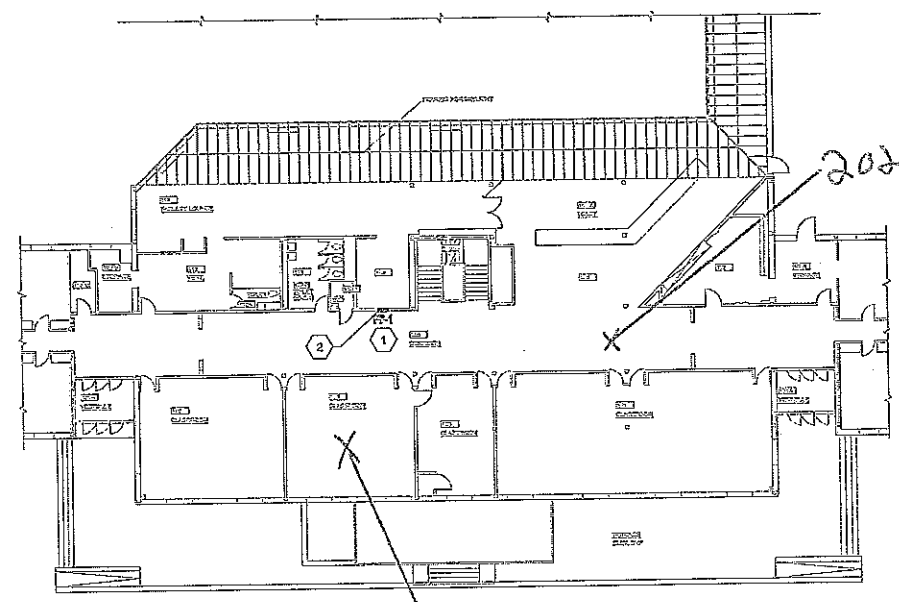
A1 CARSON - BASEMENT PLAN  
SCALE: 1/8" = 1'-0"

2  
DRAWING SPECIFIC NOTES:  
1 REMOVE EXISTING PANEL BOARD IN THIS LOCATION AND  
REPLACE WITH NEW PANEL BOARD AS SHOWN.  
2 SEE DETAIL A2/A-501 FOR ARCHITECTURAL WORK

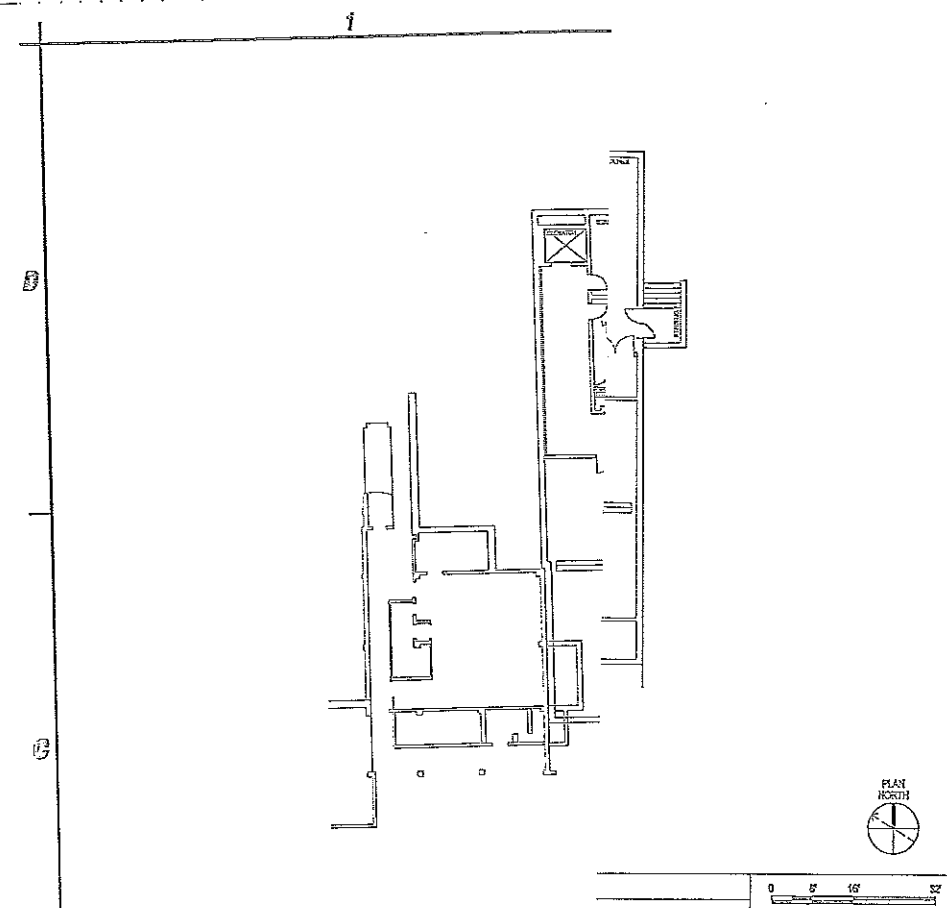
C1 TIMMERMAN - BASEMENT PLAN  
SCALE: 1/8" = 1'-0"

A1 TIMMERMAN - FIRST FLOOR PLAN  
SCALE: 1/8" = 1'-0"

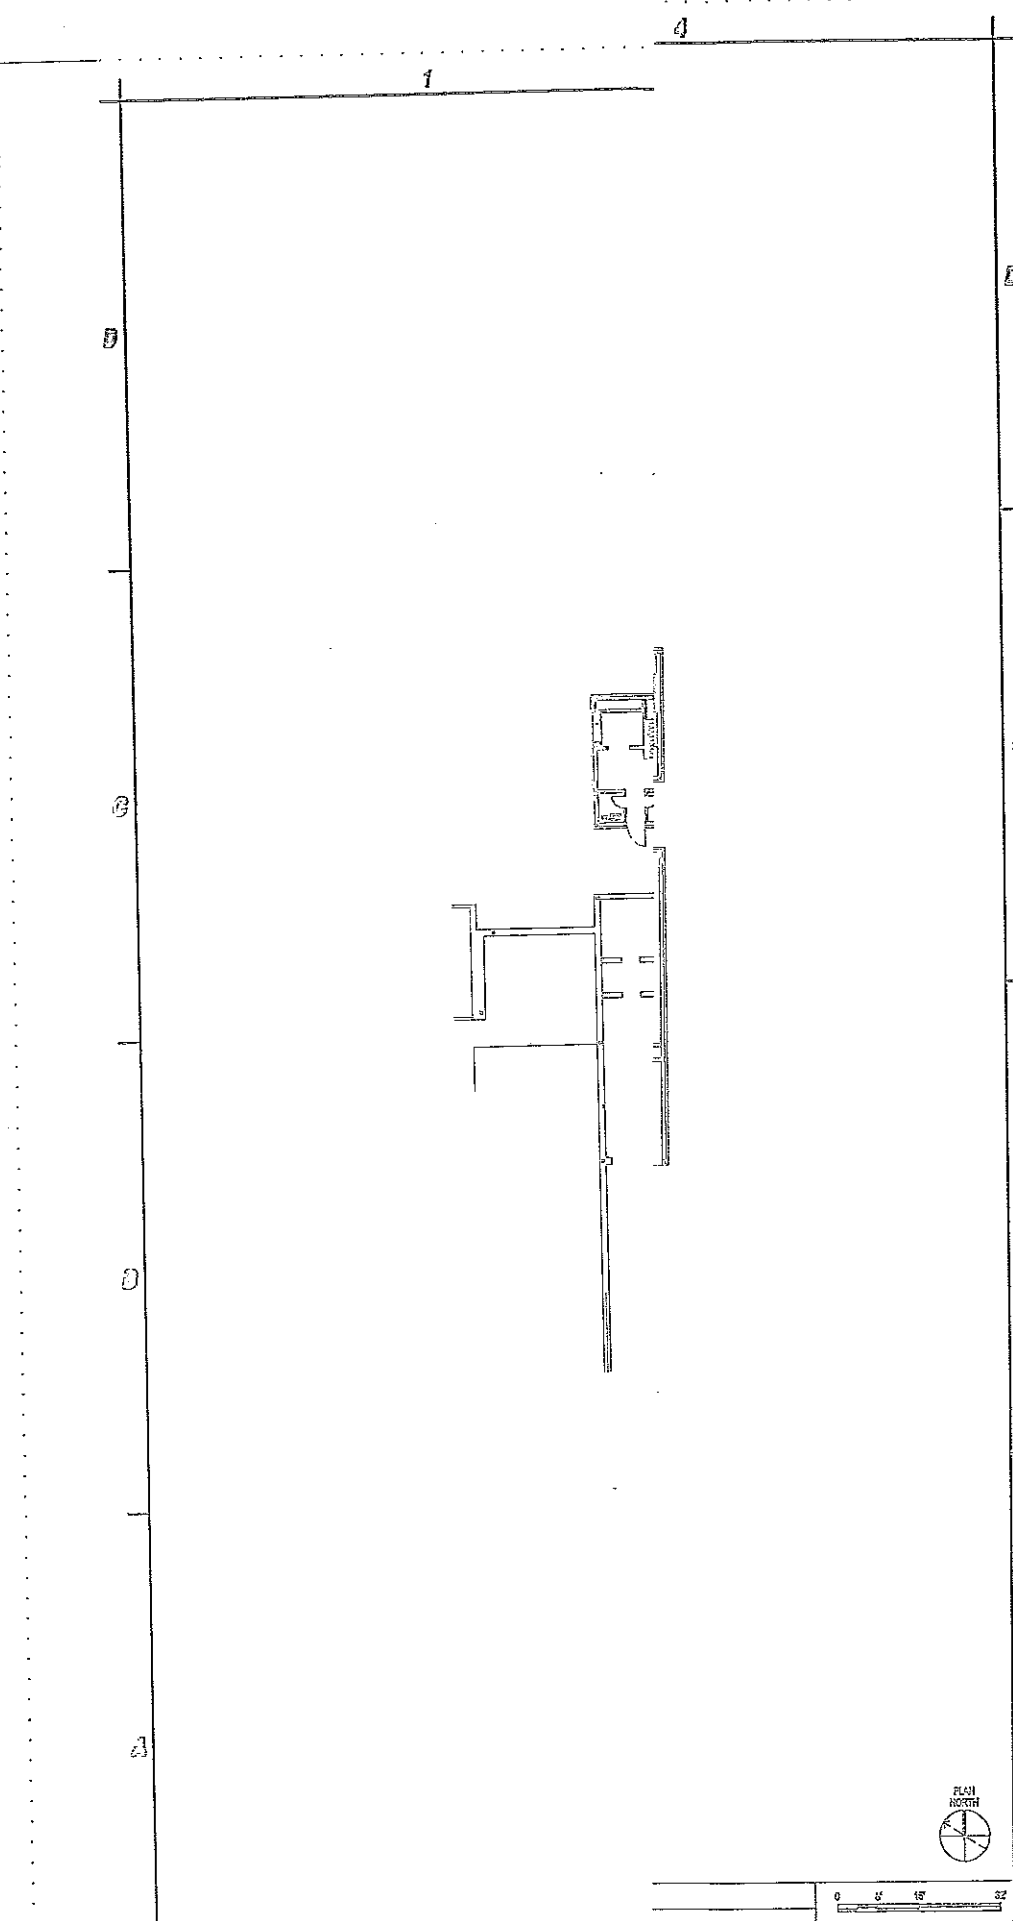
E-100-27b

ELECTRICAL  
TIMMERMAN  
SECOND FLOOR  
PLAN

A1 TIMMERMAN - SECOND FLOOR PLAN  
SCALE: 1/8" = 1'-0"
